Report No.1: Water quality monitoring and testing in the Cam and its tributaries: bacterial indicators of faecal contamination, and phosphate and nitrate status

Mike Foley, Cam Valley Forum

24th August 2021

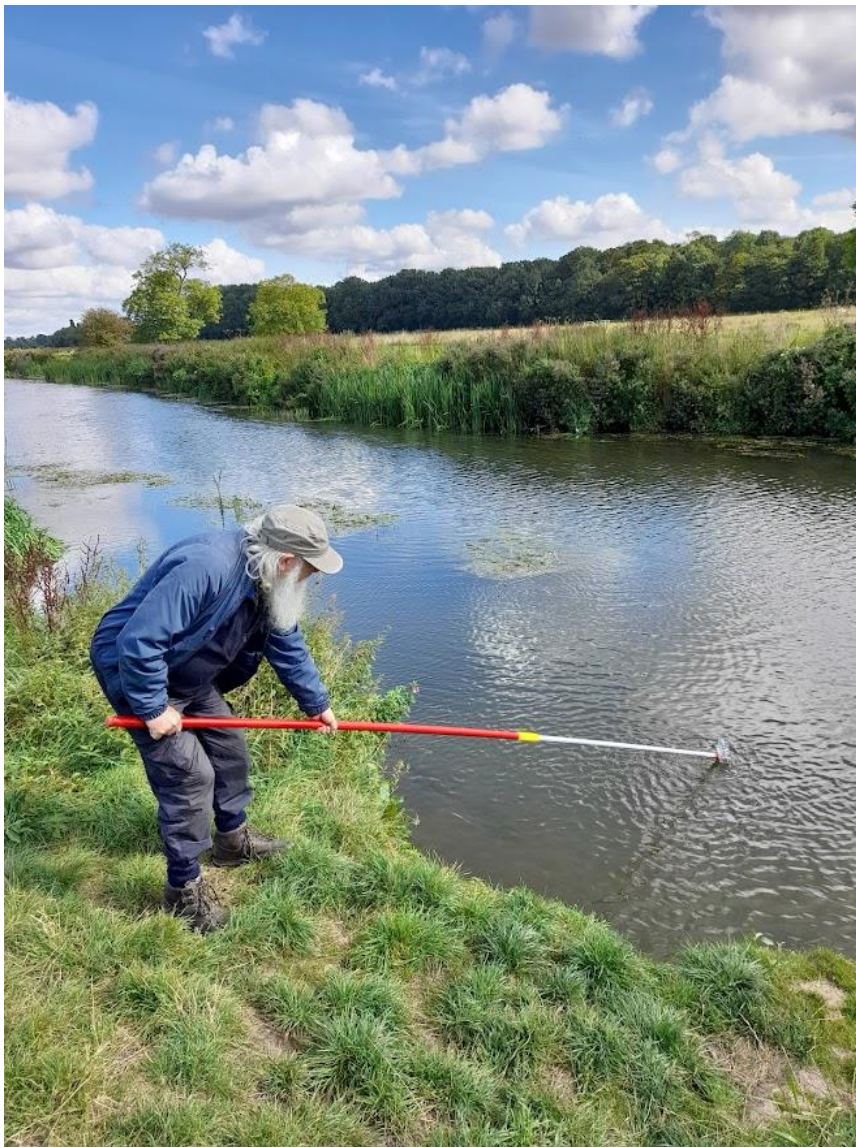
Cam Valley Forum's Bruce Huett, sampling river water at Grantchester Meadows for bacterial indicators of faecal contamination

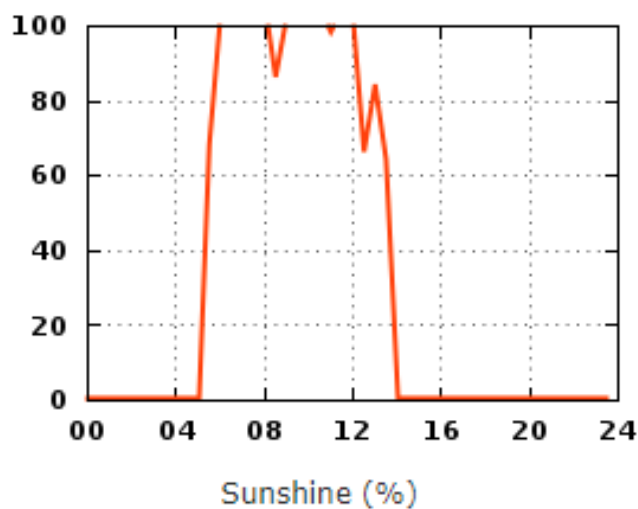
- 3.8.3 The graph shows the percent sunshine on 14th June 2021 (Digital Technology Group (DTG), University of Cambridge (amateur-maintained weather station), William Gates Building, 15 JJ Thomson Avenue, Cambridge CB3 0FD, 6 km from Haslingfield WwTW). Below is a screenshot of their web page [Reference⁴]

Figure 2: Sunshine intensity of 14th June

- 3.8.2 Conditions on and prior to the day of sampling are being recorded. Air temperature was 20-25°C; sunshine was intense until 1200 and reduced by 1330 by a veil of light cloud, though it was still remained very bright. Only sample [5] was taken after 1330 (taken at 1335), but if the source was some distance upstream, UV kill would have occurred earlier on while the bacteria were still travelling.

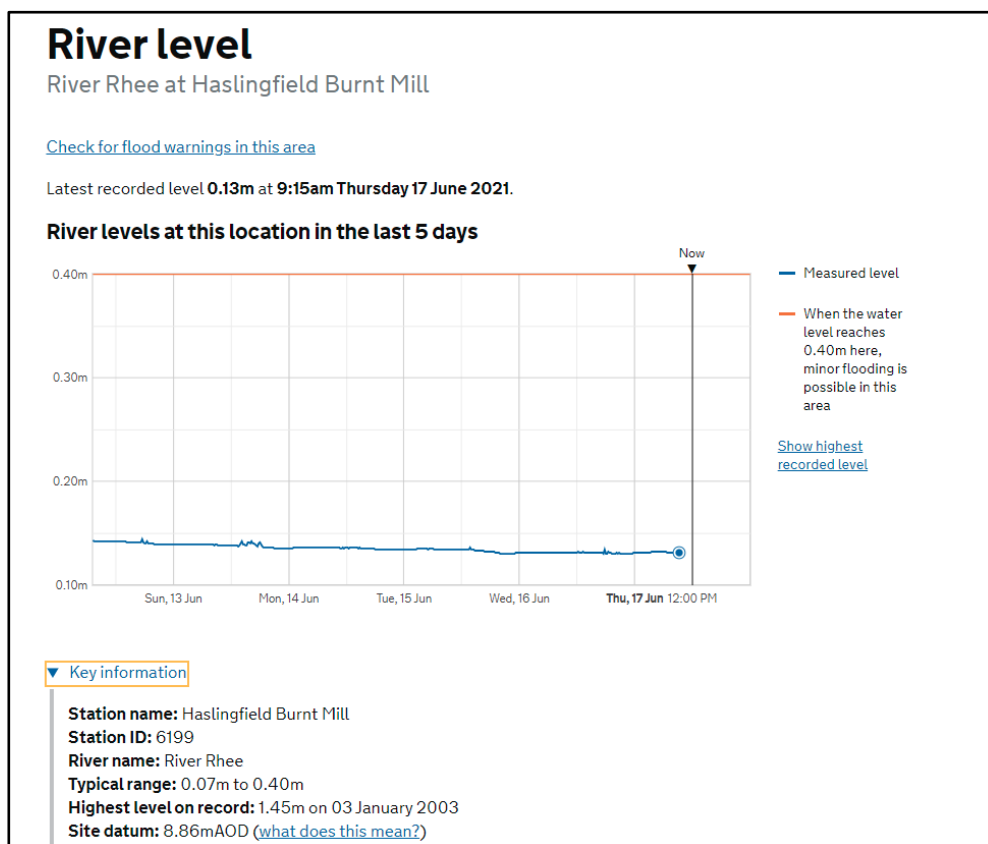
- 3.8.5 A screenshot of the river level at Burnt Mill, Haslingfield is shown below [reference⁵]. The level was dropping slightly immediately before the sampling date.

Figure 3: Level of River Rhee at Burnt Mill, Haslingfield in the period

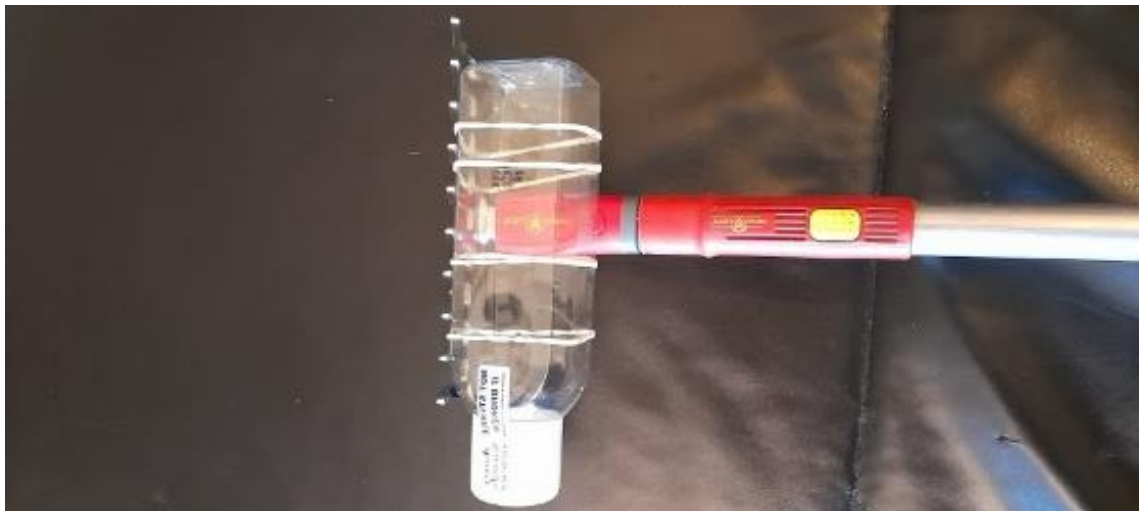
Figure 6: Secured bacterial sampling bottle on extendible (4m) Wolf Garten pole with attached rake head

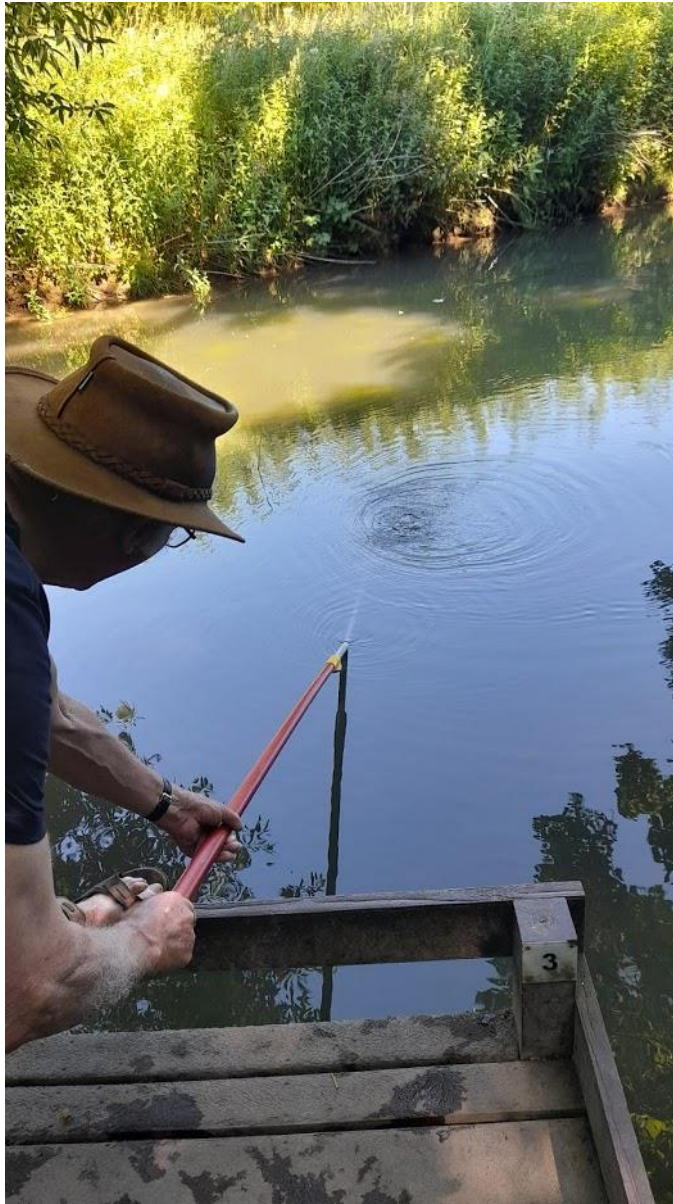
Figure 7: Below Bryon's Pool: sampling bottle immersed in river away from bank, attached to extendible pole; rate of air bubbles exiting bottle aiding judgment to adjust flow into the bottle

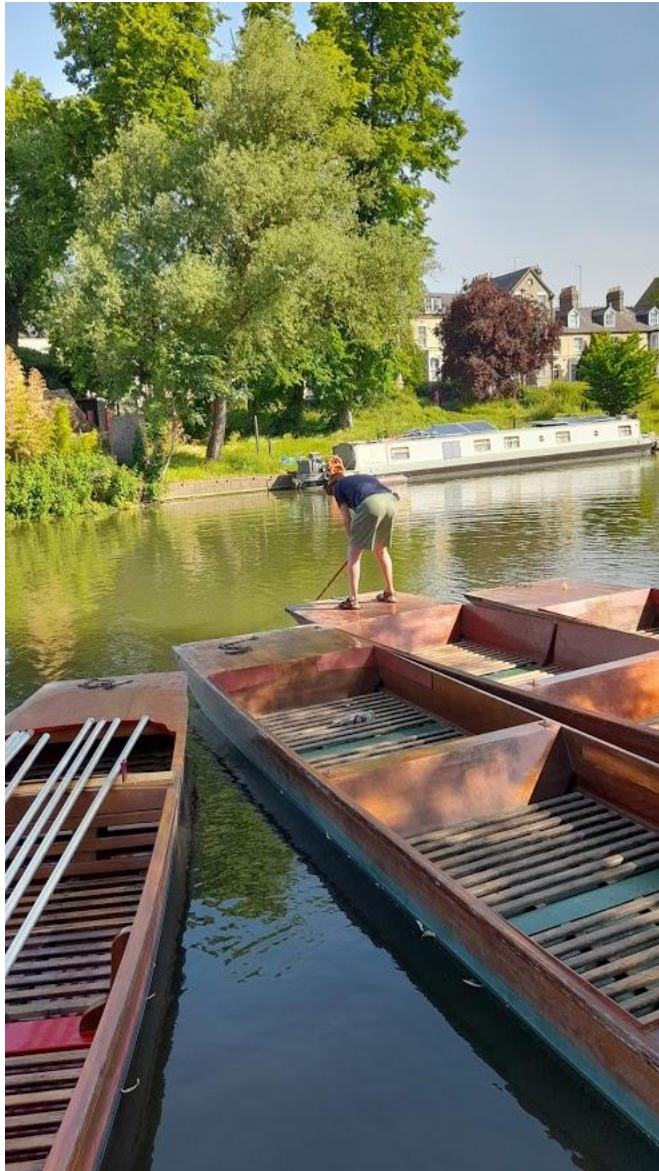
Figure 8: Sampling at Jesus Green on a wide part of the river; from a moored punt facilitating sampling further out from the bank

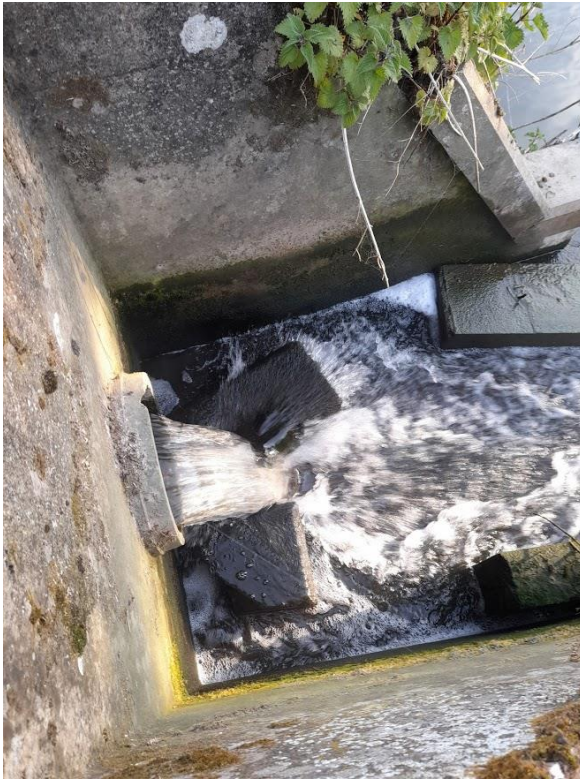
Figure 9: Haslingfield WwTW discharge point

- 3.9.1 At the Haslingfield discharge point, the treated effluent appears clear to the eye. It flows in an arc partly across river, according to the flows of the effluent and the river (Figure 10). An uneven blend of river water and effluent will occur immediately below the discharge point. Note that water turbidity was similar below and above the discharge point.

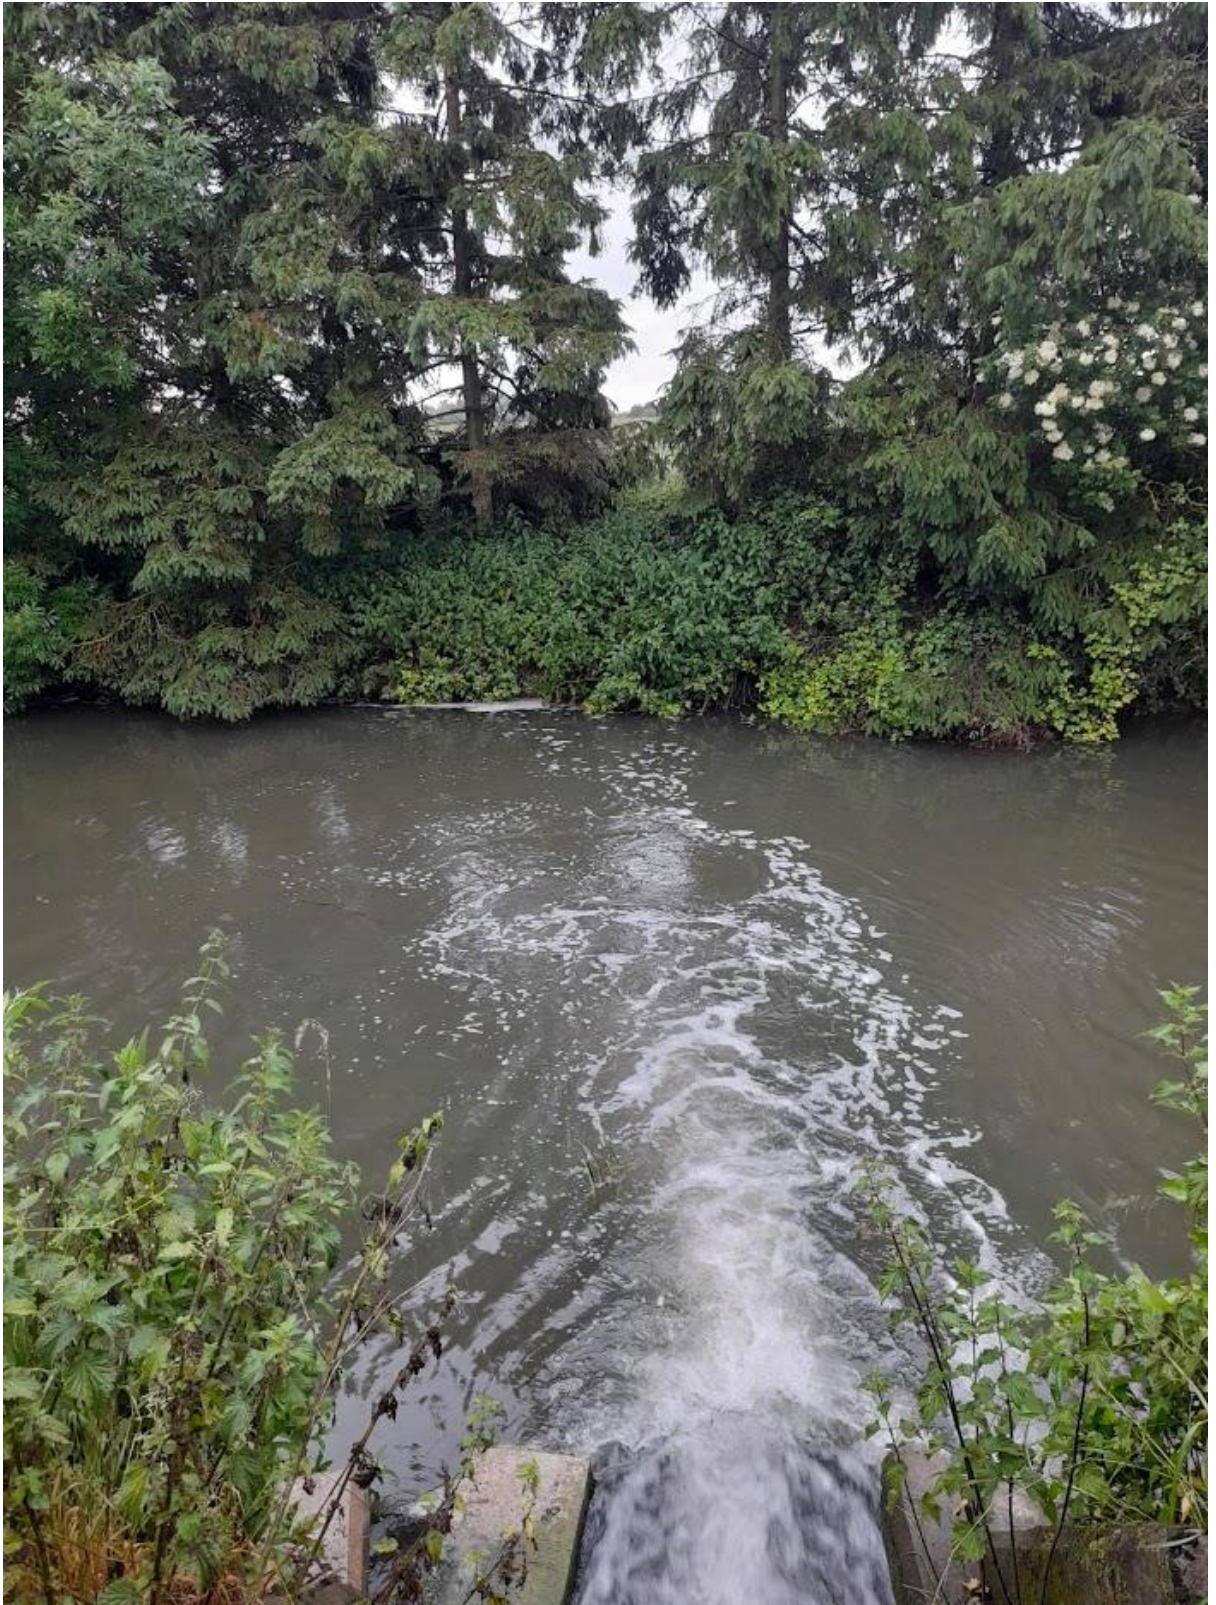
Figure 10: Effluent arcing across the Rhee

- 3.9.2 Several fish, identified as Dace from a photograph (Rob Mungovan, Wild Trout Trust) were feeding (or at least moving actively) along the upstream edge of the effluent flow.

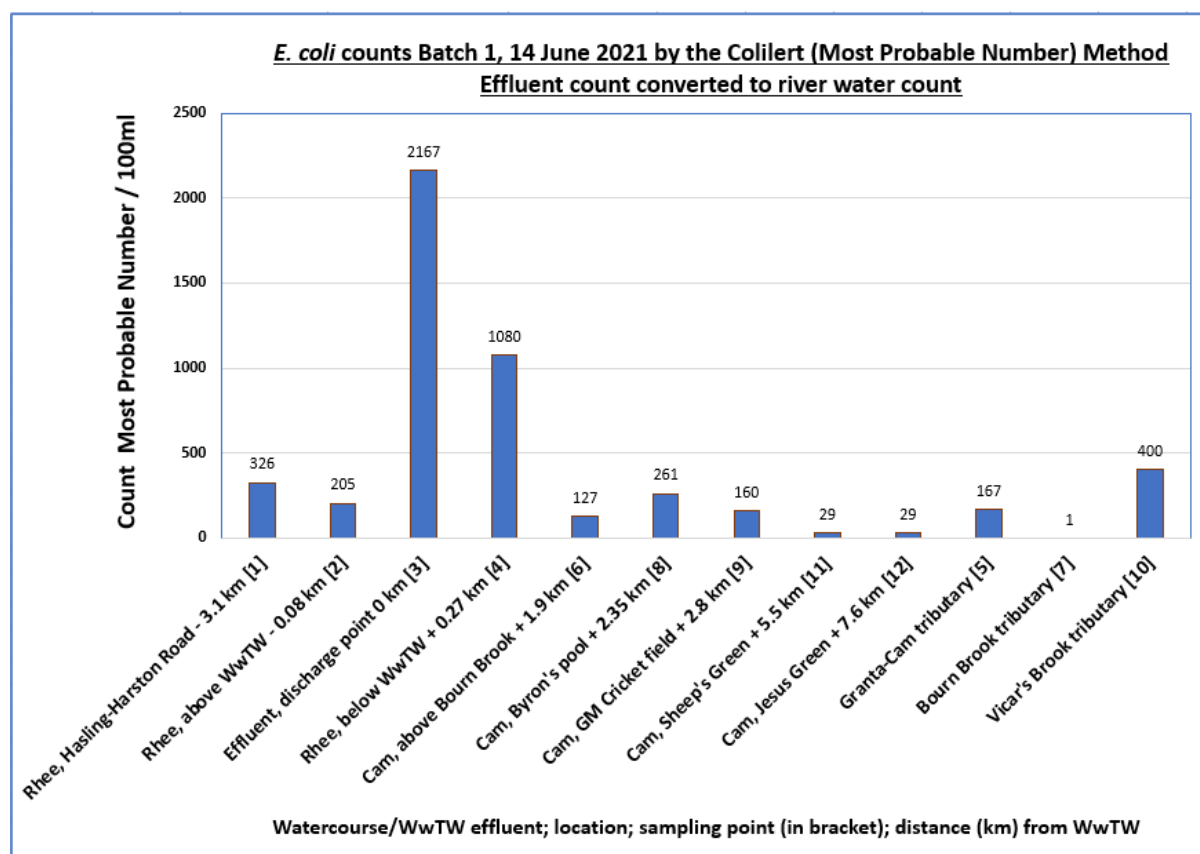
- 5.2.1 The converted effluent count can now be included in the sequence of counts on the river (Figure 12).

Figure 12: Counts of *E. coli* at the 12 sampling points (effluent count converted to a river water count)

- 5.2.2 The calculated count of *E. coli* in the river after effluent was mixed with river water forms an important part of the overall picture. Counts at eight sites along the river can be compared between each other but valuable information is gained by having a river water count from the WwTW's discharge. The count of *E. coli* immediately above the WwTW at point [2] was 9.4% of the effluent 'river count' at the WwTW and was 15% higher further upstream at point [1]. Both counts above the WwTW were higher than at point [6] which is 1.9km below the WwTW, suggesting that there is either a moderate source close to and above point [1], or a much more potent source further upstream. Potential sources of *E. coli* further upstream need to be investigated.

- 5.2.3 Sampling only 270m downstream from the WwTW at point [4], the count dropped by 38%. No dilutive water discharges from the fields are known to occur between the two points during summer months, suggesting that the marked drop over such a short distance was caused by some lethal factor, such as UV radiation, which was high on the day.

one. The doubling in numbers just below Byron's Pool (point [8]) might have been due simply to variability, or a recharge from a local, natural faecal source. At +5.5 km from the WwTW, at Sheep's Green the count was still very low and precisely the same was found at Jesus Green 2.1 km further downstream. The Vicar's Brook count was higher than most.

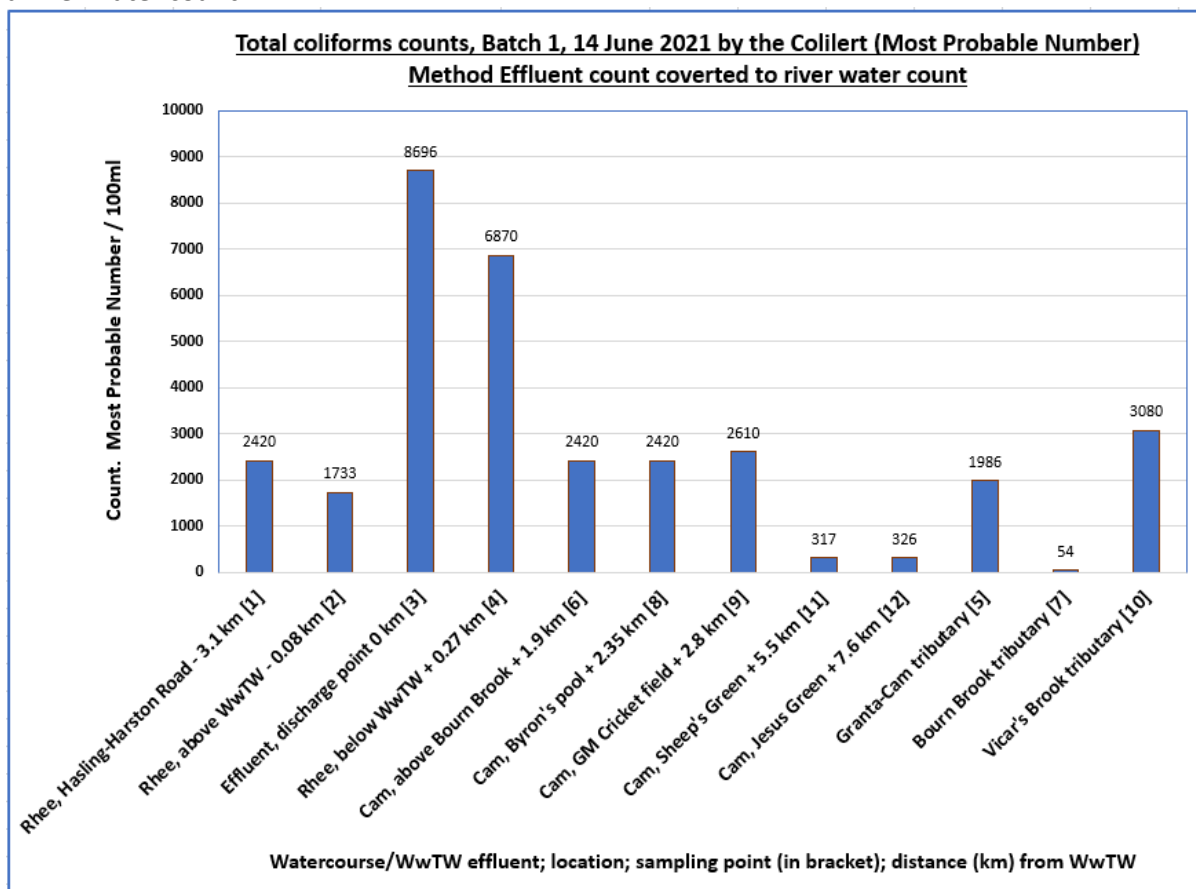
Figure 14: Counts of total coliforms at the 12 sampling points, effluent count converted to a river water count

- 5.3.2 The pattern of counts above and below the WwTW was roughly similar to that for *E. coli* with numbers always markedly higher than for *E. coli*. Much lower counts were found at the three sites mentioned above.

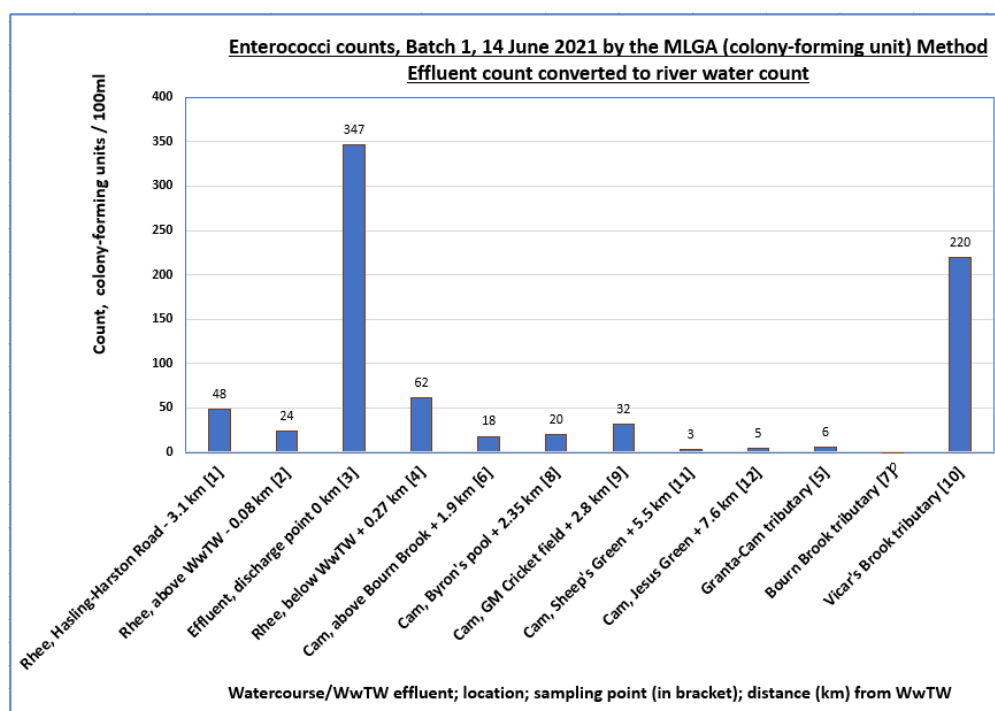
Figure 15: Counts of enterococci at the 12 sampling points, effluent count converted to a river water count

5.4.2 6200 CFUs/100ml were counted in the pure effluent. Again, the pattern of counts over distance was broadly similar to the other groups. The count at Vicar's Brook stands out as much higher than at any site except for the WwTW effluent.

5.4.3 A comparison of the abundance of *E. coli* and enterococci in this batch of samples shows that numbers of *E. coli* were consistently higher.

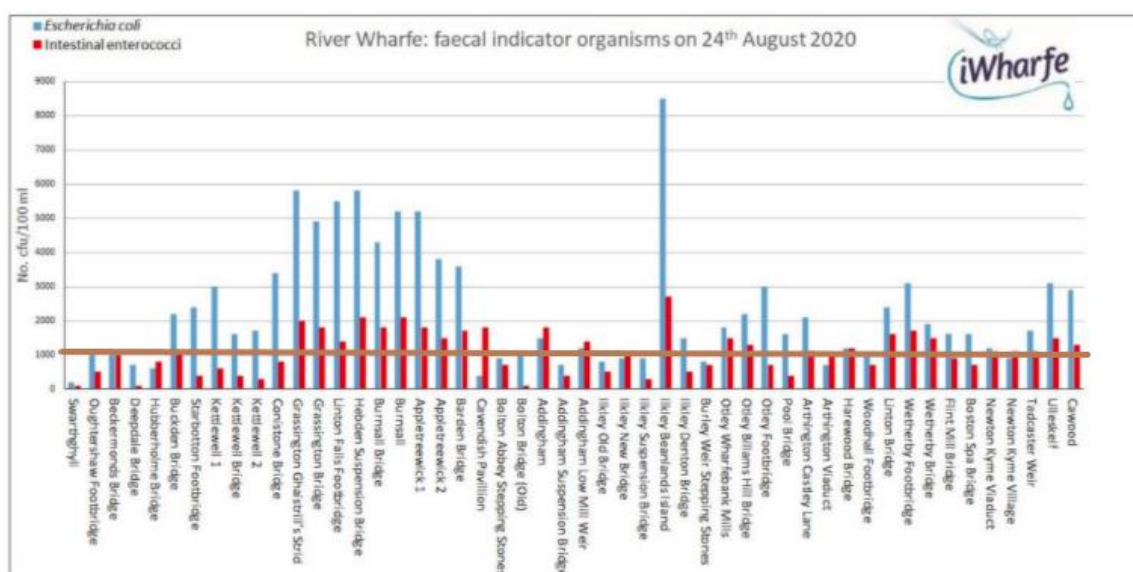
Figure 16: River Wharfe faecal indicator bacteria monitoring, 24th August 2020 ('iWHARFE')

Figure 2. E. coli and IE data for 50 sampling sites on the R. Wharfe

5.6.3 Point 1: The iWHARFE project sampled for *E. coli* and enterococci at each site, and found that, except in five cases, the counts of *E. coli* were higher and often considerably higher.

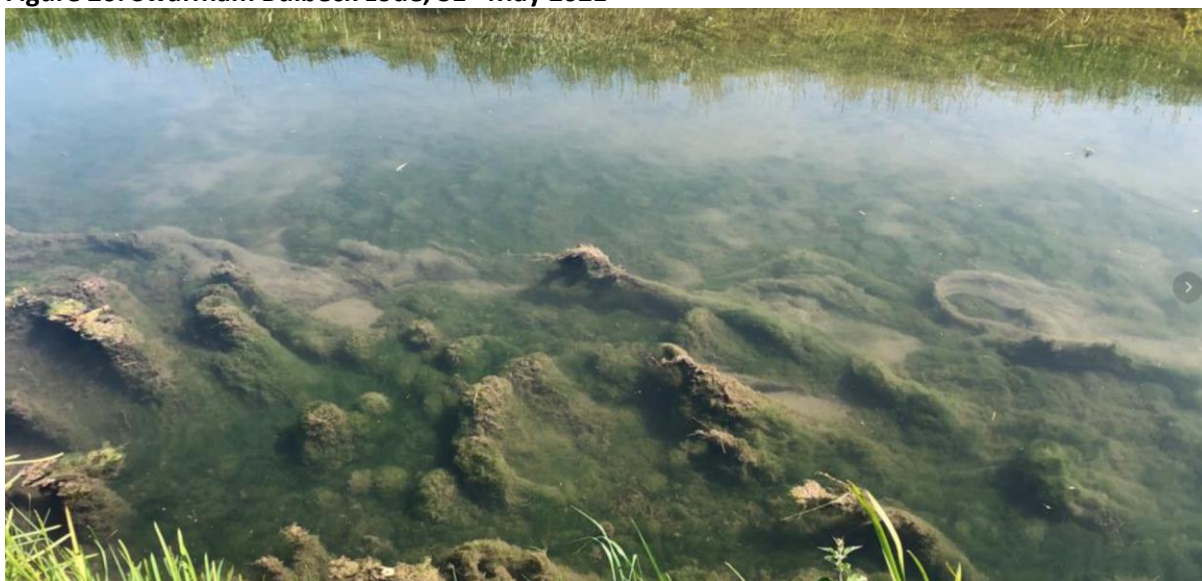
Figure 20: Swaffham Bulbeck Lode, 31st May 2021

- 9.7.1 The thick, heavy benthic layer of green material in this section of the lode is largely filamentous algae which covers the bed silt and other macrophytes, reducing light availability.
- 9.7.2 The data in Figure 21 show high levels of nitrate throughout 2109, peaking in September. Ammonia is well below a harmful level. Phosphate-P clearly peaks during summer, being of 'poor' status earlier in the year and becoming 'bad'.

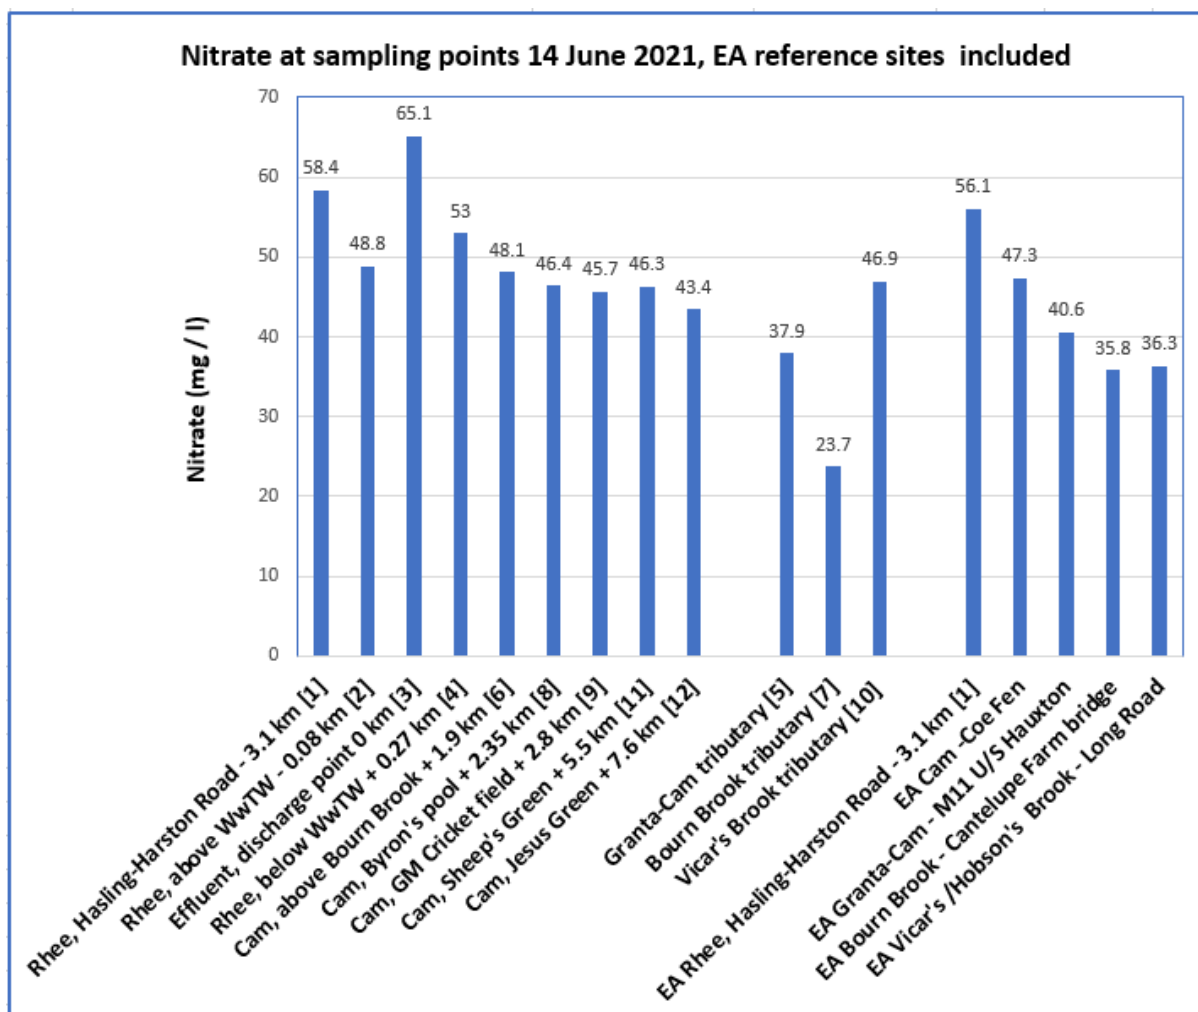
Figure 22: Nitrate concentrations of all sampling points, with mean concentrations at EA sampling points included as reference data.

The measurement of nitrate concentration refers to sampled pure effluent prior to any dilution in the river.

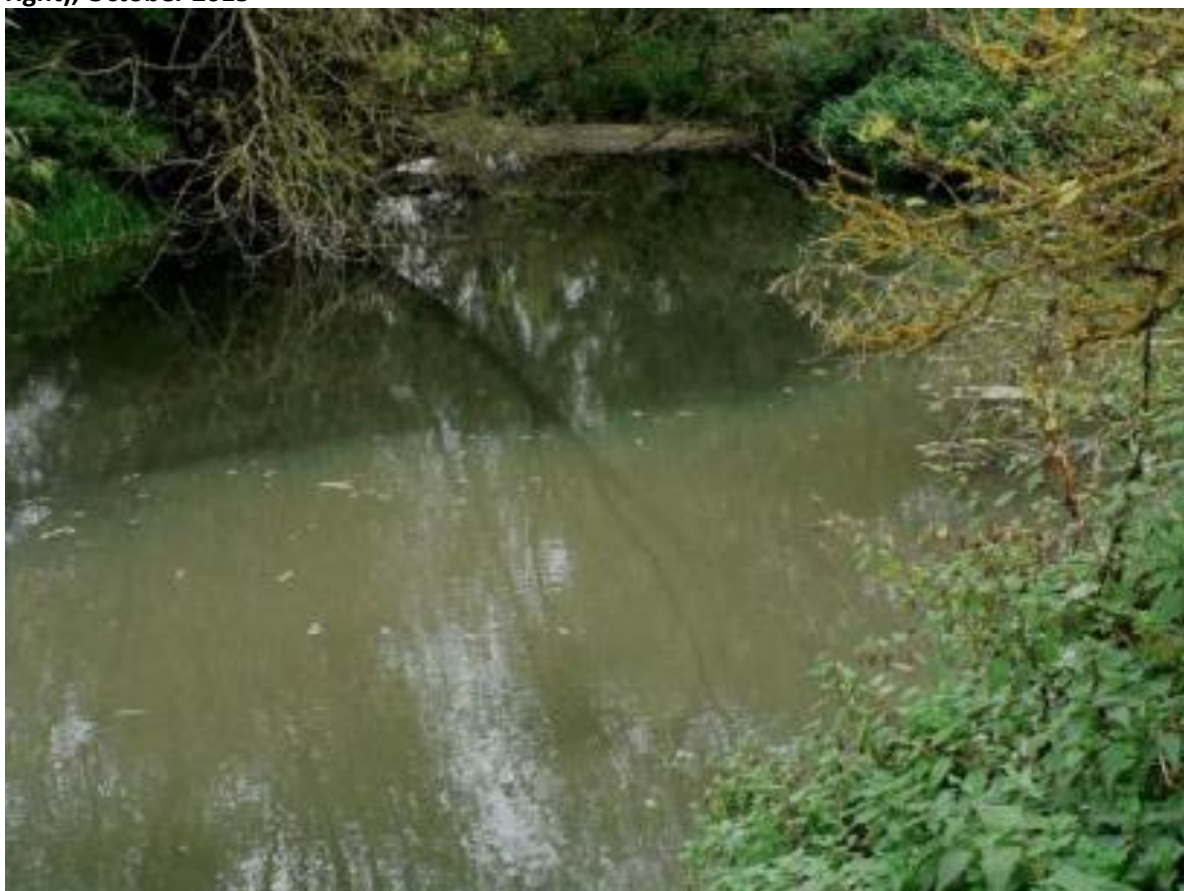
- 11.1 Turbidity is the clarity of water and it is an important factor in water quality. Materials that can cause water to be turbid include: clay colloids, silt, sediment from bank erosion, tiny inorganic matter and coloured, dissolved organic matter, algae, waste discharges, chemical precipitates, zooplankton, phytoplankton, and other microscopic organisms. Turbidity reduces photosynthetic rates, and fine sediment can clog fish gills and lower an organism's resistance to disease and parasites. Settlement of such fine suspended materials on the bed further downstream coats gravel and fish spawning grounds.
- 11.2 It is generally noted that the Rhee, and thus the Cam too downstream of it, is turbid over long periods. This problem is very obvious at Hauxton Junction, at the confluence with the clearer Granta-Cam

Figure 25: Confluence of Granta-Cam and Rhee (Rhee flows right to left, from bottom right), October 2015
