## **Investigating water turbidity of the River Rhee and Cam 2021-22**

**Mike Foley**  
**31 December 2022**

## Summary

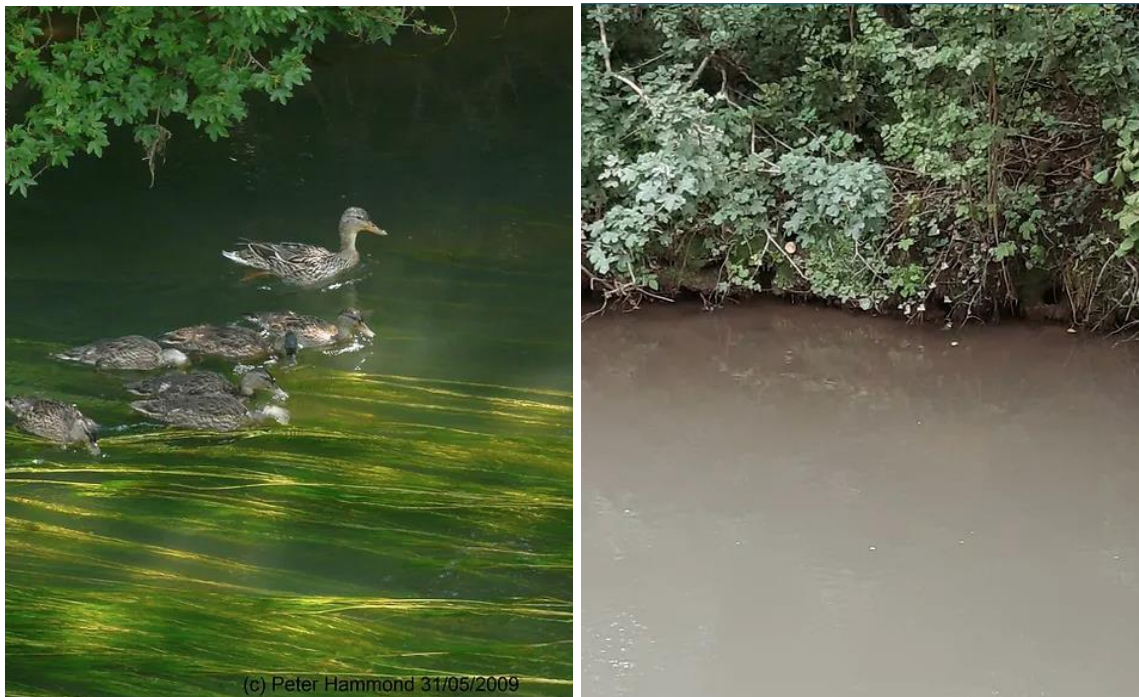
Photos: River Windrush in 2009 and again in 2020 in similar conditions

WASP – Windrush Against Sewage Pollution <https://www.windrushwasp.org/> – recently published a photograph on the River Windrush of disturbingly poor-quality water in 2020, comparing it with one of good quality taken in 2009 (in similar conditions).

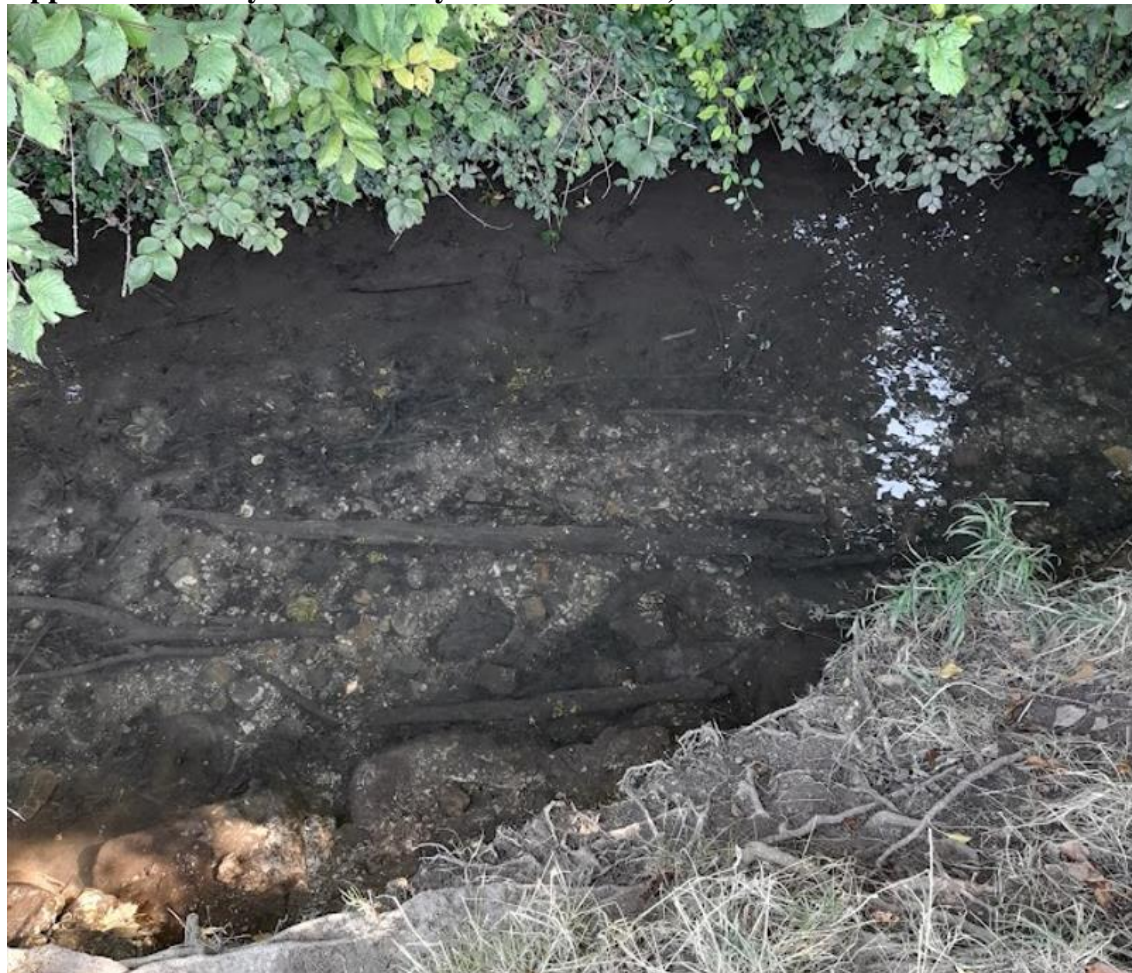
**Upper Rhee – very low turbidity at Ashwell End, 07/09/21**

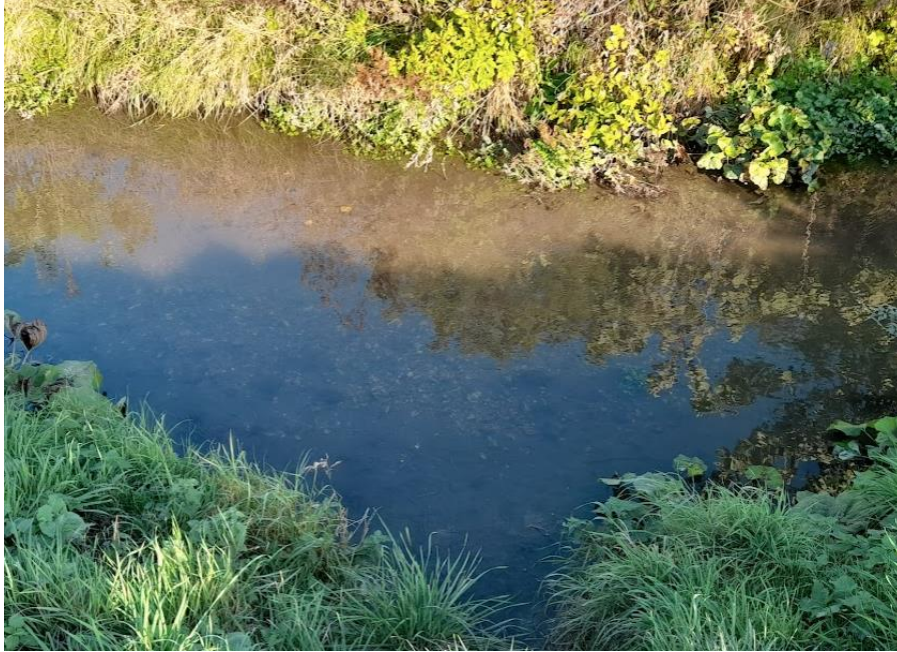
**Also, at Ashwell End 20/10/21**

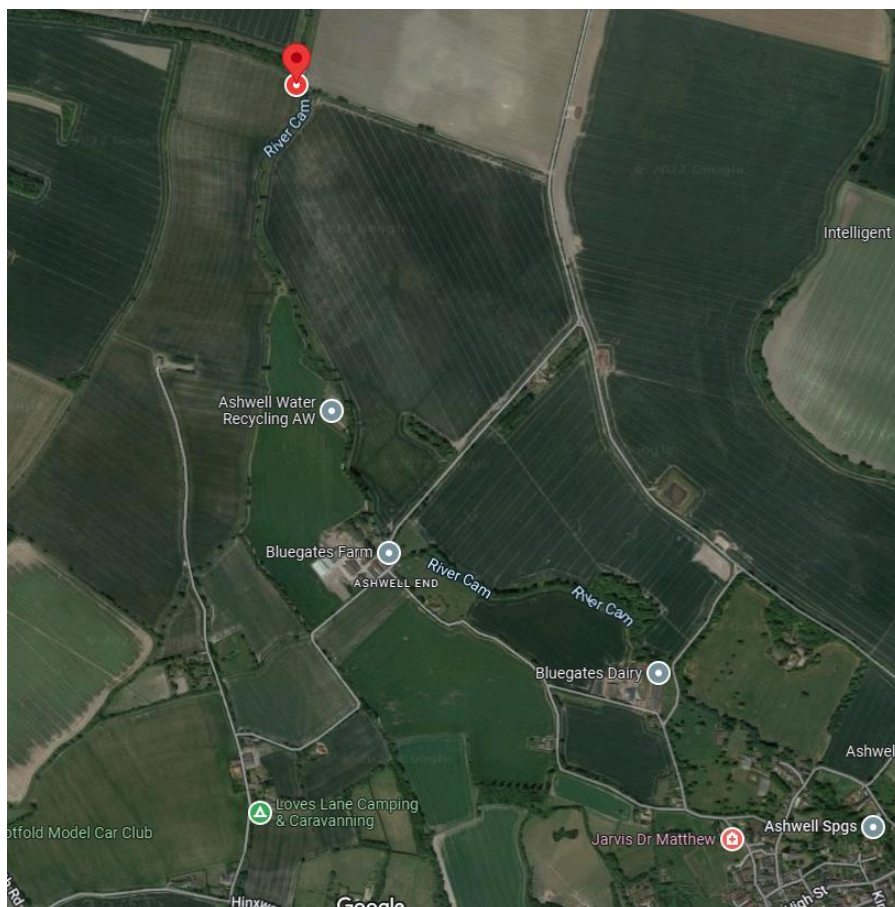
**Downstream of Ashwell End, red marker shows where obvious turbidity is present  
20/10/21**

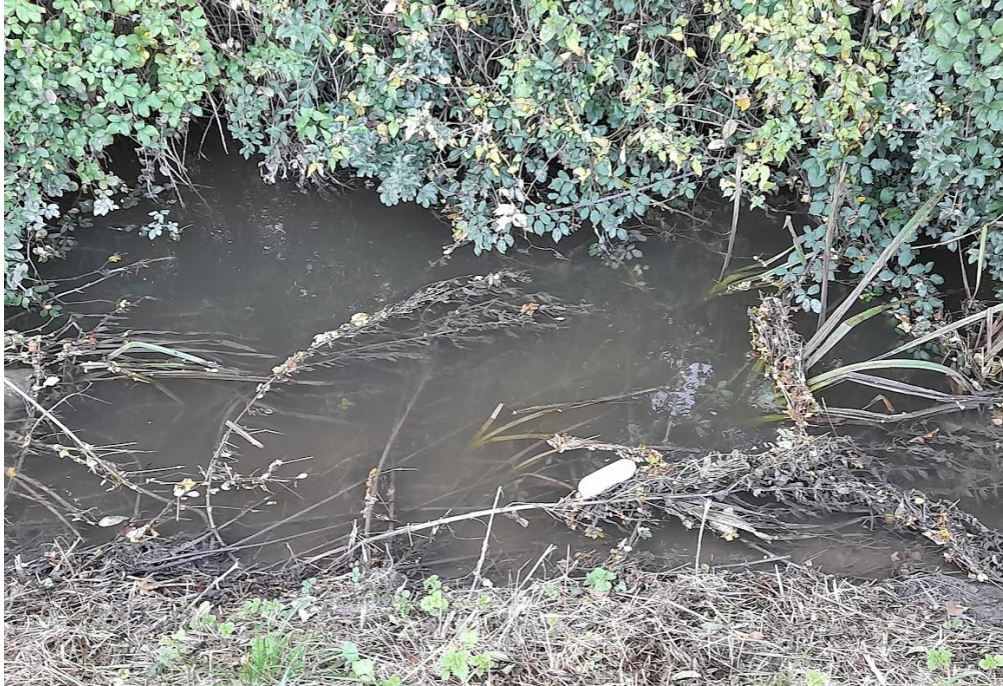
**Downstream of Ashwell End, obvious signs of turbidity 20/10/21 (see map above)**

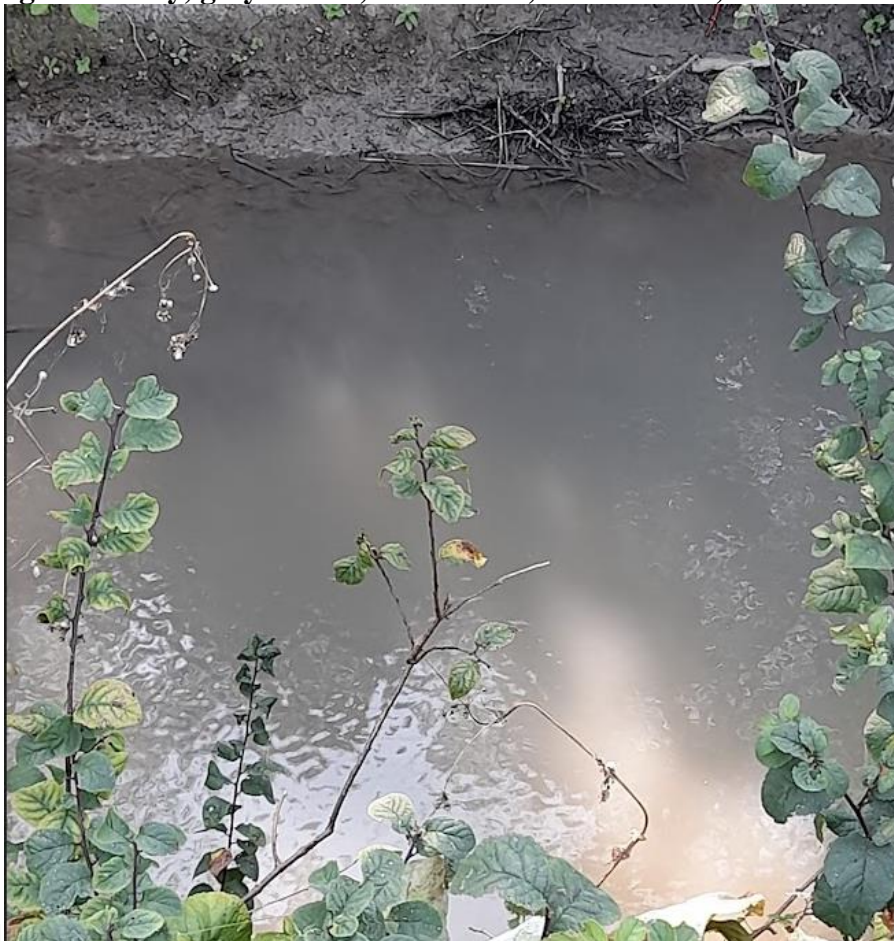
**Rhee – high turbidity, grey-brown, at HOOKS, Potton Road, near Guilden Morden,**

**07/09/21**

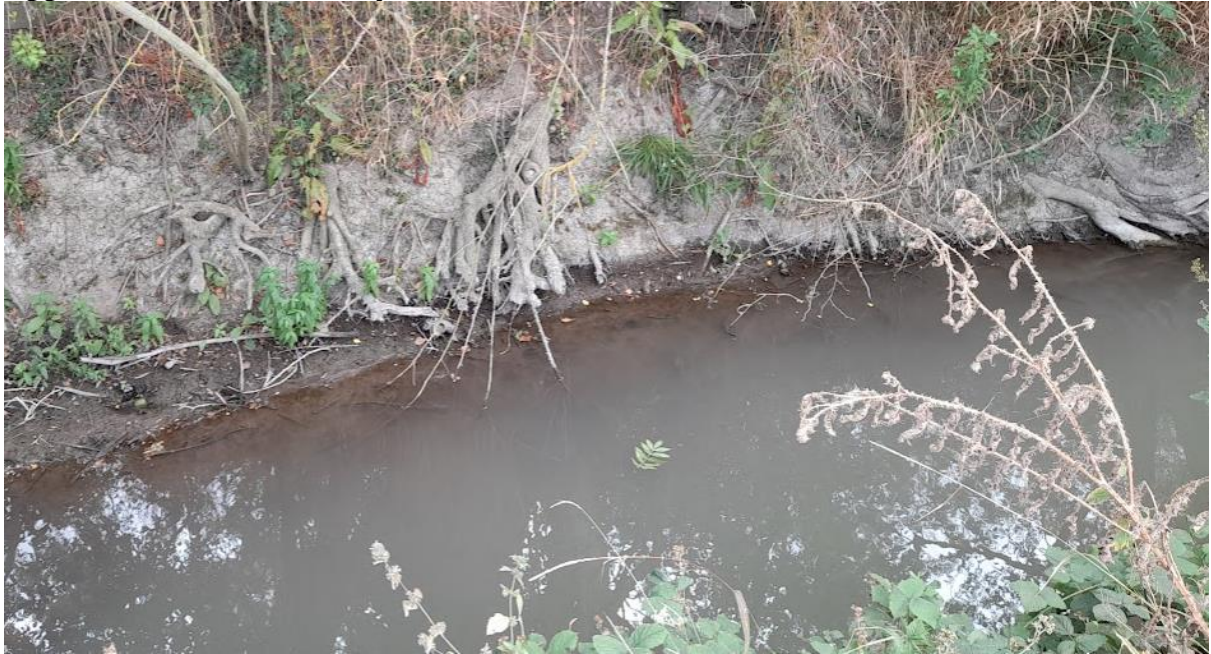
**Upper Rhee – high turbidity at HOOKS, Potton Road, near Guilden Morden, 03/08/22**

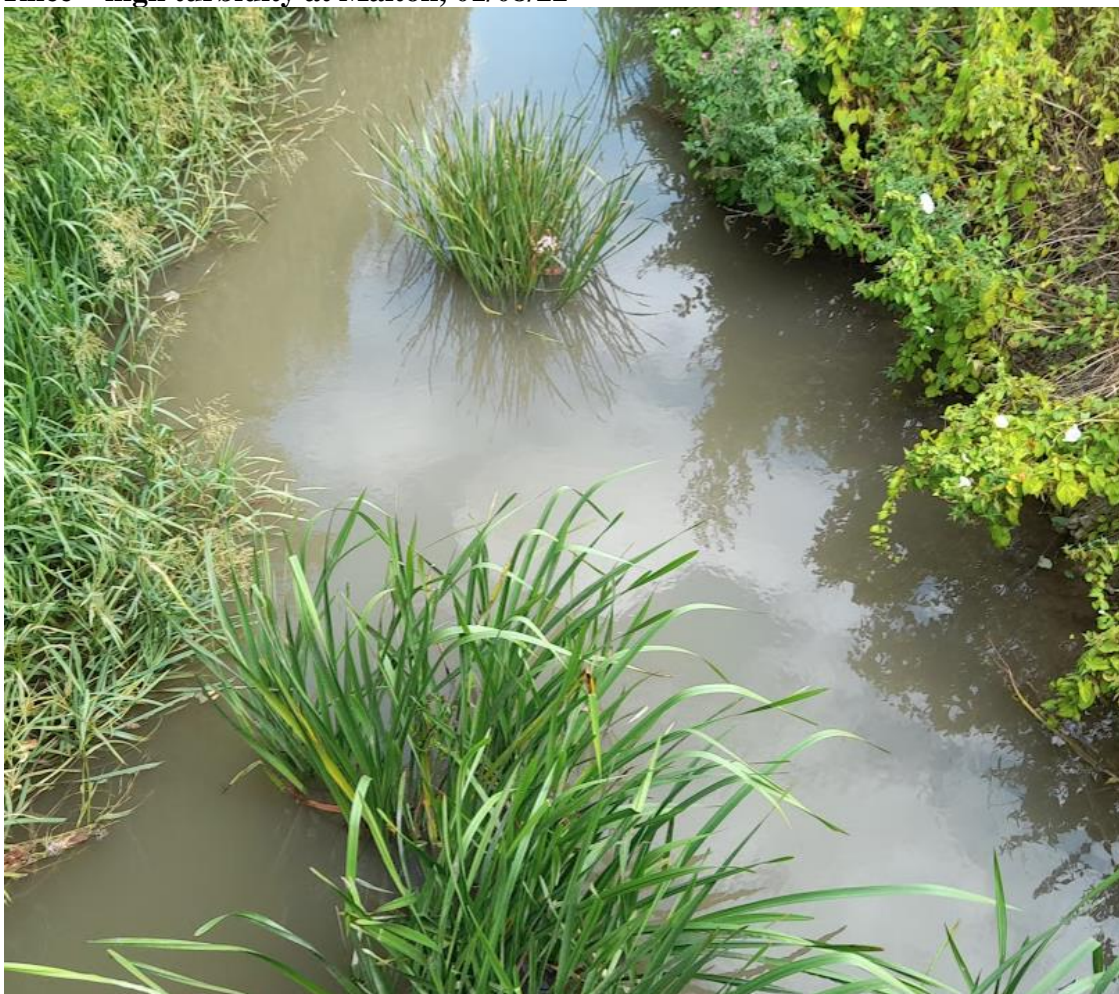
**Rhee – high turbidity at Malton, 01/08/22**

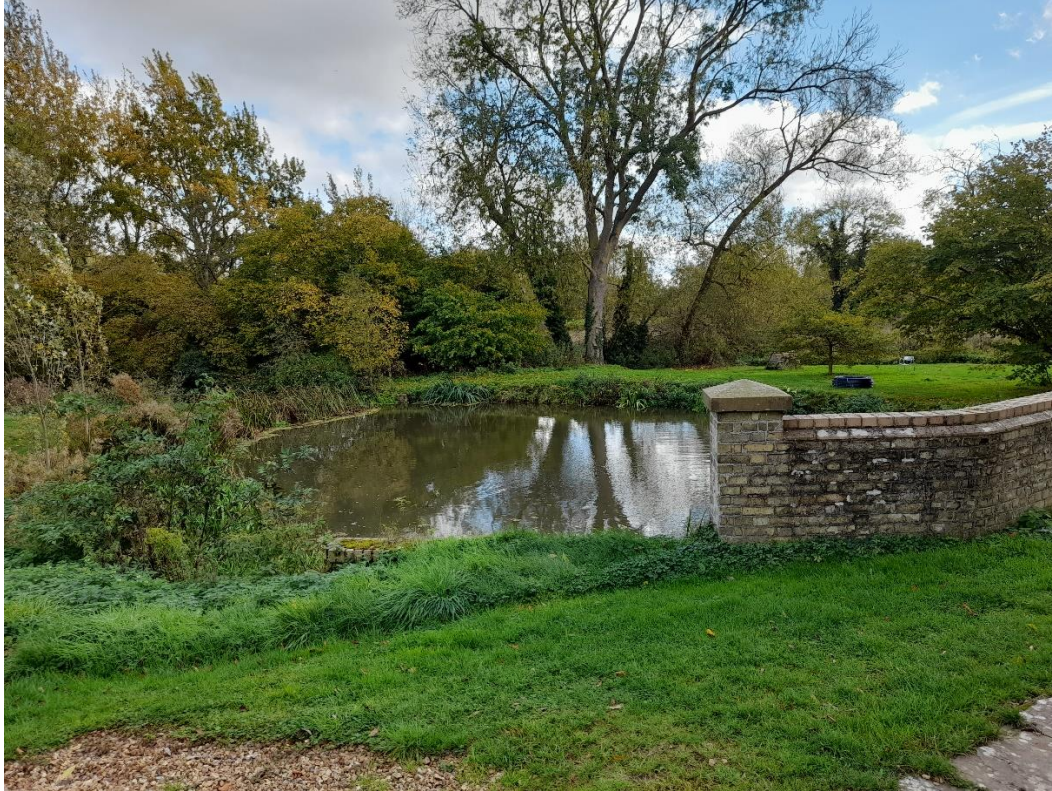
**Rhee – high turbidity at Bulbeck Mill pond, above Barrington weir, 31/10/22**

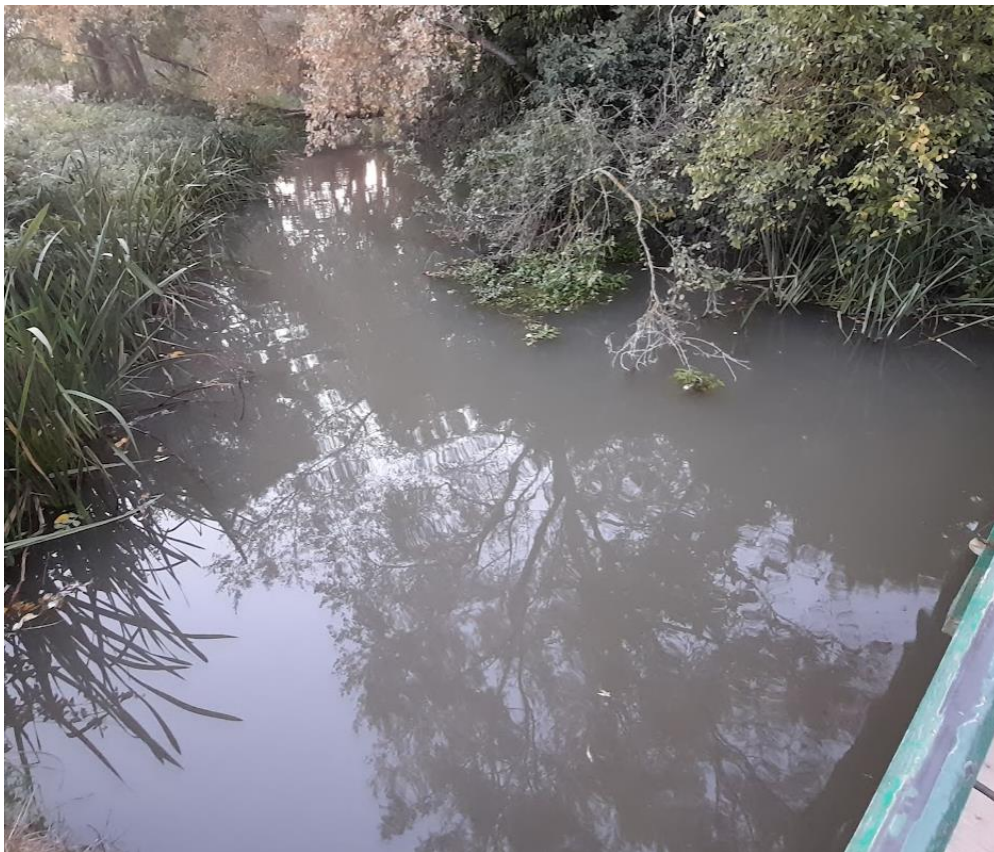
**Rhee - turbidity high at BOOT, Boot Lane footbridge, Barrington, below Barrington weir, 06/10/22**

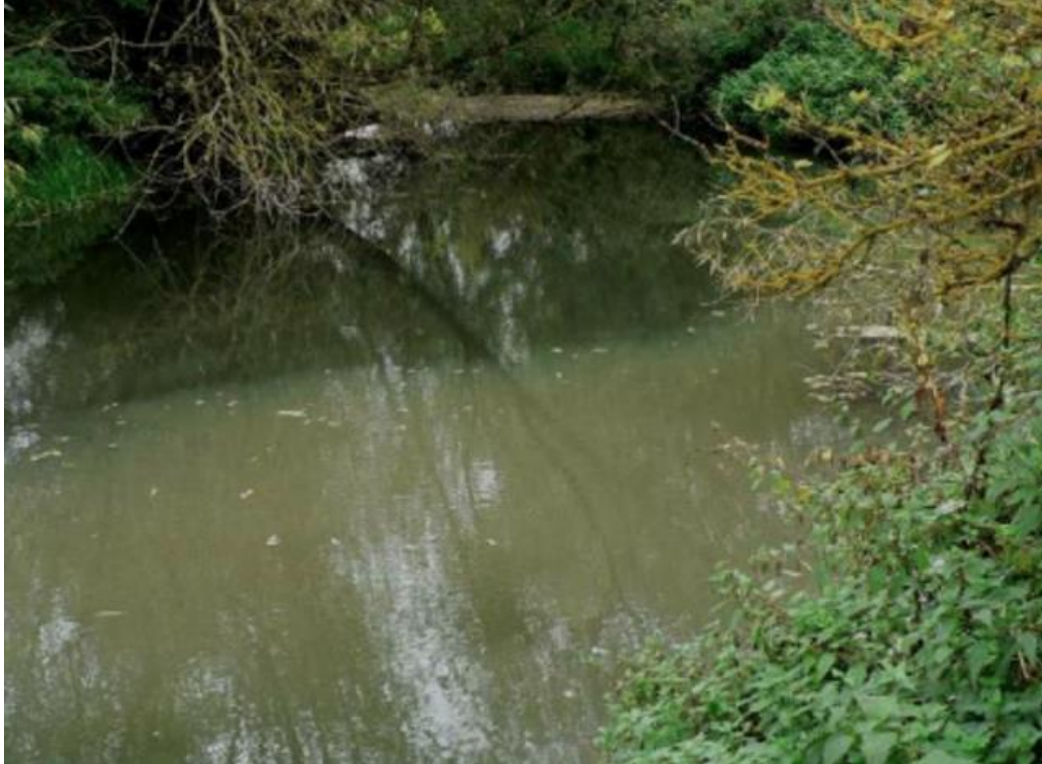
**Clearer water exiting the Essex Cam at Hauxton Junction (Rhee flow from lower right)**

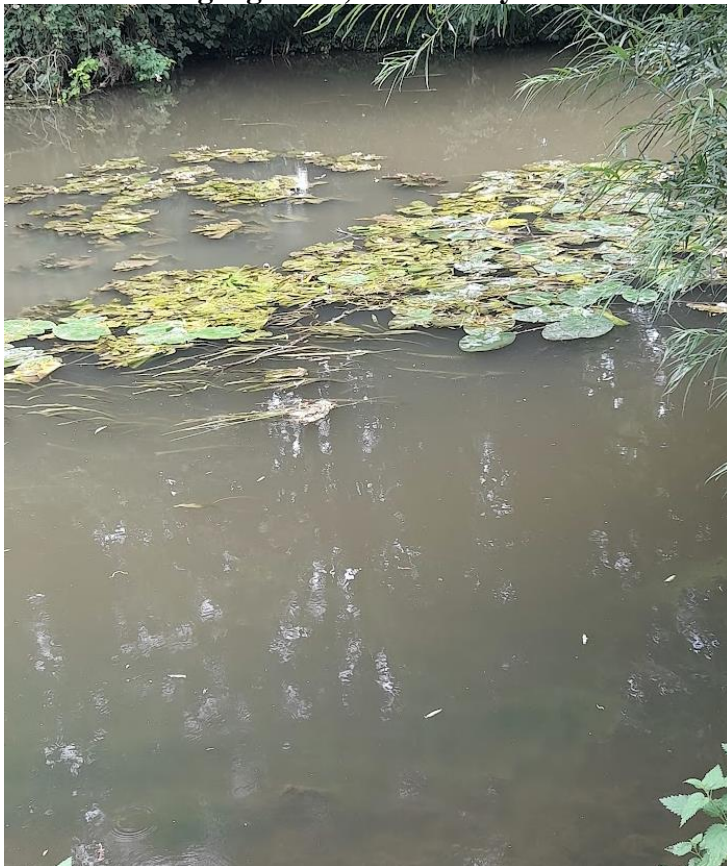
**Cam, upstream of weir at Byron's Pool, 28/07/21. Substantial amounts of benthic filamentous algal growth, more easily seen in the shallower area nearer bank**

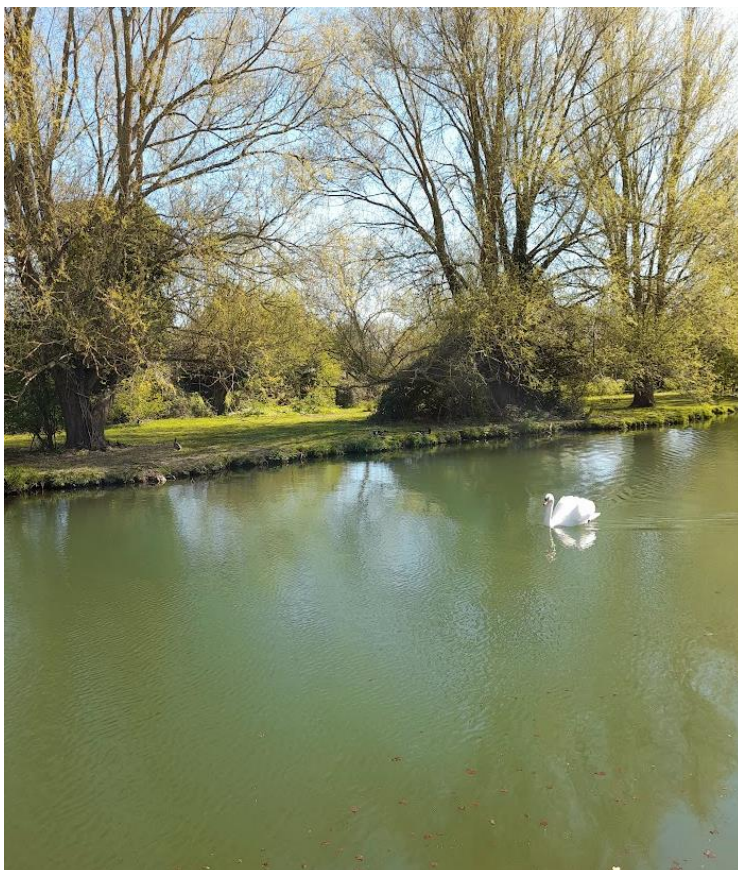
**Sheep's Green 23/04/21 one minute earlier than above, angled towards sun, apparent colour difference**

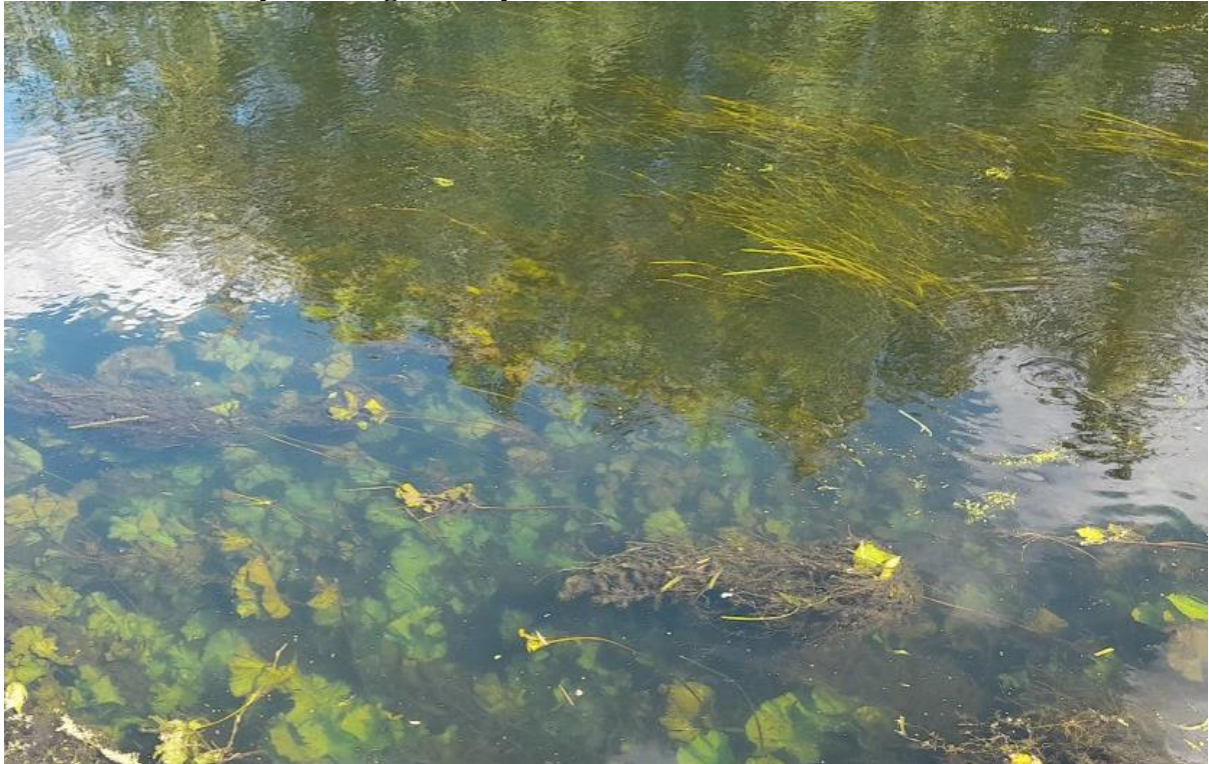
**Cam - low turbidity Horningsea-Clayhithe 05/08/22**

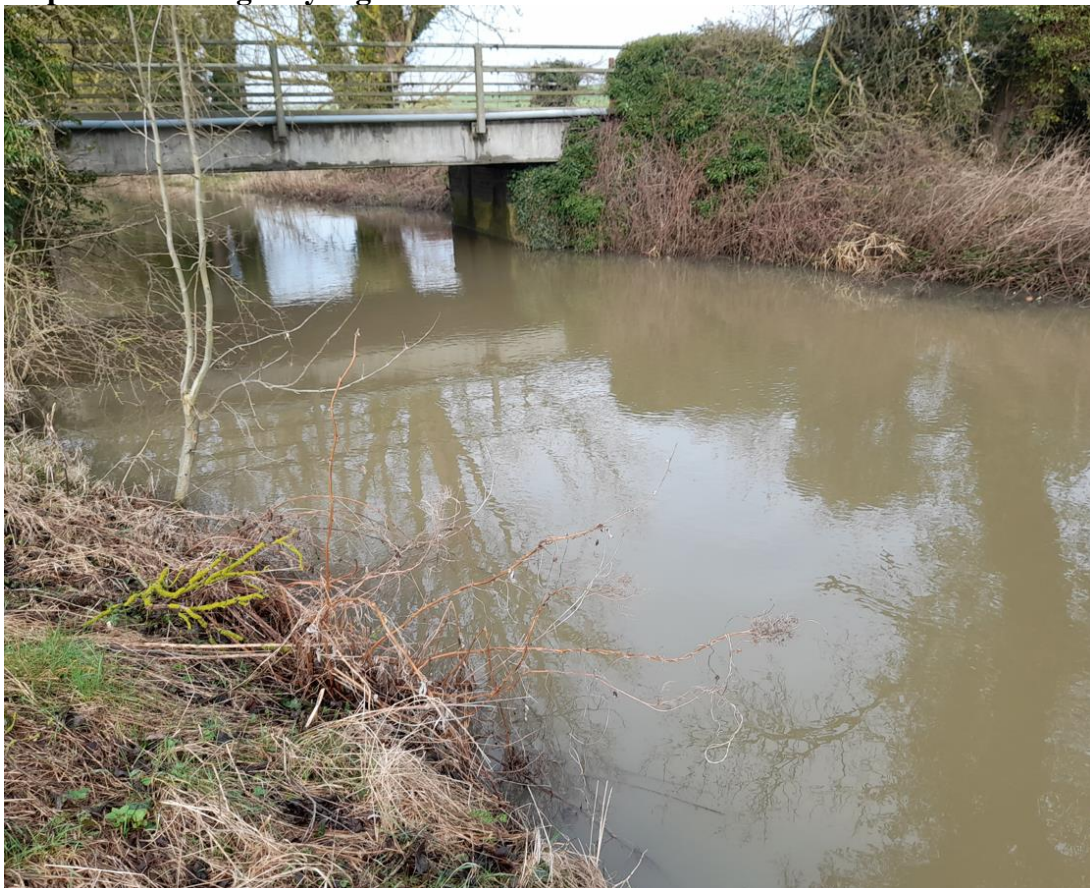
**Bourn Brook high turbidity, DTI 30cm, 03/03/2022, 'normal' turbidity caused by soil suspension during very high flows**

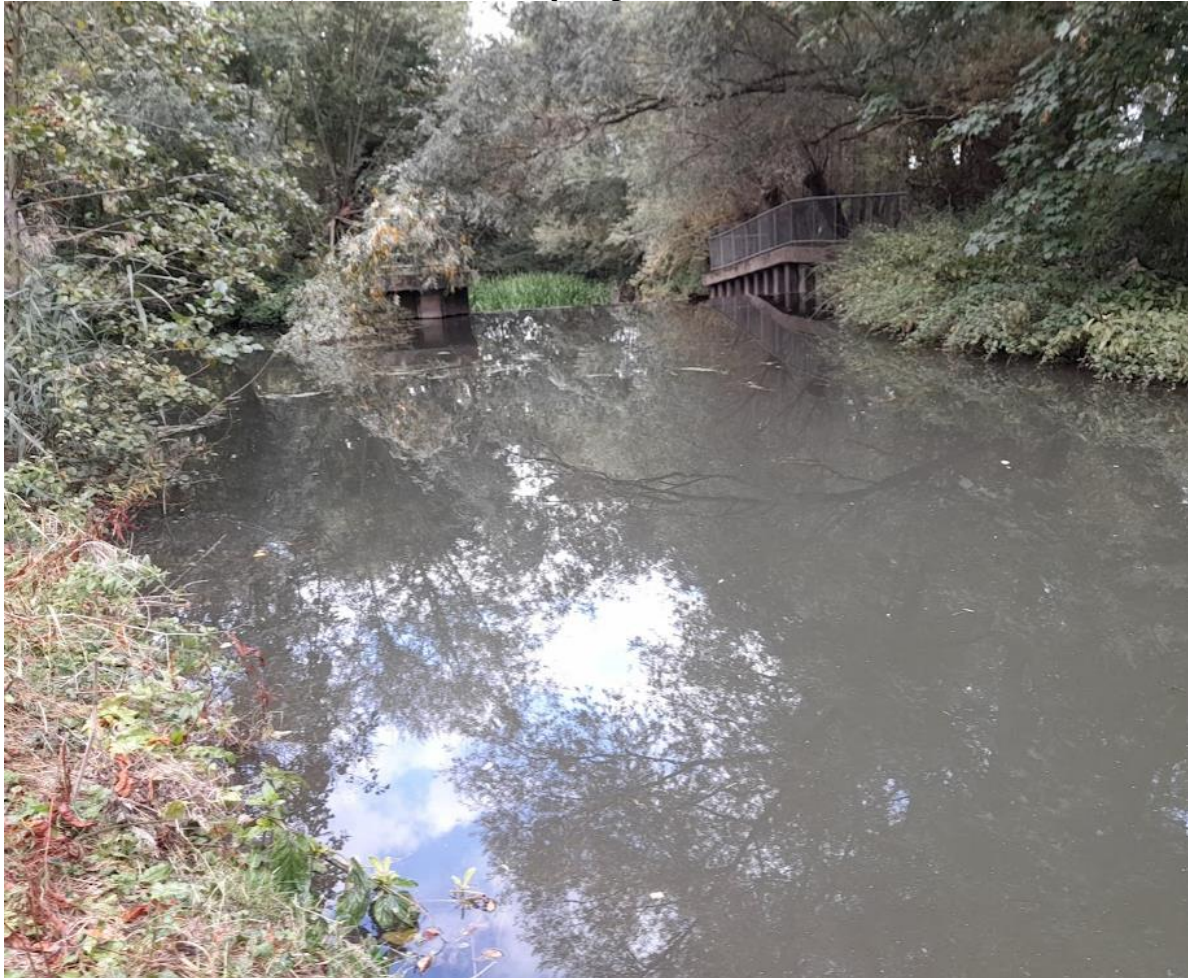
## **Hauxton Mill stretch, moderate turbidity - upstream of weir 28/09/22**

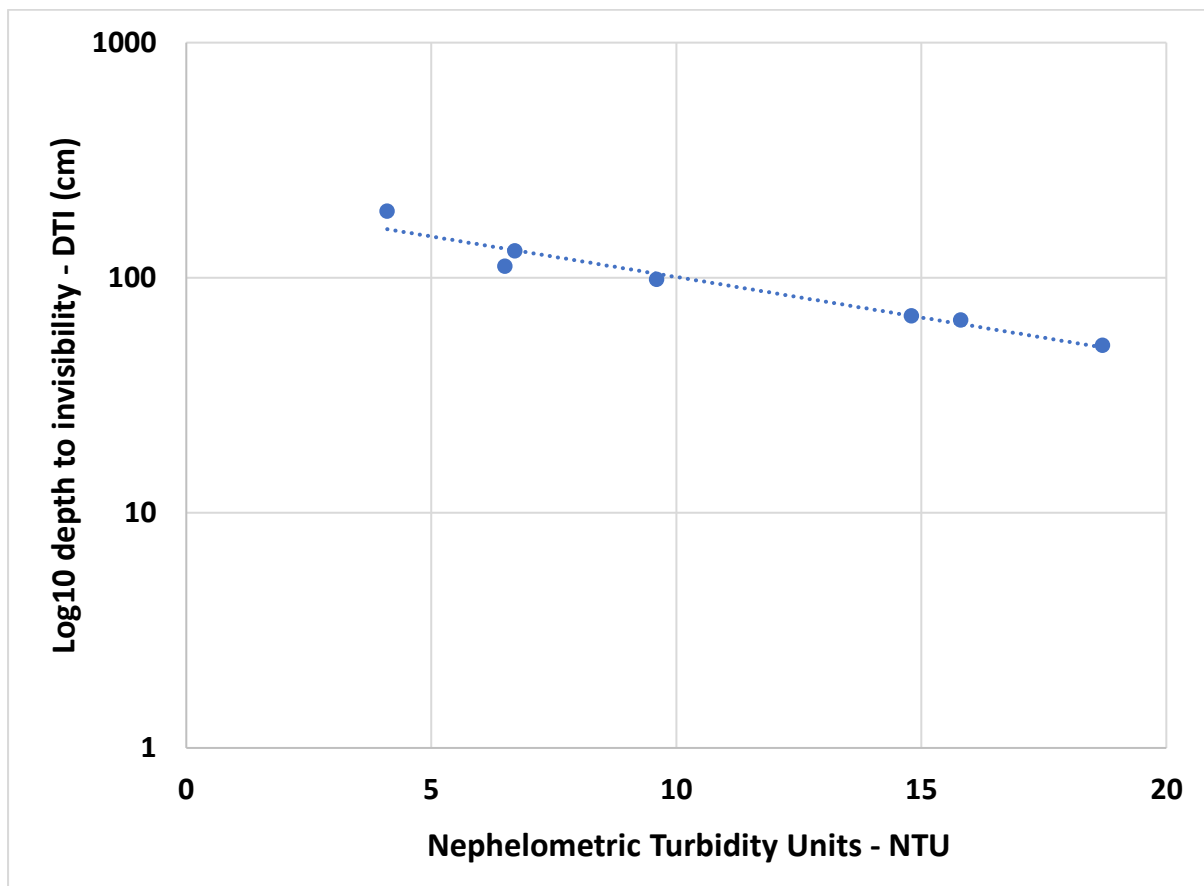
The seven pairs of measurements were plotted using a  $\log_{10}$  scale for DTI against NTU.

Relationship between measurements of turbidity by DTI and NTU methods

Although the range of sites was restricted to those where a DTI could be obtained, the correlation was remarkably strong considering that determining the point where the rake head disappears (and reappears to give a mean reading based on the two values) would be considered to be a much cruder method.

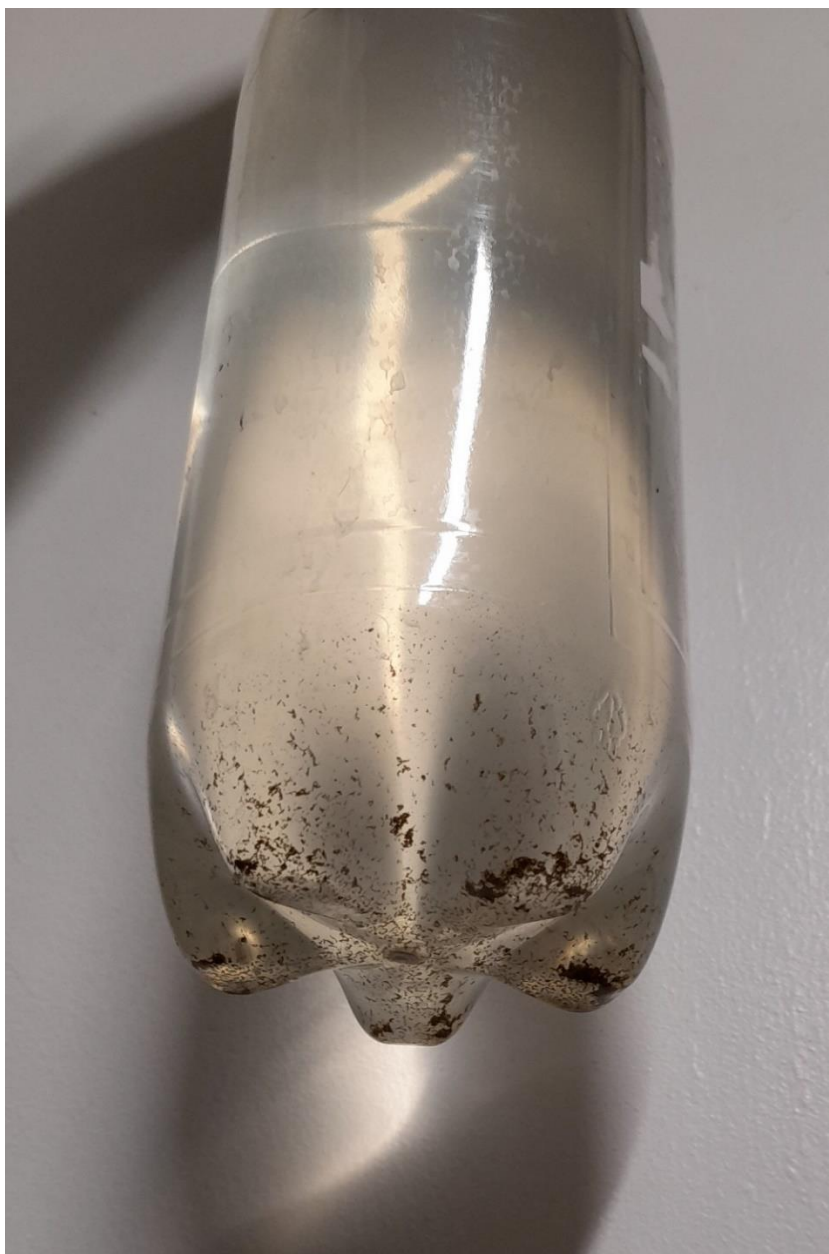
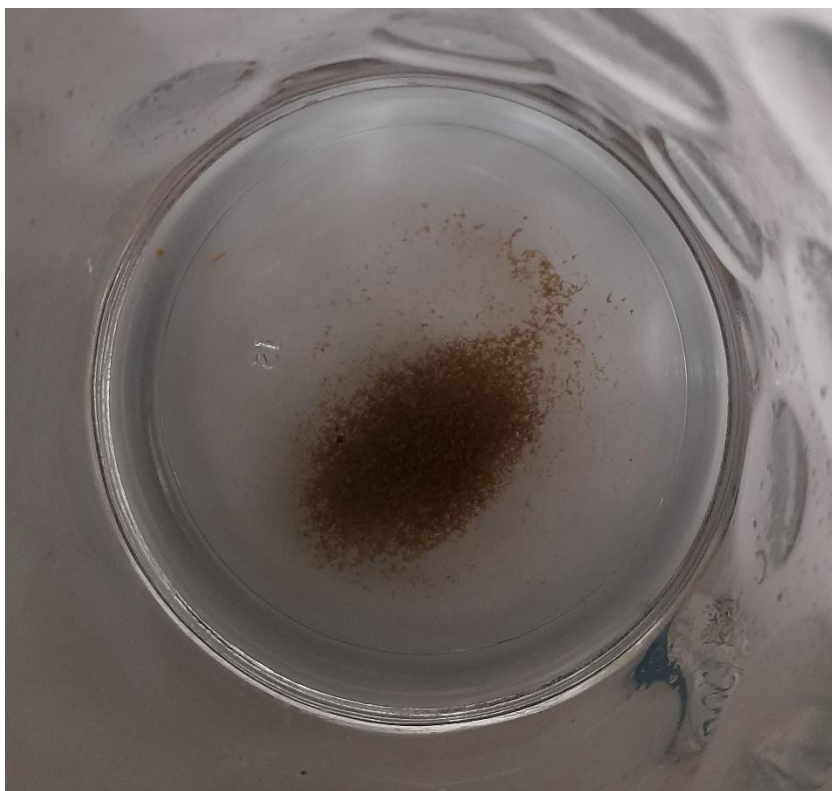
Sample of Rhee water was taken at BOOT (Barrington) on 7 October. Sampled water in one litre bottles were observed for up to 36 hours. After 30 minutes, particulate brown material had dropped out, and after 2 hours, most of this type of material had been deposited at the base of the bottles. A brown haze persisted. After the base of the bottle with deposit was photographed, most of the water was drawn off and the brown material transferred to a dish to be photographed.

4. In samples from Boot Lane, Barrington, brown particulates dropped out to the base of the sample bottle leaving a persistent pale brown haze throughout the water. Microscopy at x 400 did not reveal numbers of unicellular algae or diatoms to account for the turbidity. Particles within the haze were irregularly shaped with many less than 500 nanometres suggestive of soil rather than organic matter. It is not clear if the nano-particulates created the brown haze. A soils specialist would need to become involved.
