Essex Cam Report

**Water quality testing by Cam Valley Forum on The
Essex Cam and its tributaries**

Mike Foley

23 February 2024

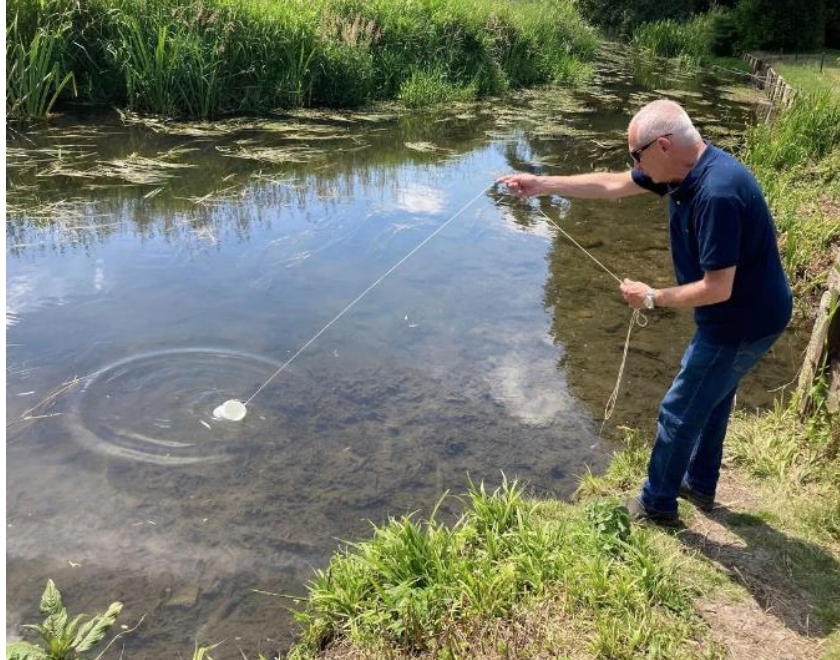
River Cam at Great Chesterford, June 2022; the bed is in very poor state covered with algal mats. Richard Pavitt is engaged in orthophosphate monitoring for CURAT (Cam Upper Reaches Action Team) Credit: EssexLive

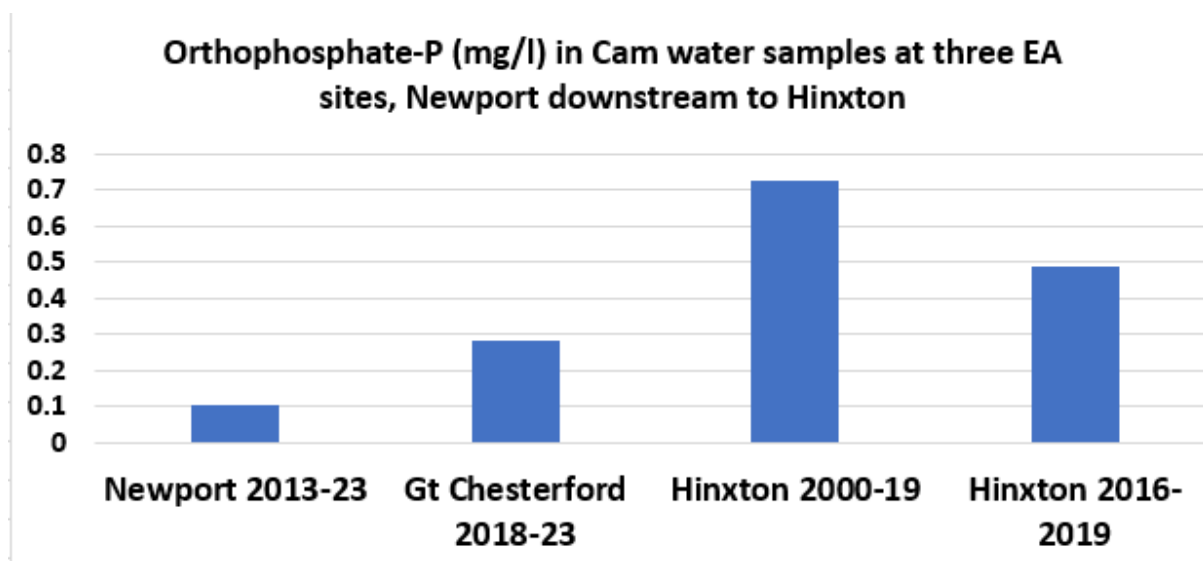
The following charts show data extracted from EA WIMS. In sequence the charts are for the sampling sites at Newport (Station Road), Great Chesterford road bridge, then Hinxtion road bridge. They are not the same range of years, and often they are not sampled on the same dates thus factors such as flow cannot be discounted. Periods such as COVID-19 lockdown produced gaps in sampling, which shows up in the charts.

Nevertheless, the mean figures of orthophosphate-P at each site show a marked increases in levels of orthophosphate downstream, particularly at Hinxtion. The increase is not so marked if Hinxtion data earlier than 2016 is omitted.

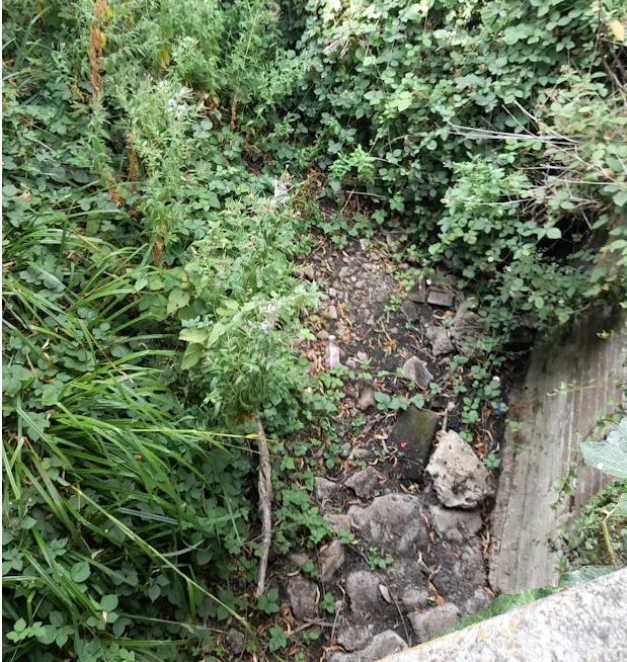
Cam Station Road bridge, Newport, 16 August 2022

The Cam at Station Road bridge, Newport was damp at most, with no flow. EA sampling reports for the same site confirm that no-flow situations occurred on 15 visits between 17 June to 18 Oct with just three samplings achieved in that period.

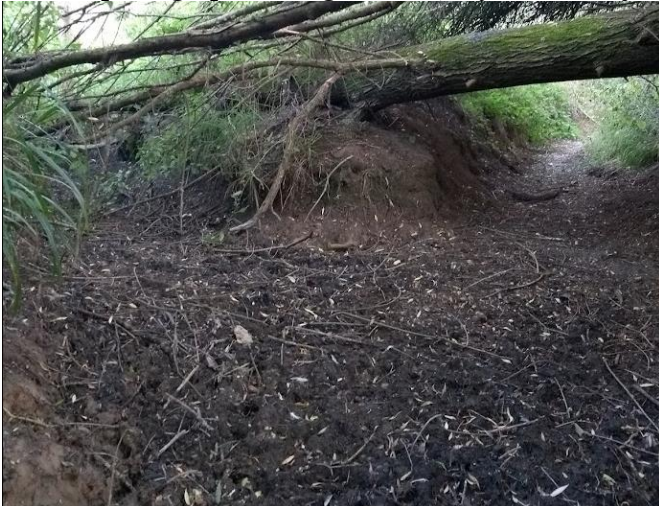
The Cam consisted only of pools of stagnant water. Further upstream, Wicken Water and Debden Water were not flowing into the Cam, similar to the situation during dry periods in 2019.

Archive photograph 29 August 2019, dry bed at confluence of Debden Water and Cam

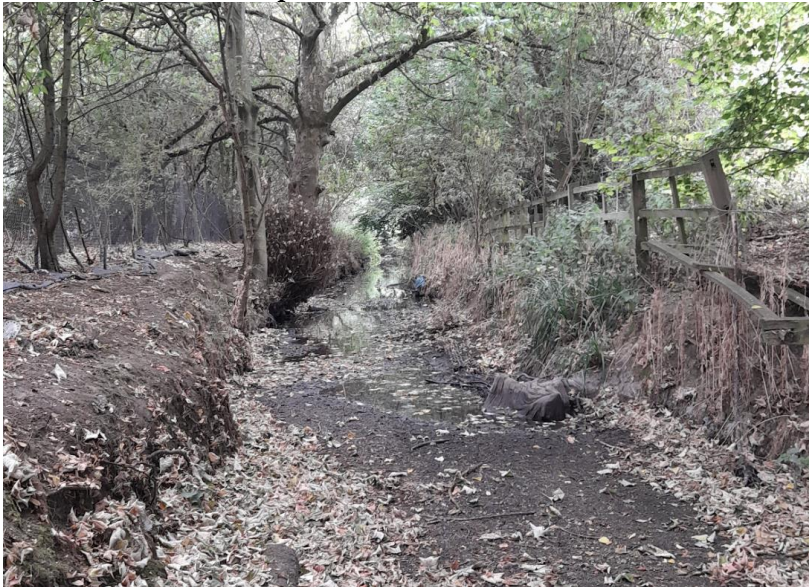
Madgate Slade 16 August 2022, from upstream of the STW discharge outfall. The discharge can be seen in the distance; the discharge flow is sufficient to move the discharge backwards upstream about 30m.

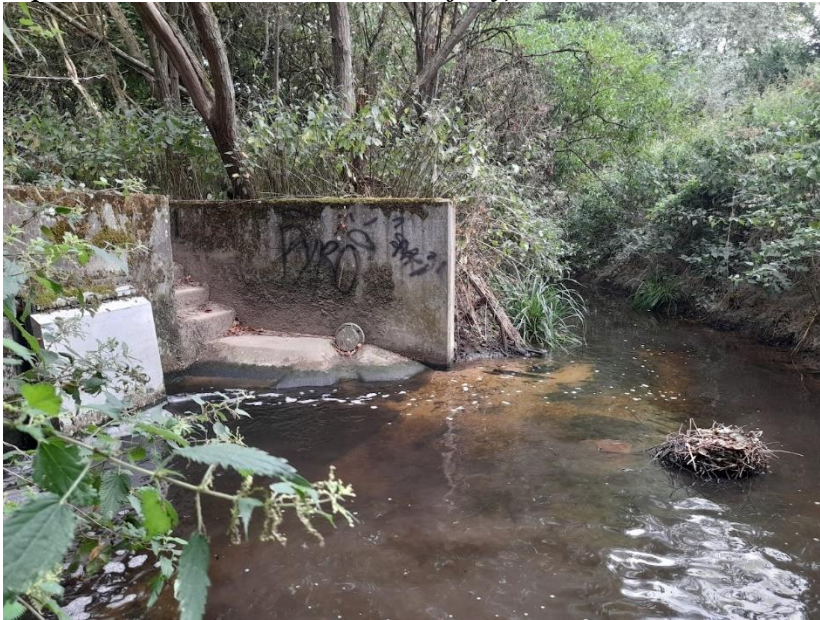
Saffron Walden STW discharge outfall point into the Madgate Slade, 16 August 2022. We hope that the Moorhens bred successfully, with minimal human disturbance.

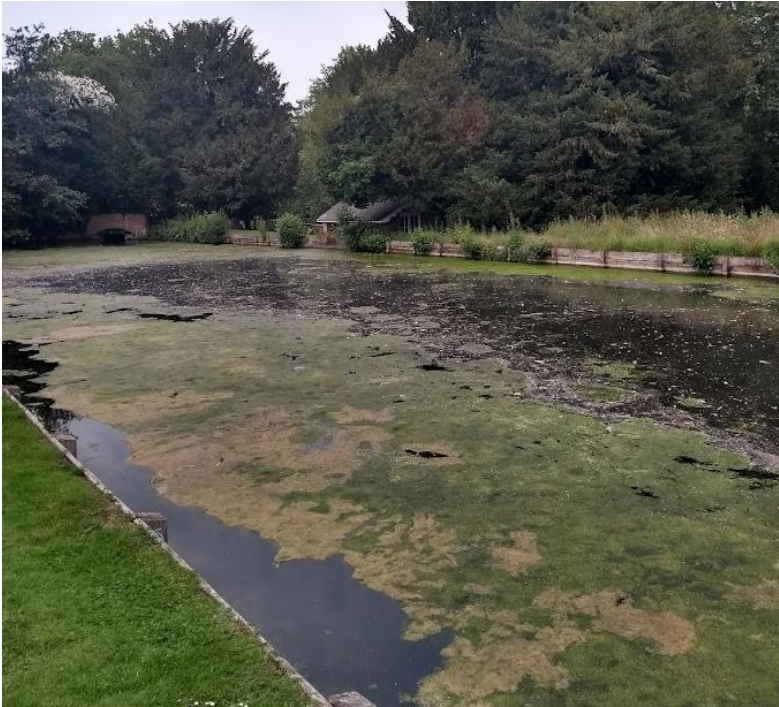
Archive photograph, Cam in eutrophic state - Audley End Hall Gardens, 24 June 2019

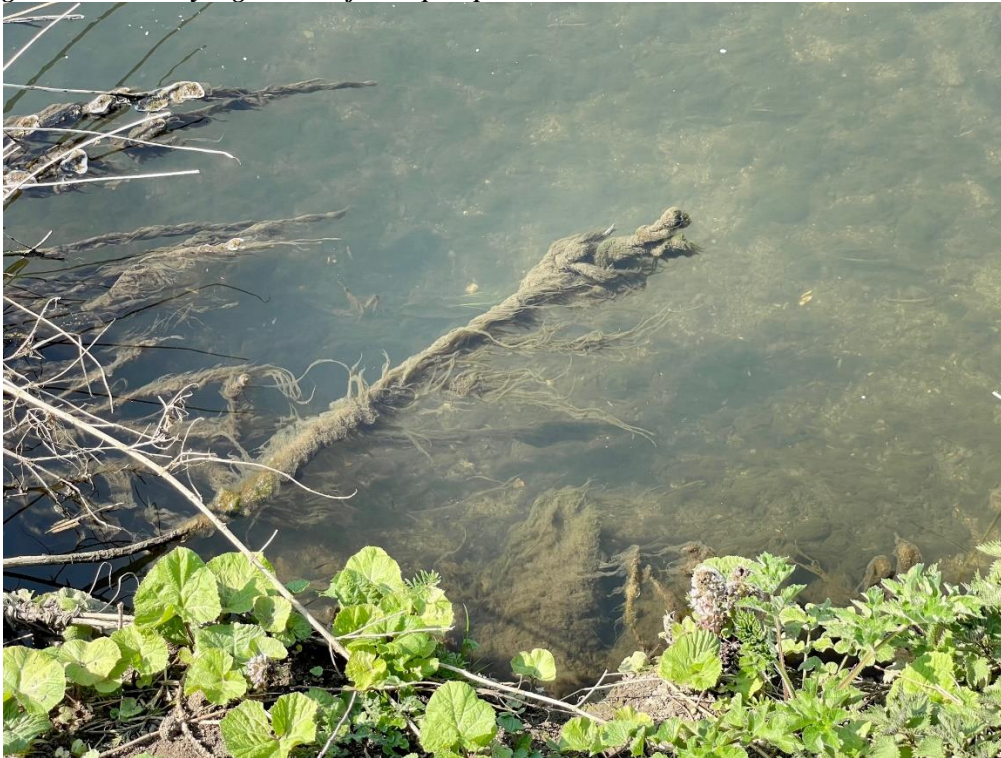
Cam - just downstream of Little Chesterford, 26 March 2022, Algal mats over the river mat, strong growth enabled by high levels of orthophosphate

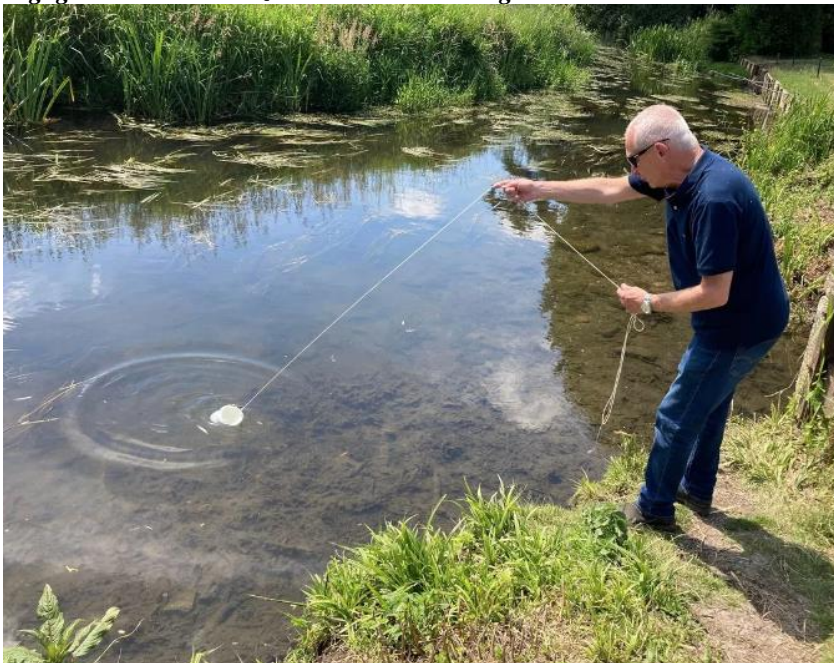
Cam – Great Chesterford, June 2022, Very poor-looking river bed with algal mats. Richard Pavitt engaged in CURAT citizen science monitoring

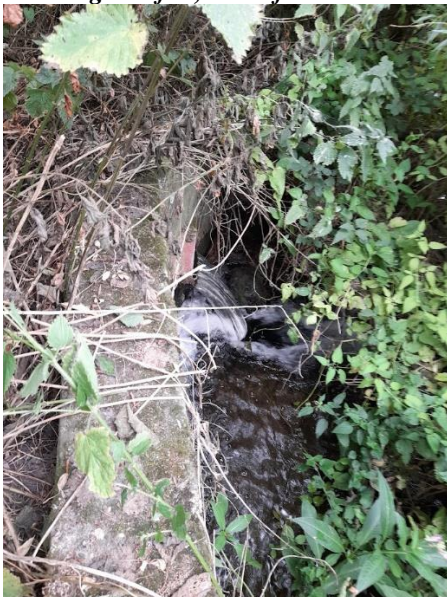
Discharge outfall, west of M11 and downstream of Great Chesterford

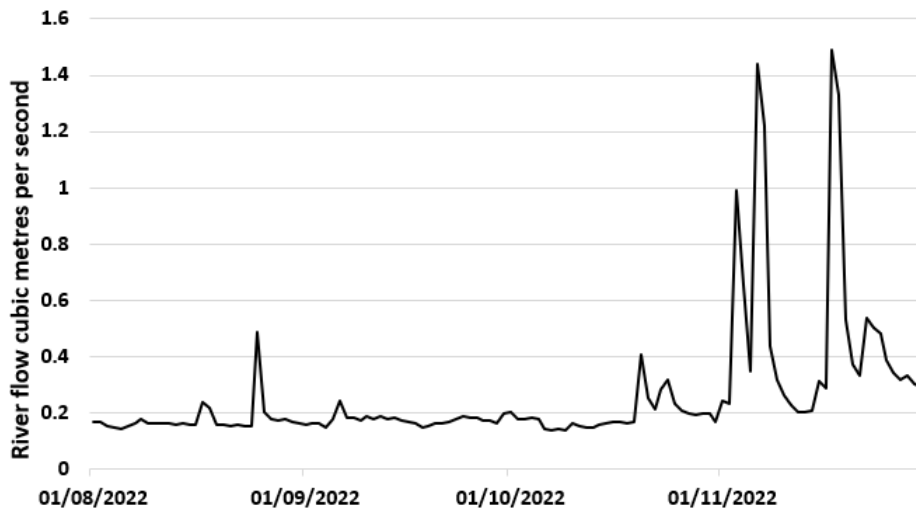
River flow recorded by the EA at Great Chesterford

16 August - 158 l/s
23 November - 501 l/s
28 November - 331 l/s

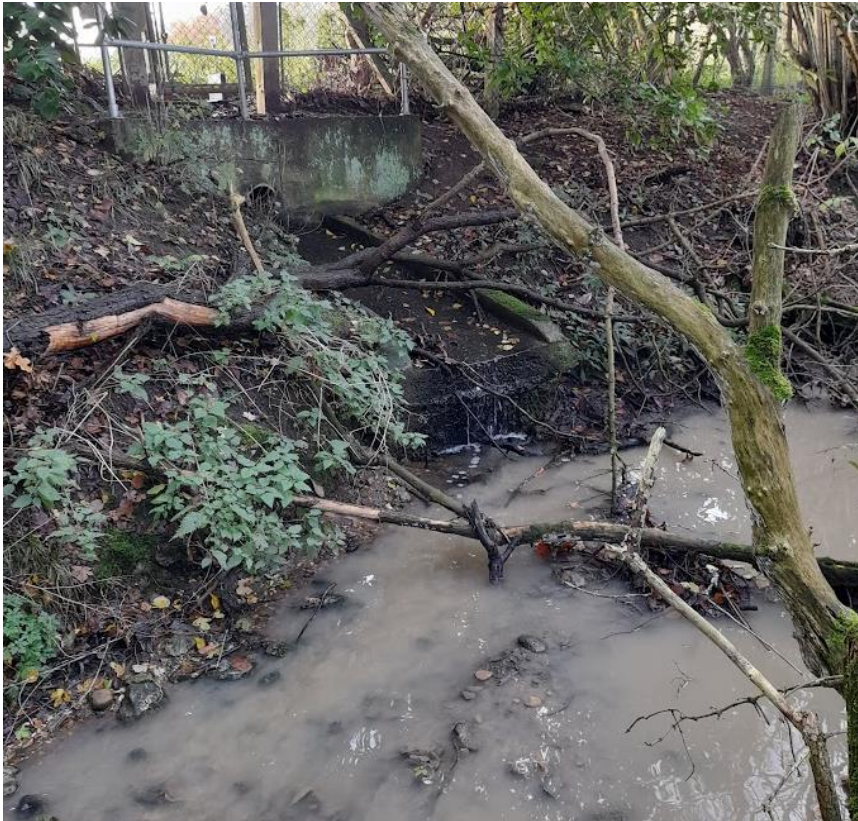
Quendon STW outfall and its discharge ditch, 23 November at 1407h. The effluent discharge is no more than a trickle at this time

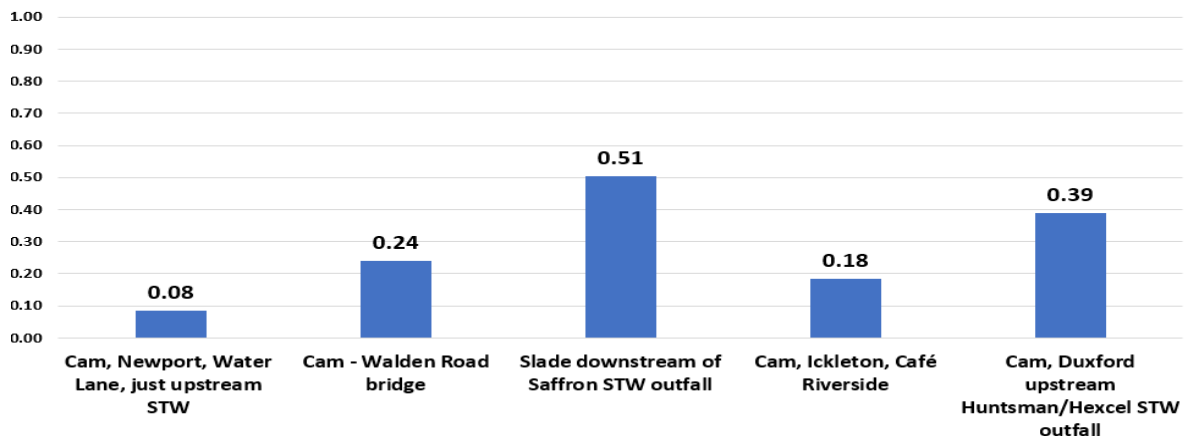
Concentrations of orthophosphate (mg/l) in river samples 23 November 2022 at sites from Newport to Duxford

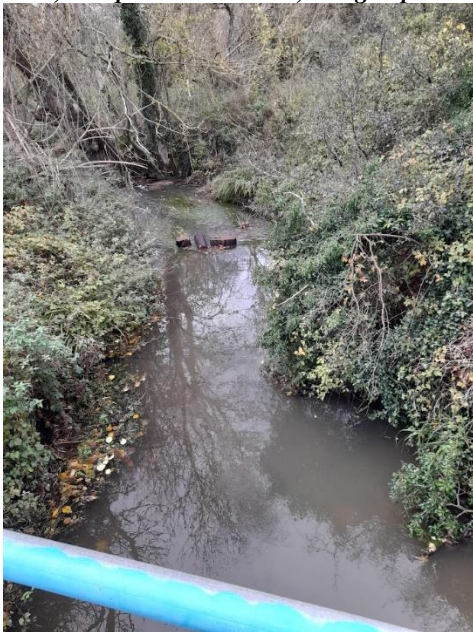
Cam, Newport Water Lane, bridge upstream of Newport STW, 23 November 2022

The result of just 0.08 mg/l orthophosphate-P just above Newport SWT is of interest. At Newport, Station Road on 21 November, the EA recorded orthophosphate-P at 0.071 mg/l. It might be said that over the 1.1km between the two sampling sites there had been no very little addition of orthophosphate into the river. Yet on one hand at least Wicken Brook and Debdon Water were flowing into the Cam and increasing its flow, but also the river was passing through the edge of Newport and pollution from urban sources was likely to be entering the river, particularly after rainfall.

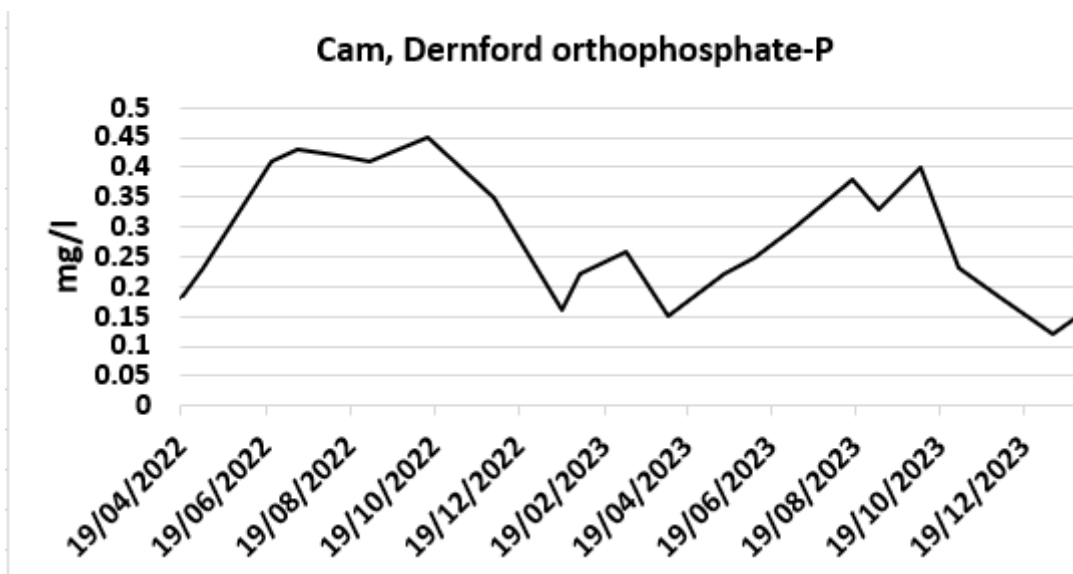
The trends in orthophosphate levels are also clear to see at Dernford Lock, at the end of the reach Audley End to Stapleford

Even during the highest dilutive river flows, orthophosphate concentrations are not reduced to less than about 0.1 mg/l. As the concentrations approach their peaks in summer, they become intolerably high.

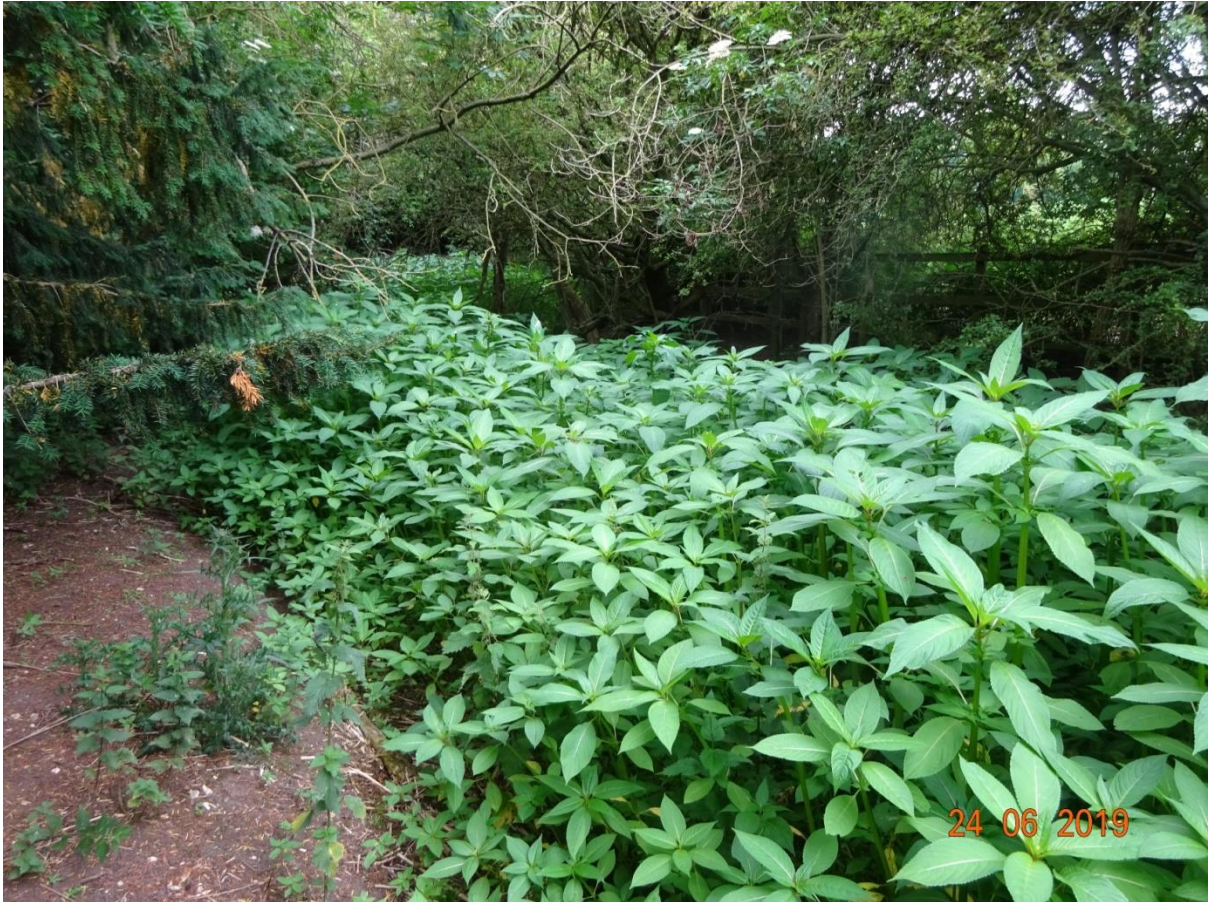
Audley End overspill loop ditch, 24th June 2019

Just two attempts at Balsam ‘bashing’ by a CURAT team in 2022 made significant inroads into this huge stand, with dramatically fewer plants growing there in 2023.

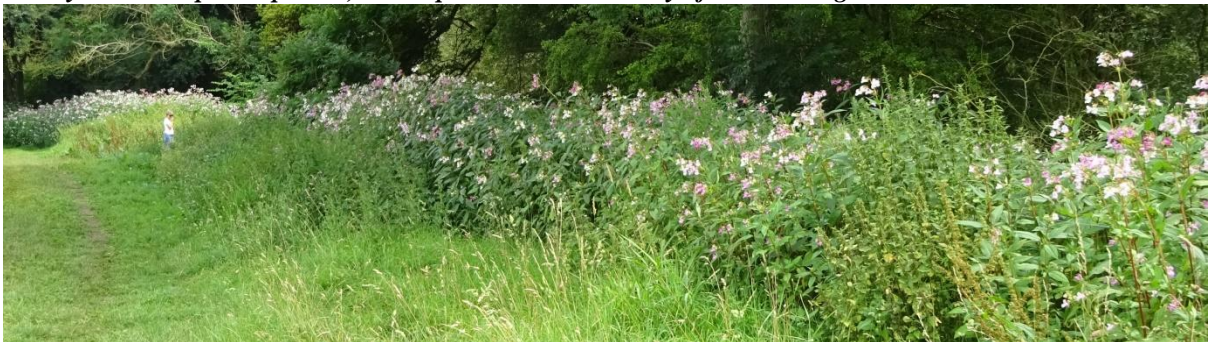
Audley End overspill loop ditch, more open section. Note lady of normal height in distance

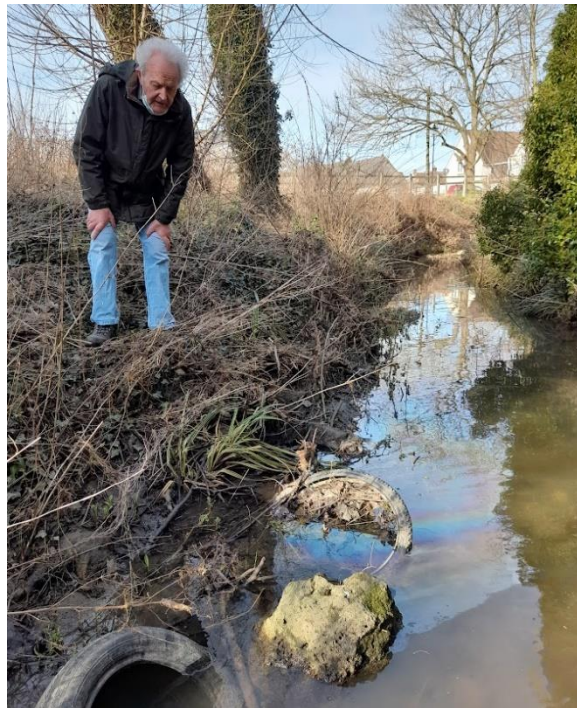
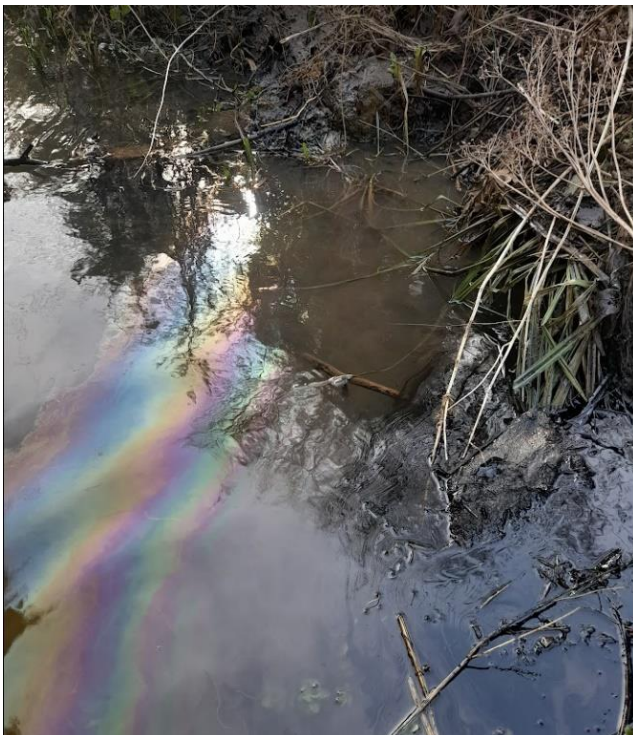
Derek Smith, The Common Newport, bike wheel partly submerged

More serious pollution was our discovery of a source of viscous black oil exiting from a pipe in the bank, close to the bike wheel. Just a small amount polluted the water badly. The Parish Council and EA were informed (EA reference 1895948), and very quickly EA visited, laid down an oil-trapping boom, and after investigation confirmed that a nearby commercial oil tank was leaking into a surface water drain pipe.

Light bike oil to left, viscous black oil, bottom right
