Pollution from roads - Road sweepings – Addenbrooke's Road - Analysis Results

Steve Boreham

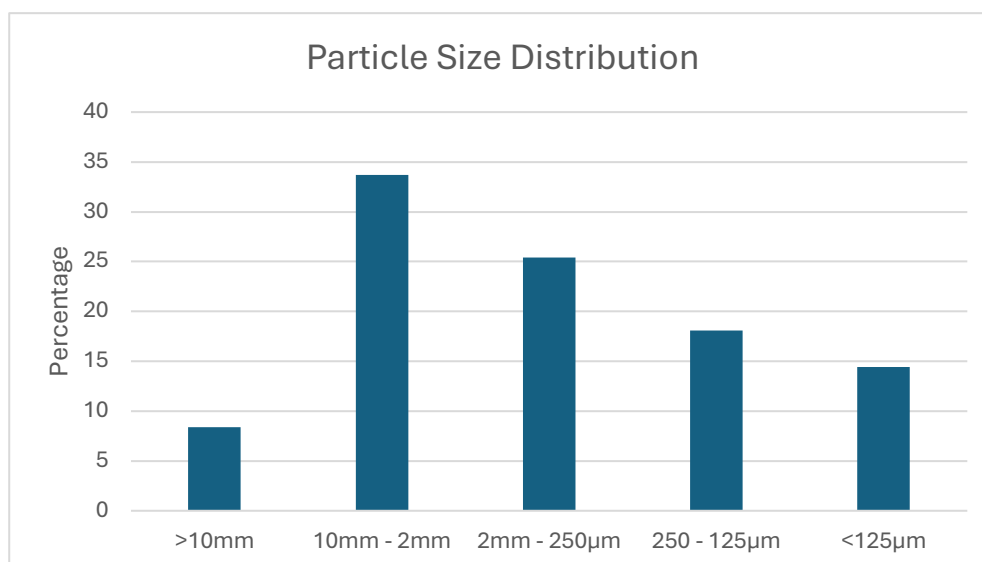
Particle Size Analysis

Medium-coarse sand (2mm - 250µm) comprised ca.40% by weight and the larger clasts (>2mm & >10mm) comprised ca.25%, leaving the fines (<250µm) at ca.35%.

I also used a Neodymium magnet to remove and quantify the Magnetic Component from each fraction. Some of this appeared to be rust debris from vehicles. Whilst the Magnetic Component was ca.10% overall, it was most common in the 10mm - 2mm fraction, which contained a metal screw.

<i>Fraction</i>	<i>All Clasts</i>		<i>Magnetic Component</i>		
	<i>Weight (g)</i>	<i>Percentage</i>	<i>Weight (g)</i>	<i>Percentage</i>	
>10mm	41.99	8.40	0.00	0.00	
10mm - 2mm	168.46	33.69	17.26	3.45	
2mm - 250µm	127.00	25.40	4.60	2.91	
250 - 125µm	90.51	18.10	2.90	2.02	
<125µm	72.04	14.41	2.75	1.53	
TOTAL	500.00		27.51	9.91	%

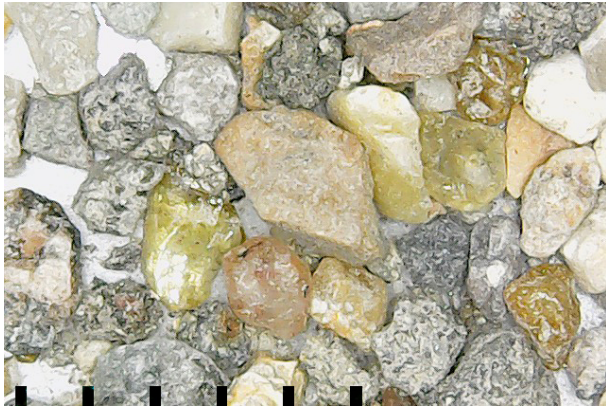
Low-power microscope photos of different fractions of the Road Sweepings from Addenbrooke's Road.

The black ticks are 1mm apart.

>2mm clasts (quartz, flint, stone)

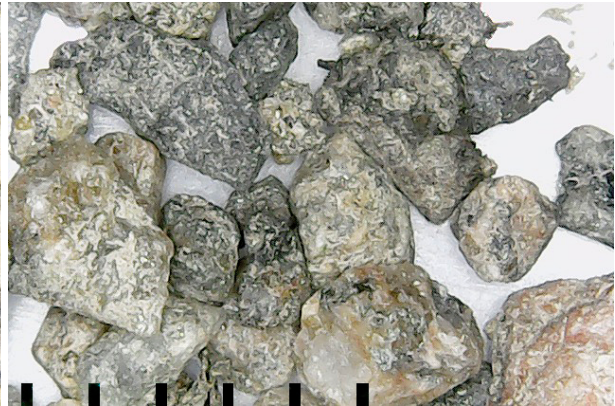
>2mm magnetic component

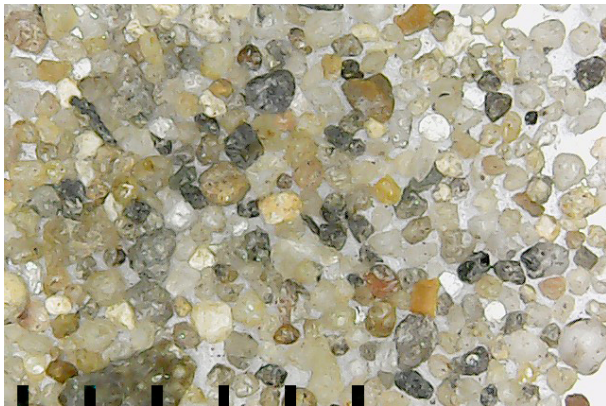
>250µm clasts (quartz, flint, stone)

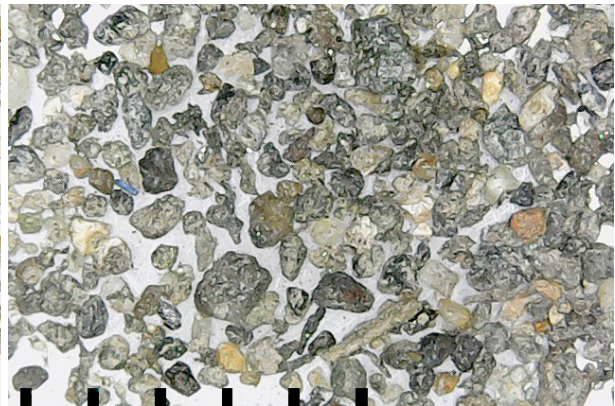
>250µm magnetic component

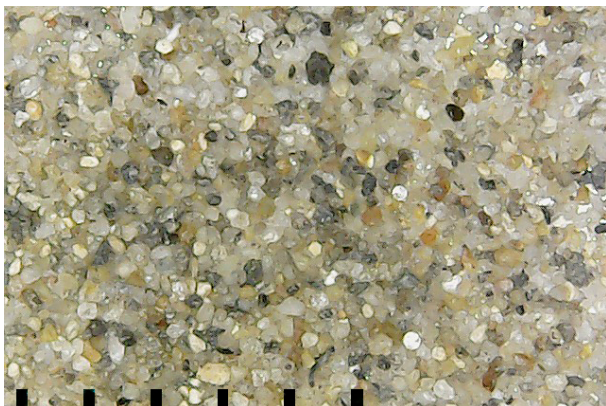
>125µm clasts (quartz, flint, stone)

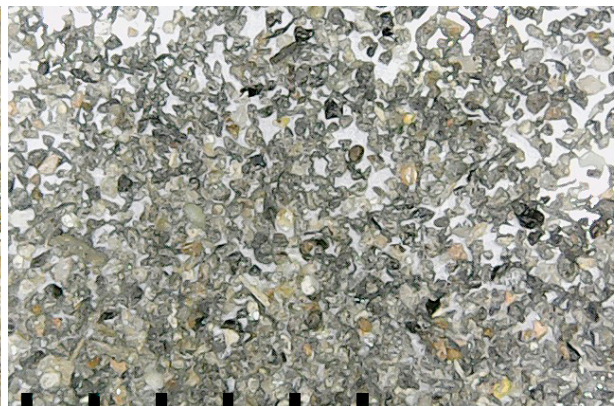
>250µm magnetic component
