Why are the Rhee and Cam murky?

Can we clean them up?

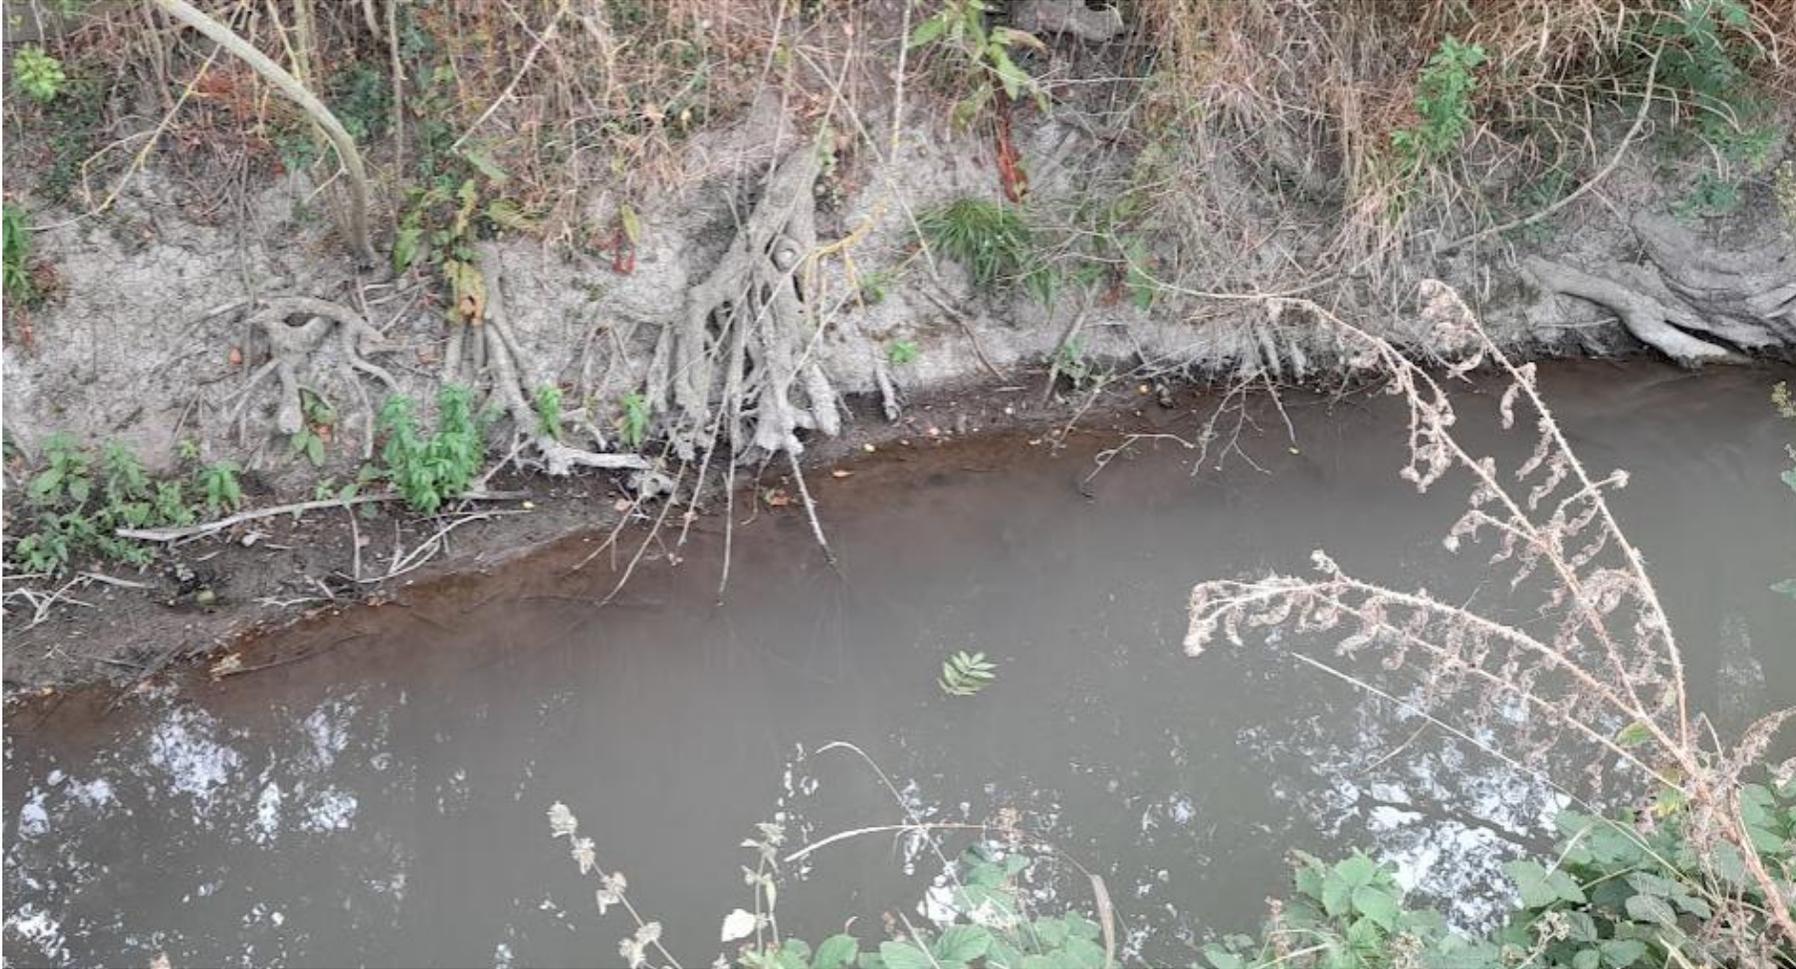
Upper Rhee – high turbidity at Potton Road, near Guilden Morden, 03/08/22 Note the colour of the bank soil, and the severe erosion.

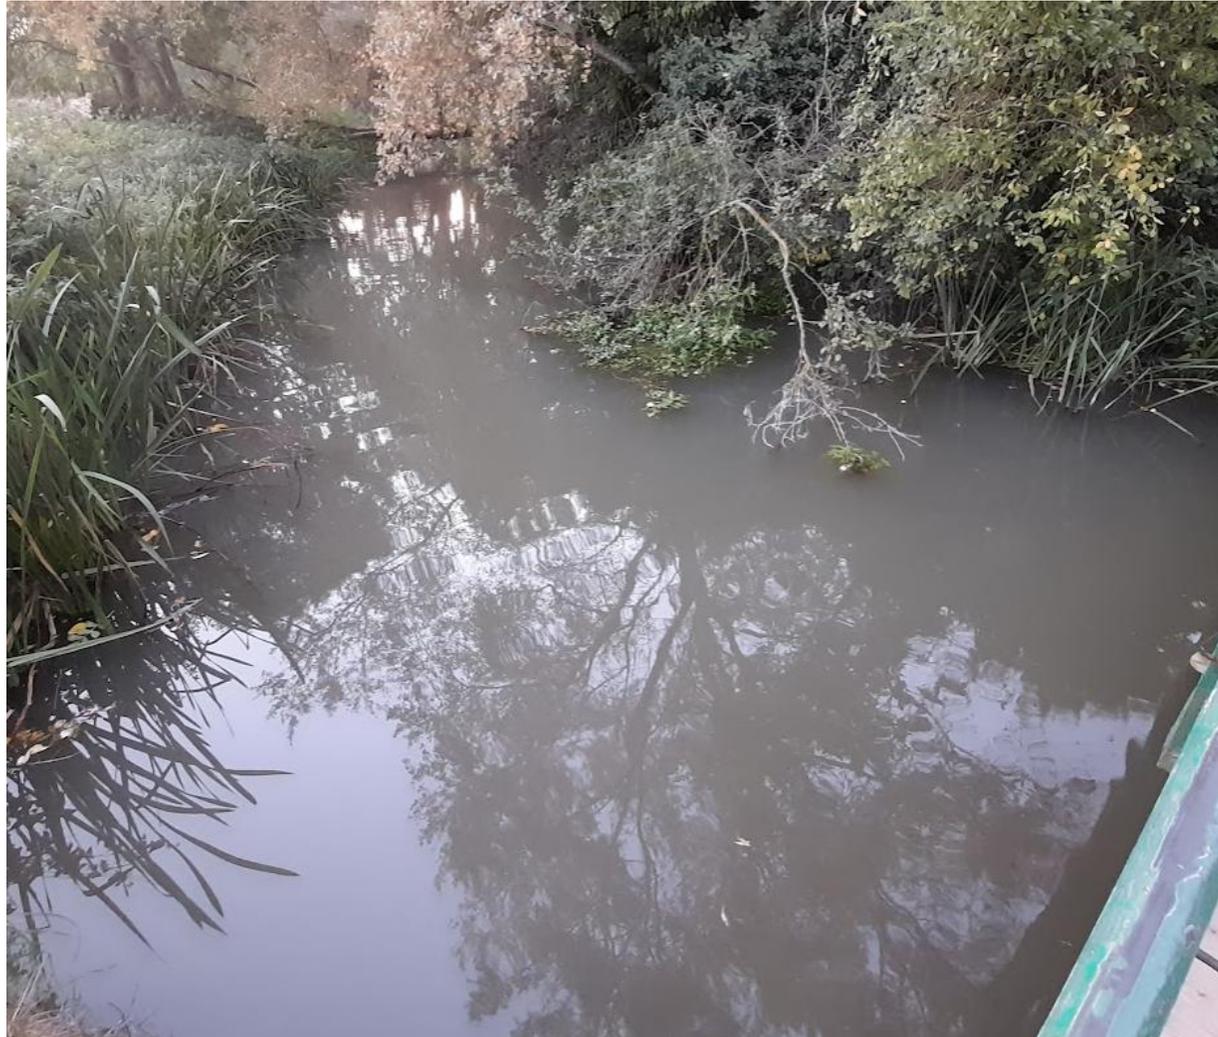
**Rhee - turbidity high at Boot Lane footbridge, Barrington,
below Barrington weir, 06/10/22**

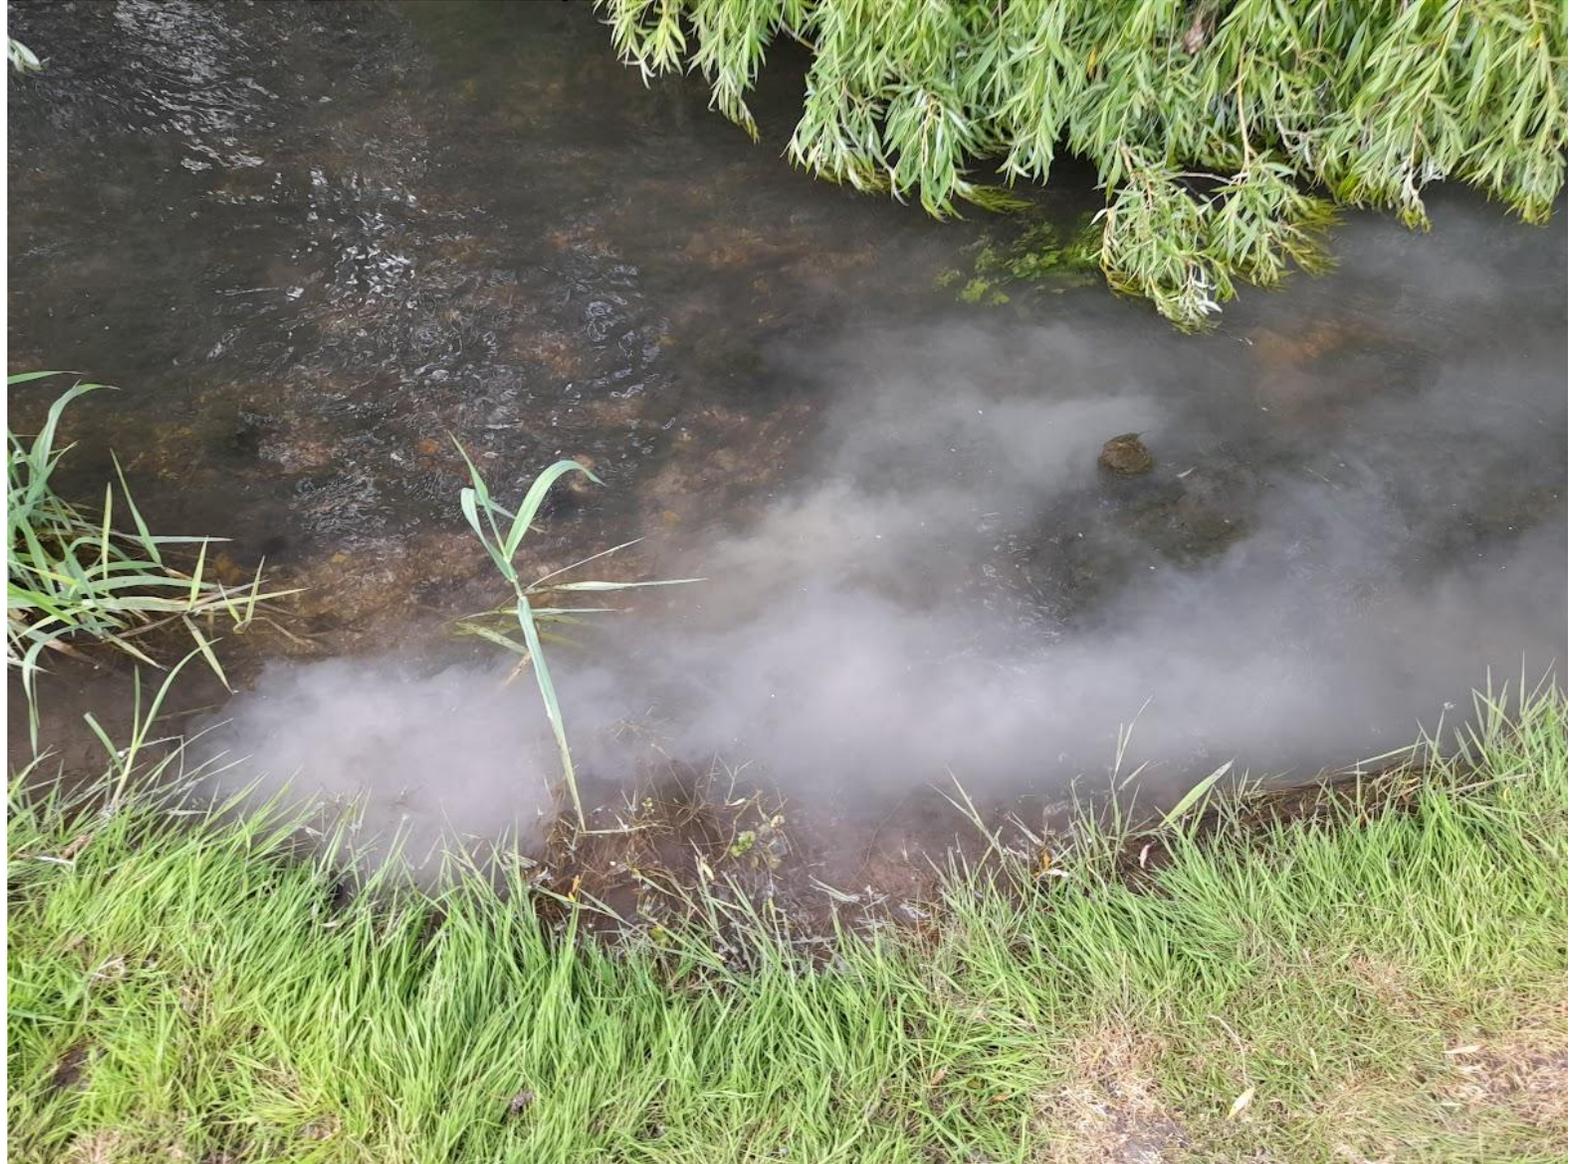
Mill River, near Wendy

Gentle wiggling of rake into bed.
Sediment of a Gault Clayey
colour, slow to settle

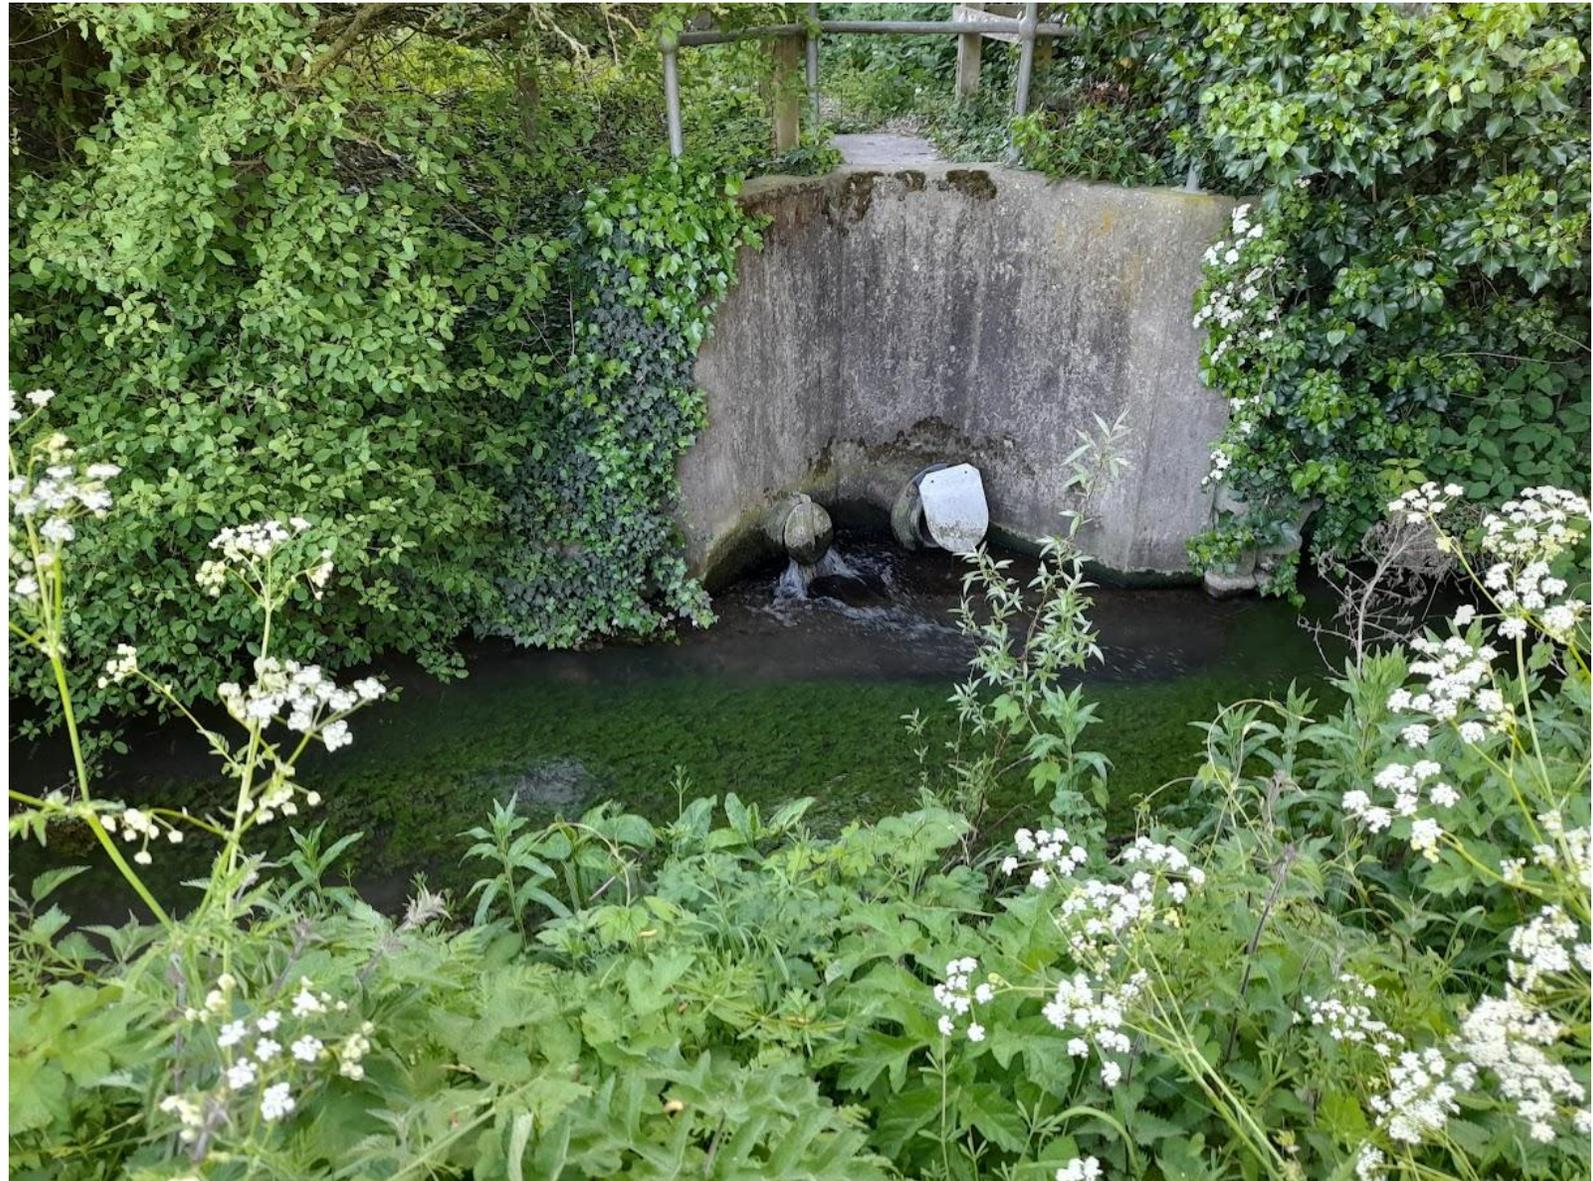
Ashwell STW effluent discharge outfall into Rhee

Effluent sampling reveals
it can be very clear

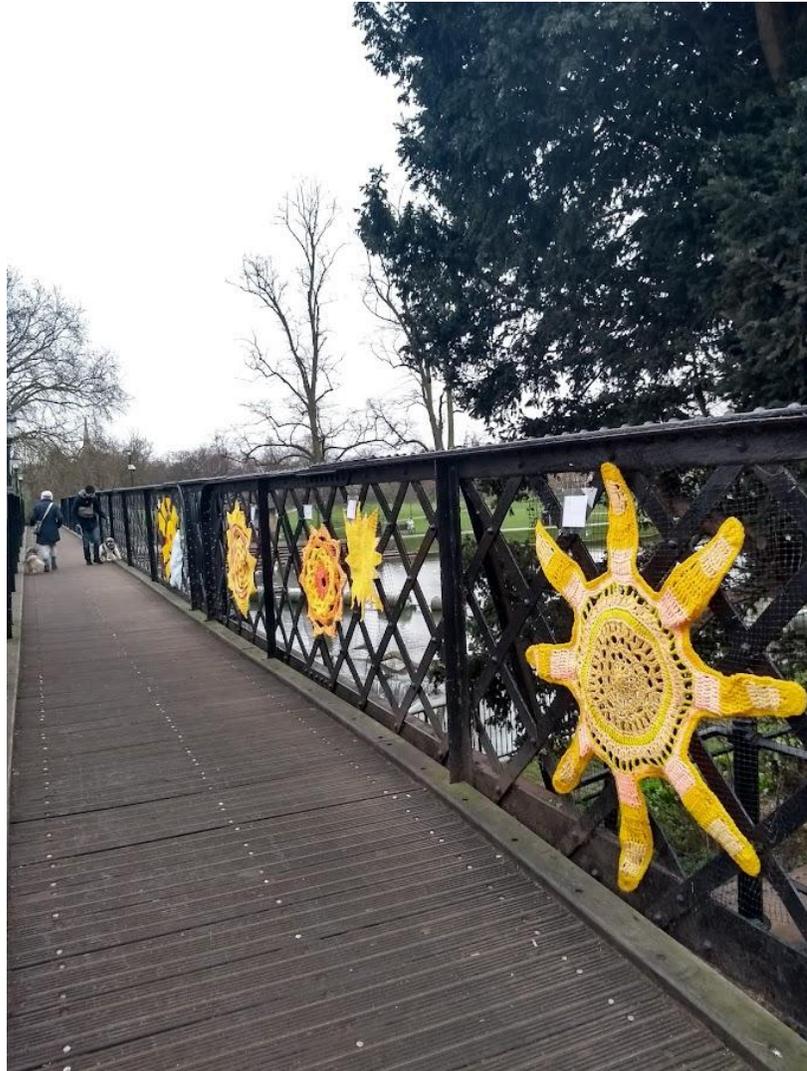
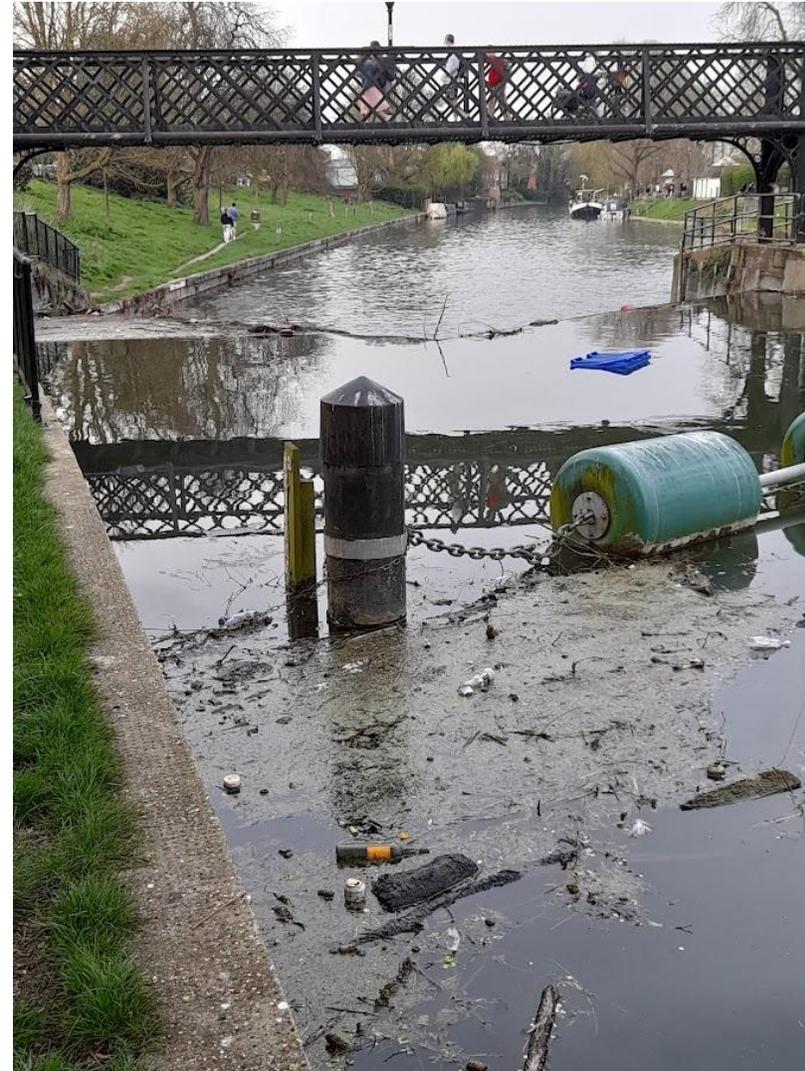
Jesus Green weir – further slowdown of suspended sediment as sediment settles to bed in low flows

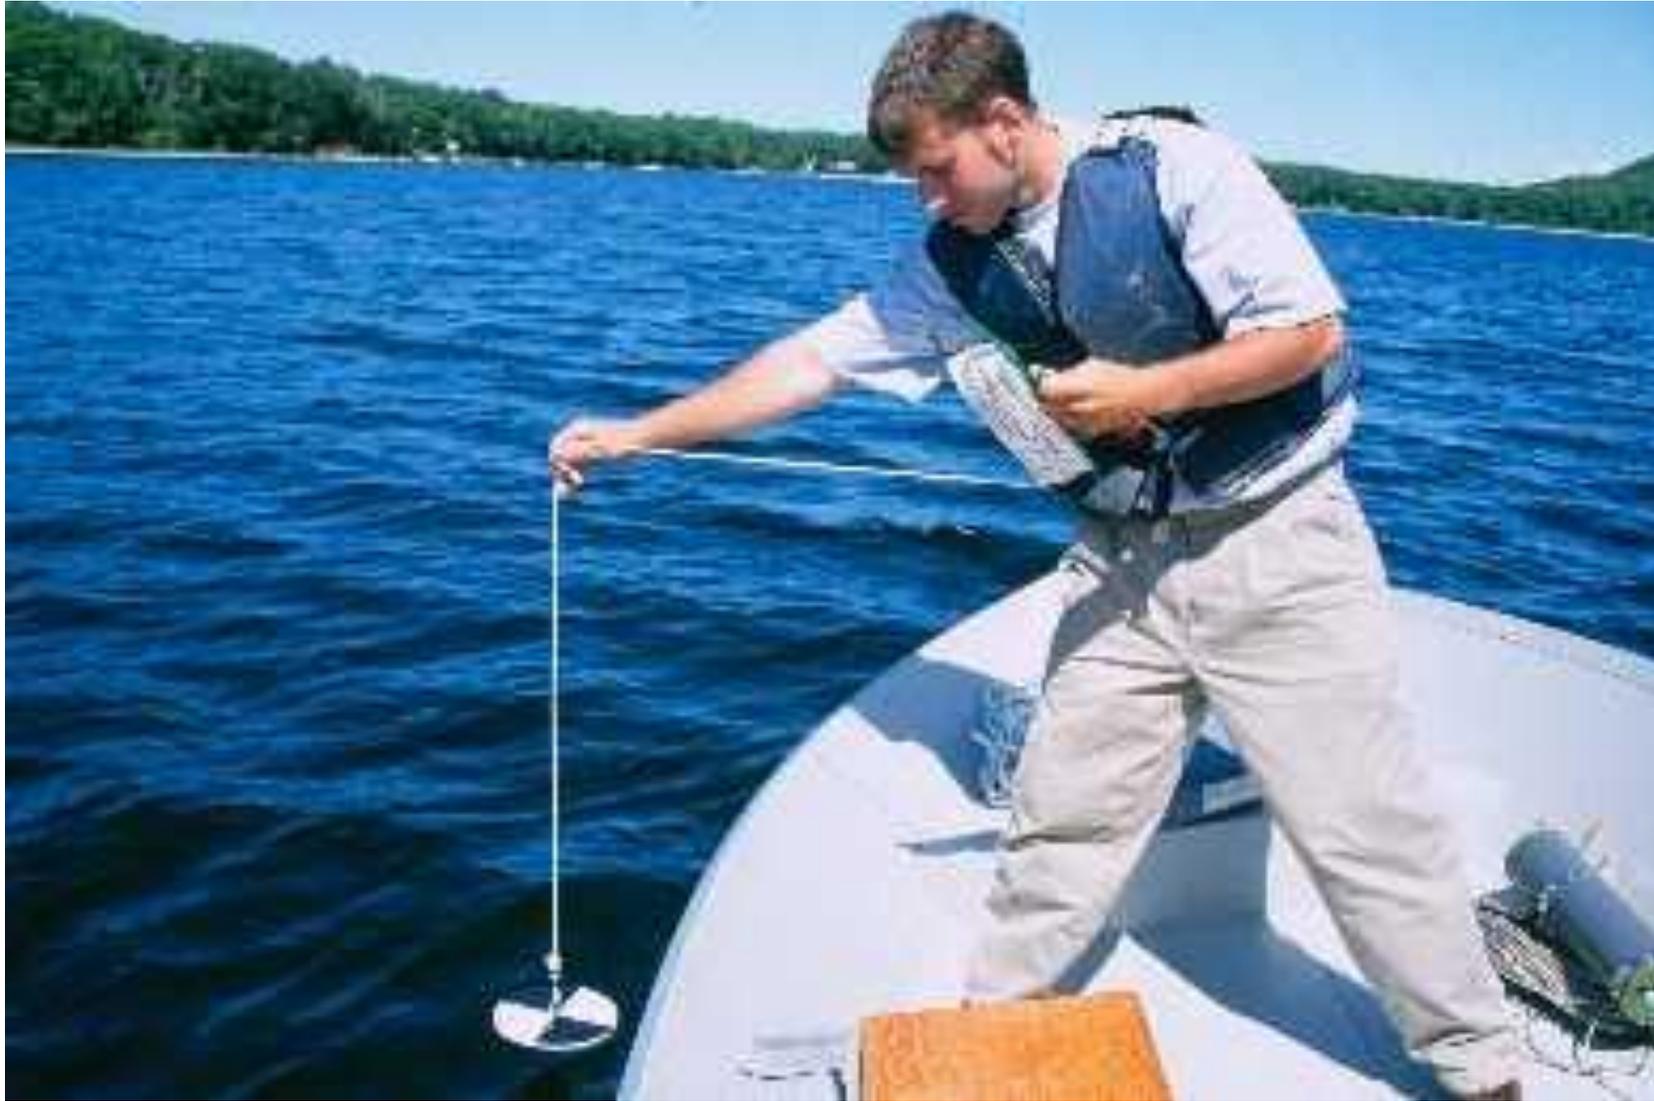
Secchi disk, unsuitable testing shallow water

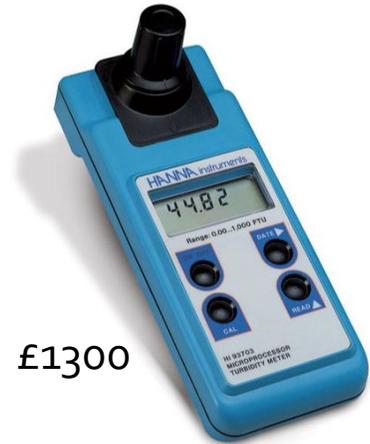
Hanna HI-93703

£1300

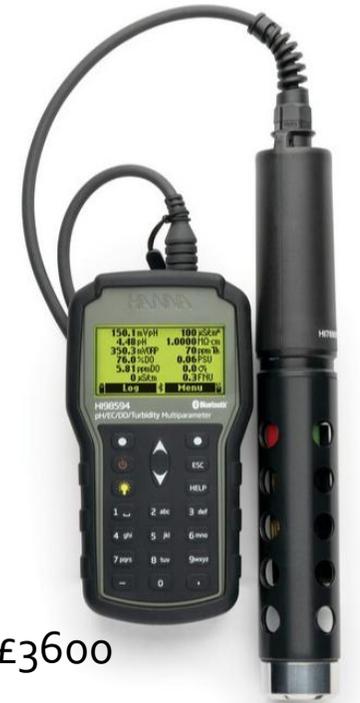
~£3600

Hanna HI-98594
Multiprobe in action.

This can be both lab
and field based

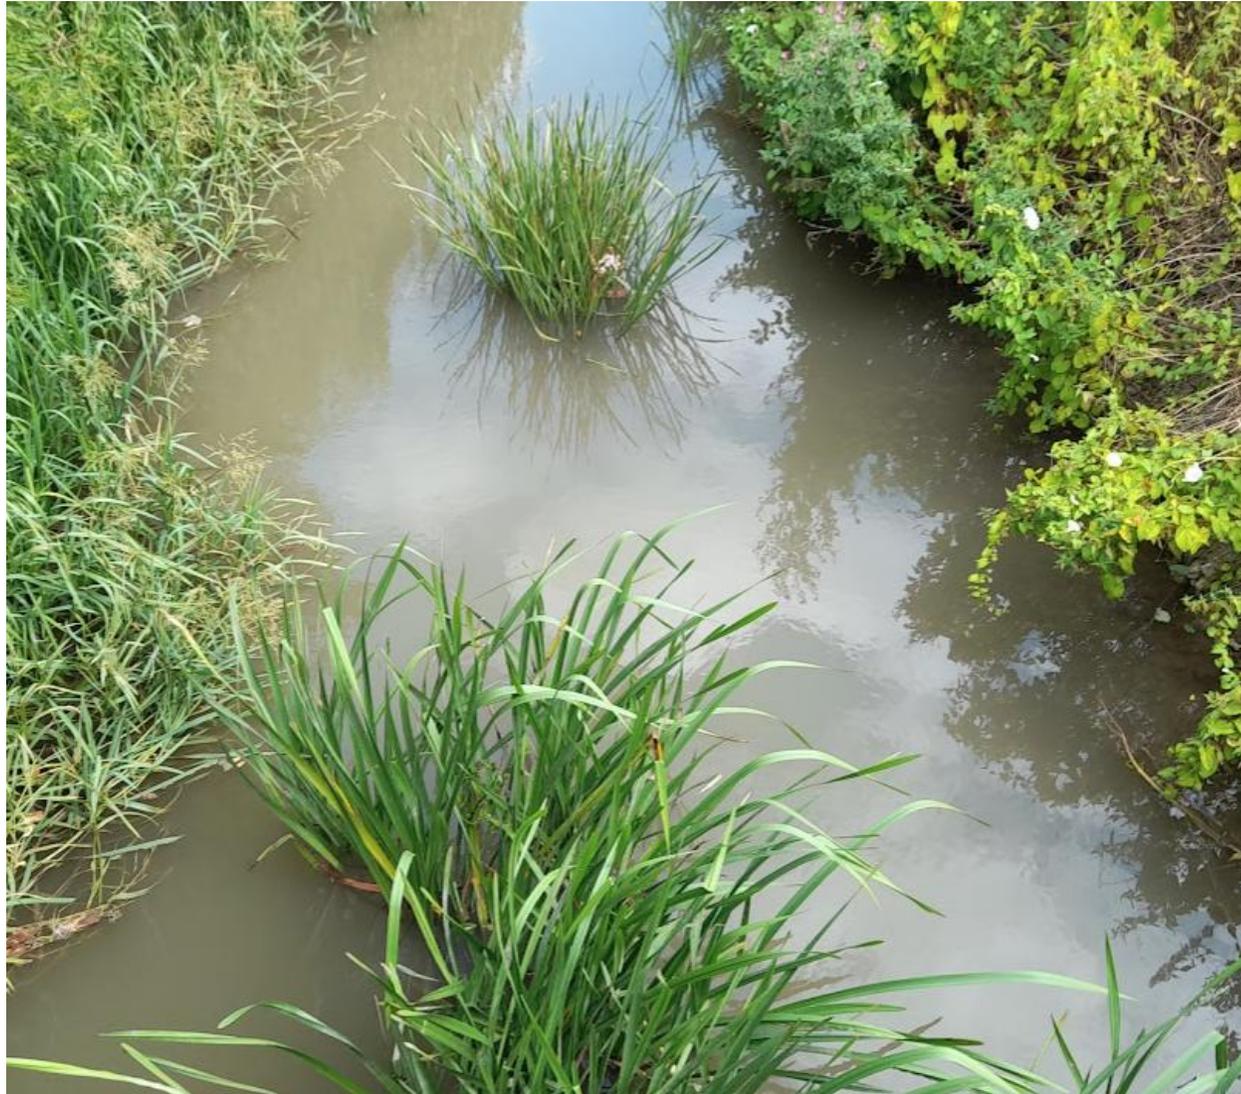
Rhee – high turbidity at Malton Farm, 01/08/22 – brutish plants starting to dominate

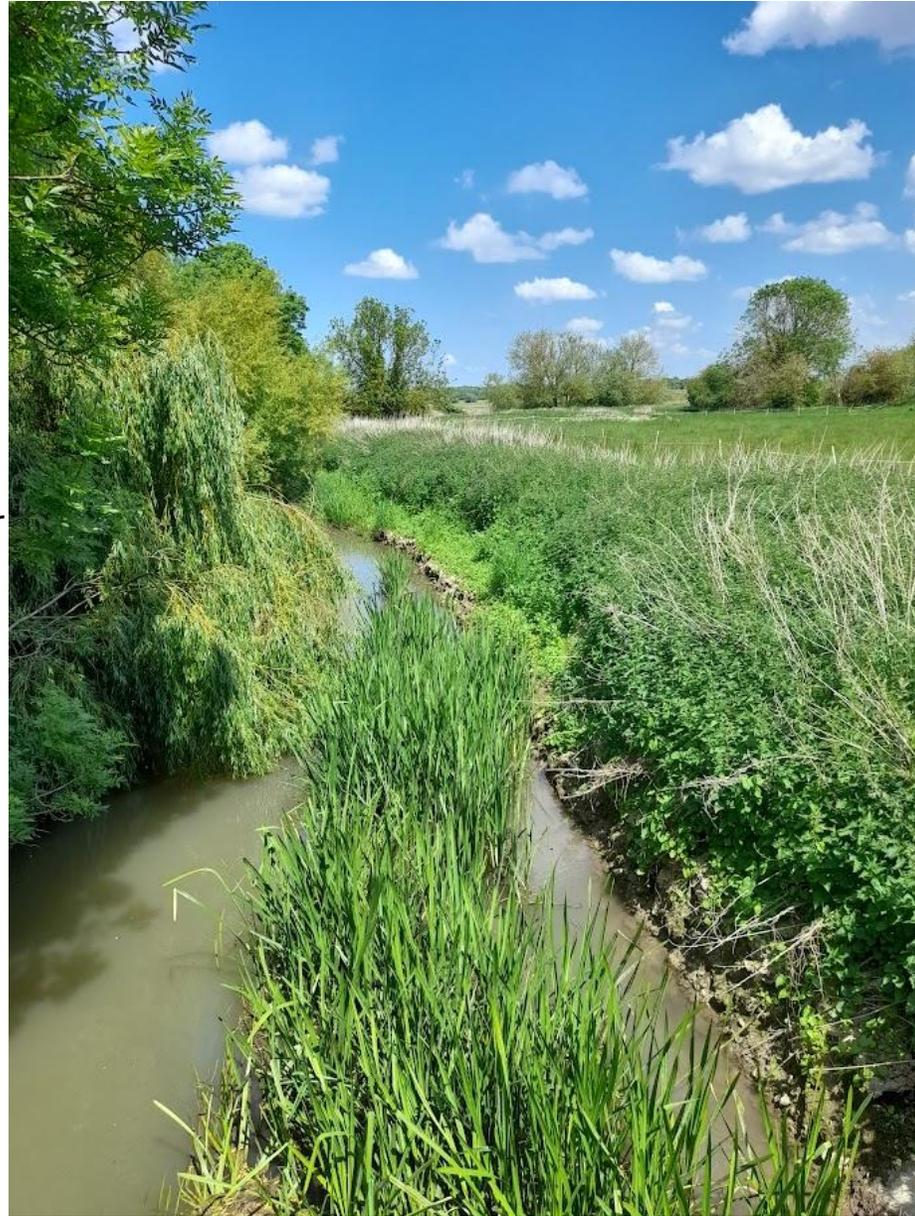
Rhee - Malton Farm bridge
Unbranched Bur-reed

Many holes and unstable lower
bank on right hand side

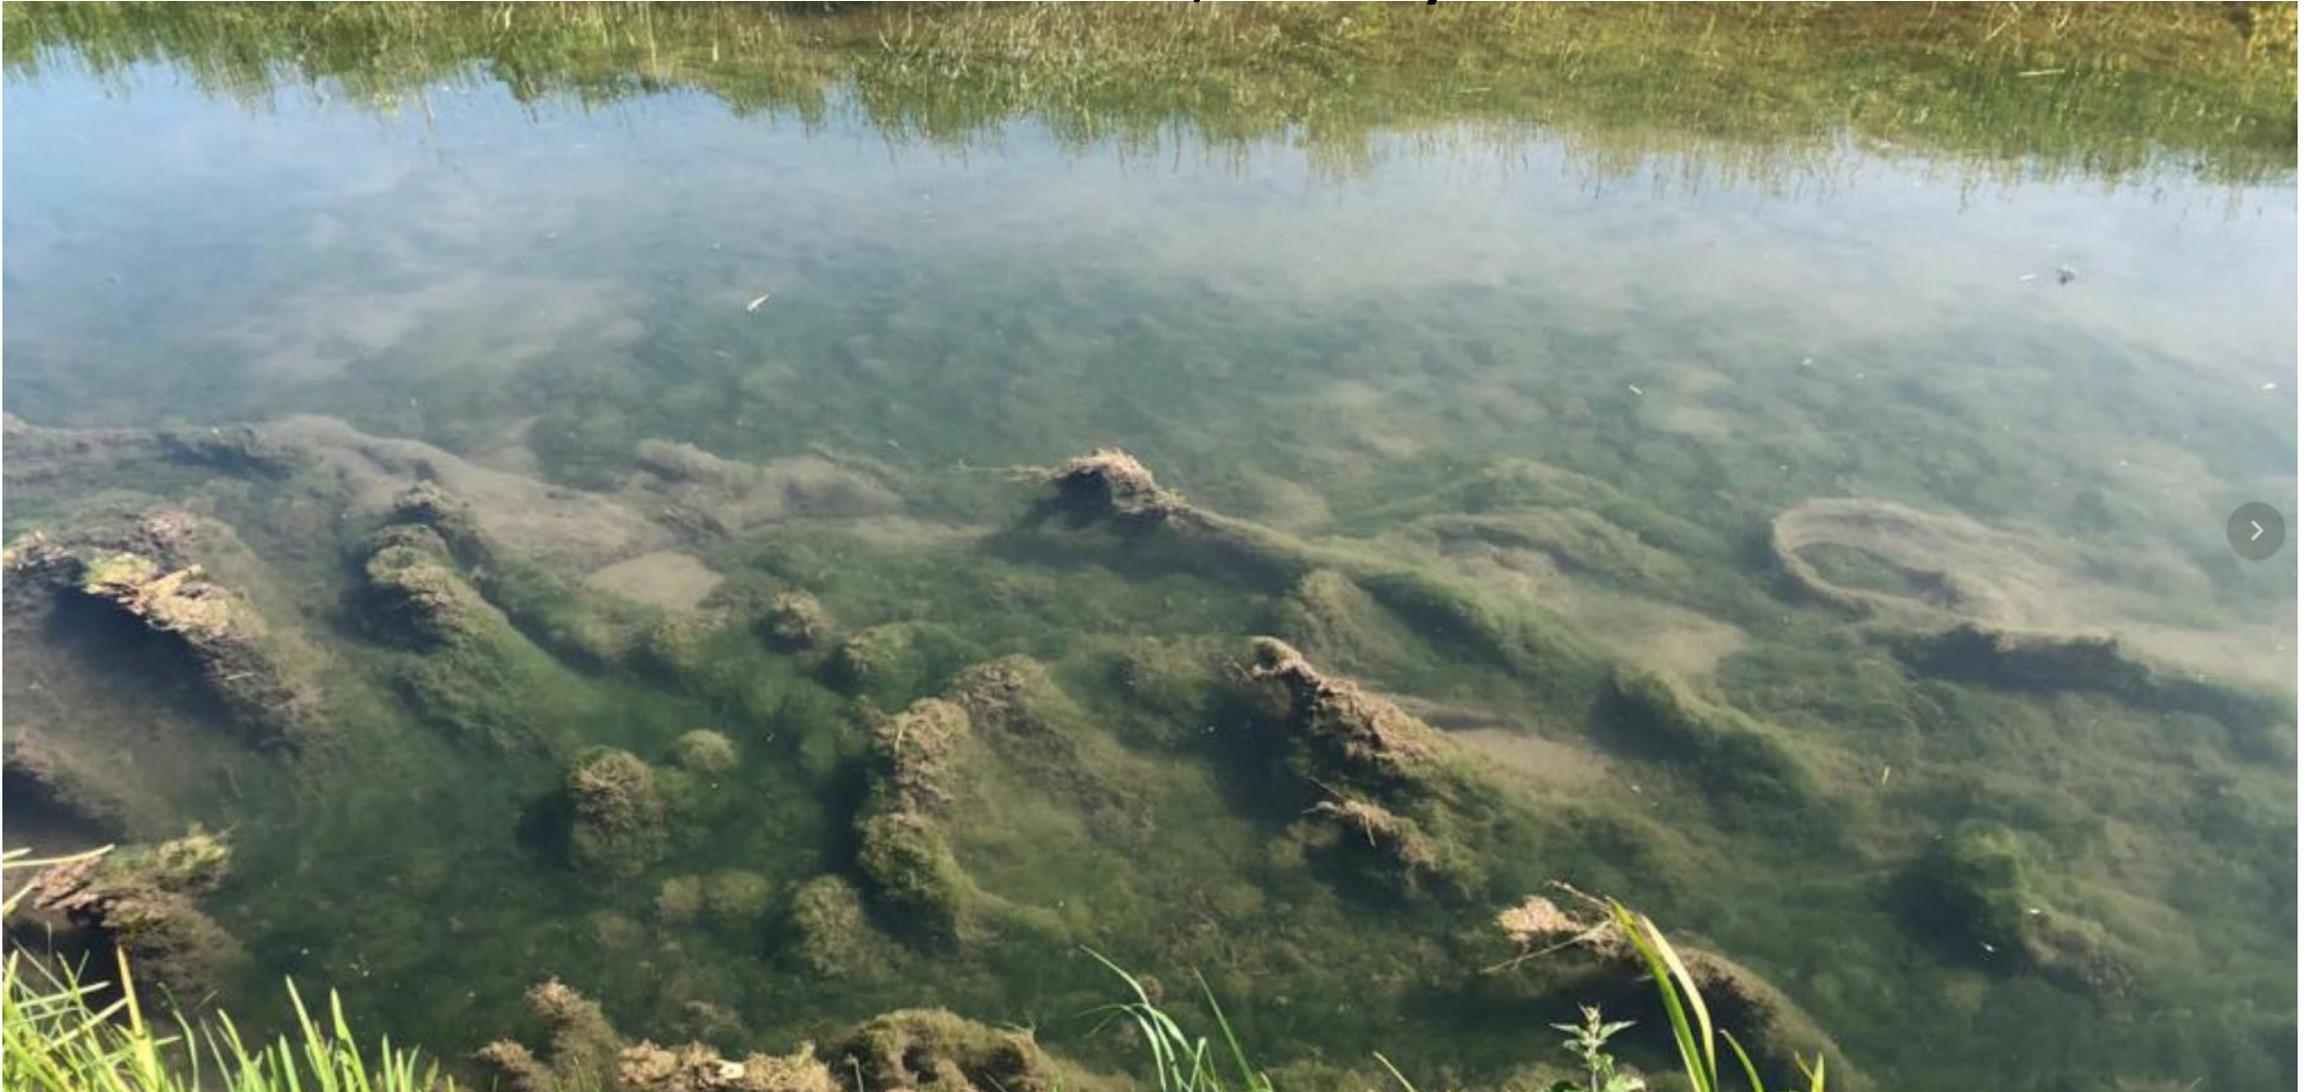
Phosphate overload creating a eutrophic watercourse

Swaffham Bulbeck Lode, 31st May 2021

Source: Bottisham sewage treatment works (96% phosphate attribution by EA)

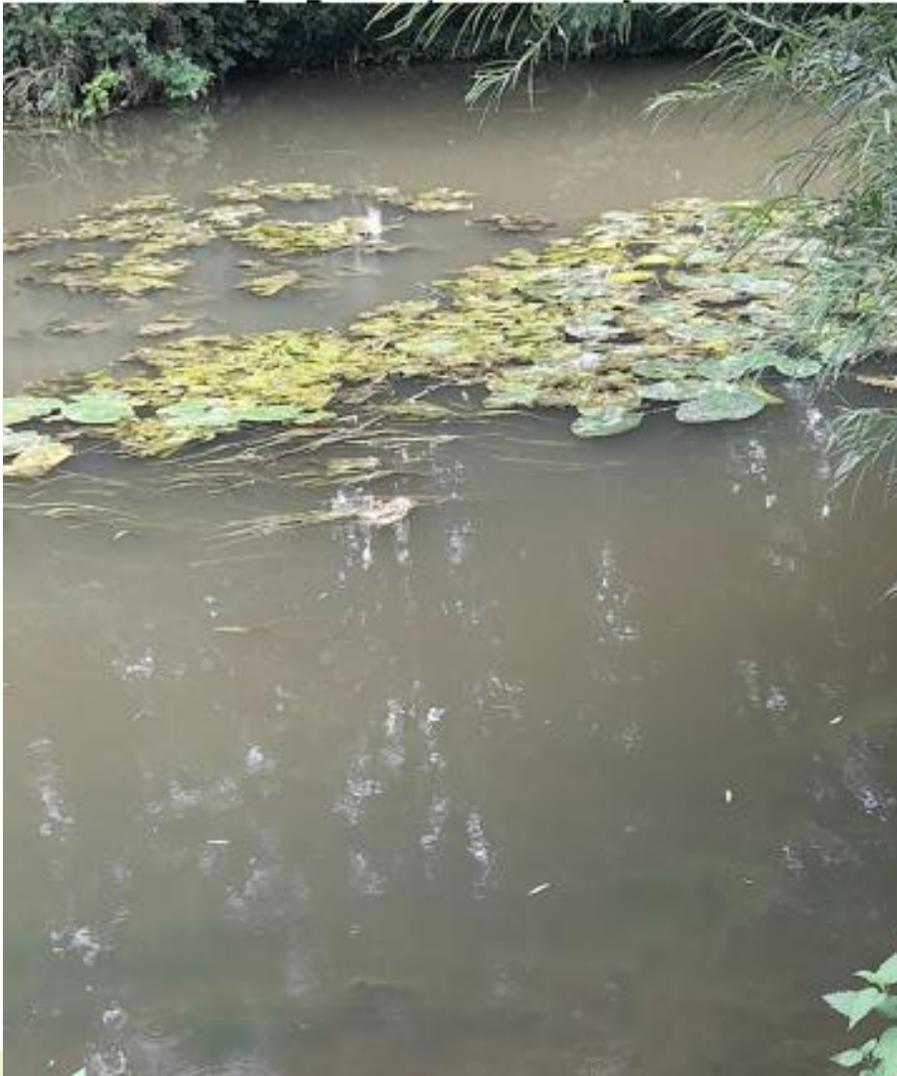
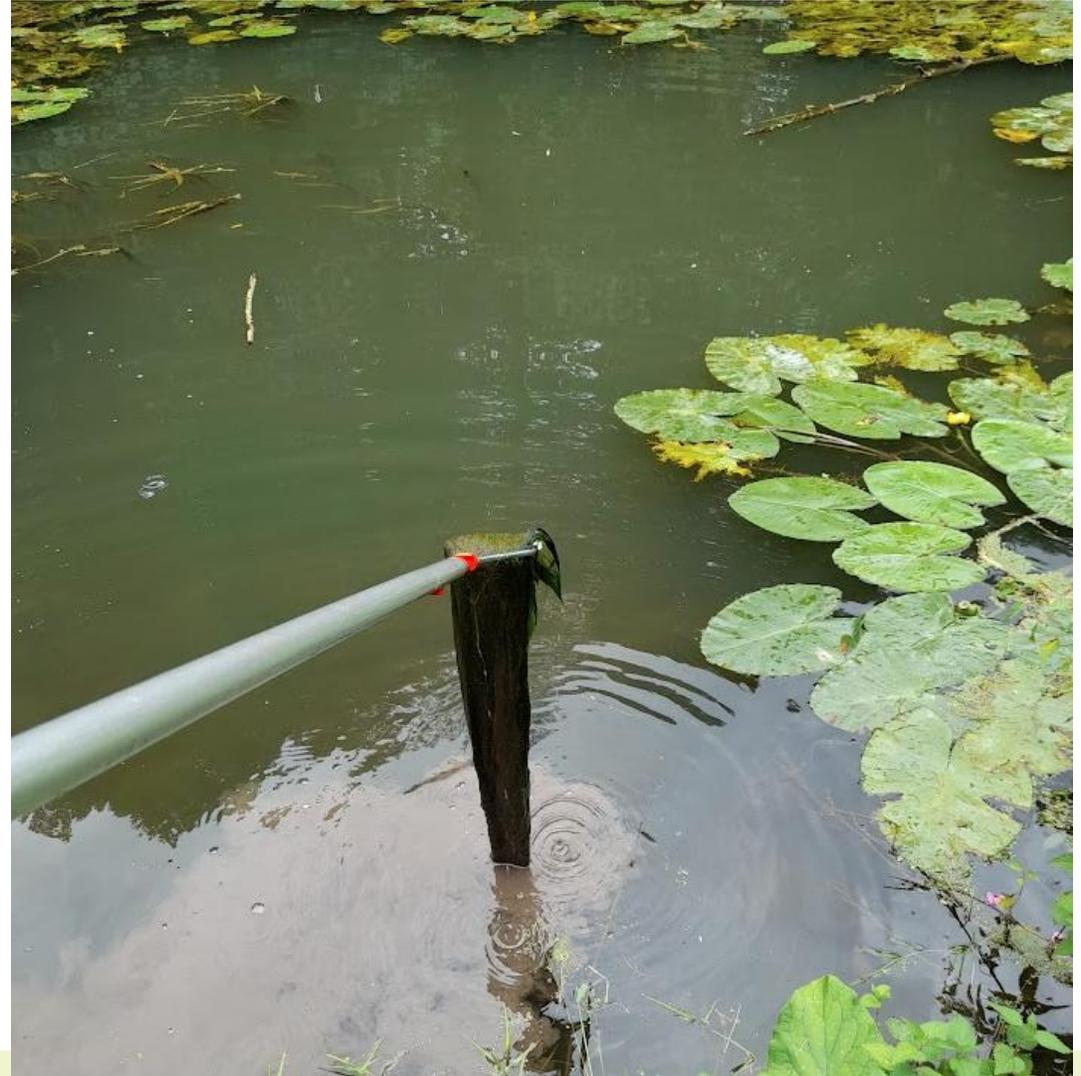
River bed algal mats: River Cam, Byron's Pool, 27 July 2021

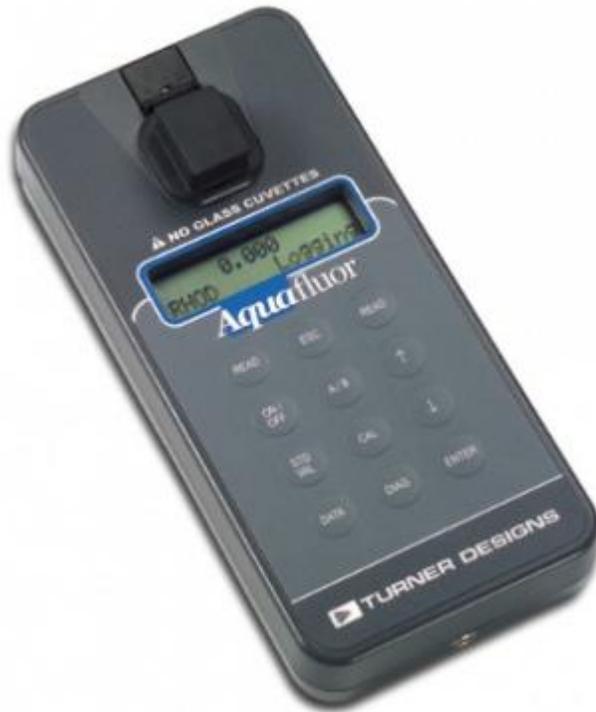
Turner Aquafluor Chlorophyll *a* and phaeophytin meter (£4,000)

Zero readings of Chlor *a* in the upper Rhee and Cam

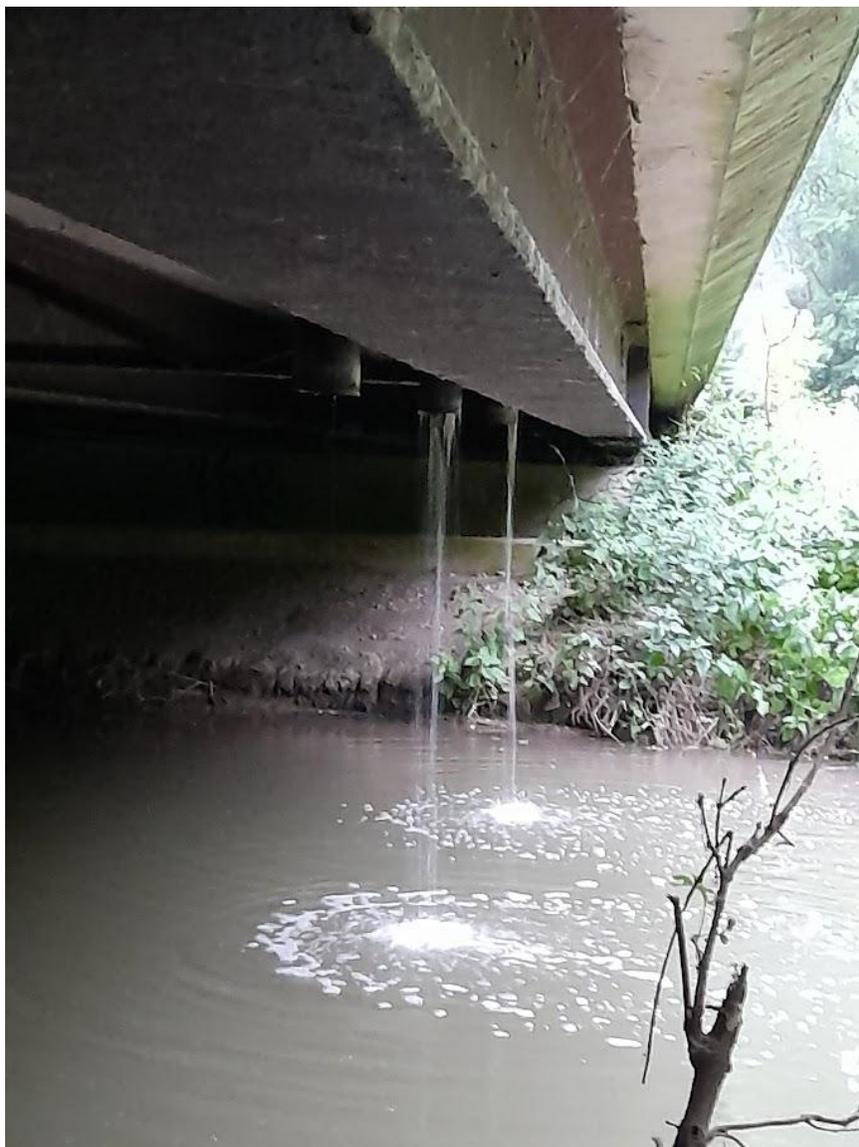
Cam /M11 bridge 24 May 2025, 0602, about one hour after start of rainfall

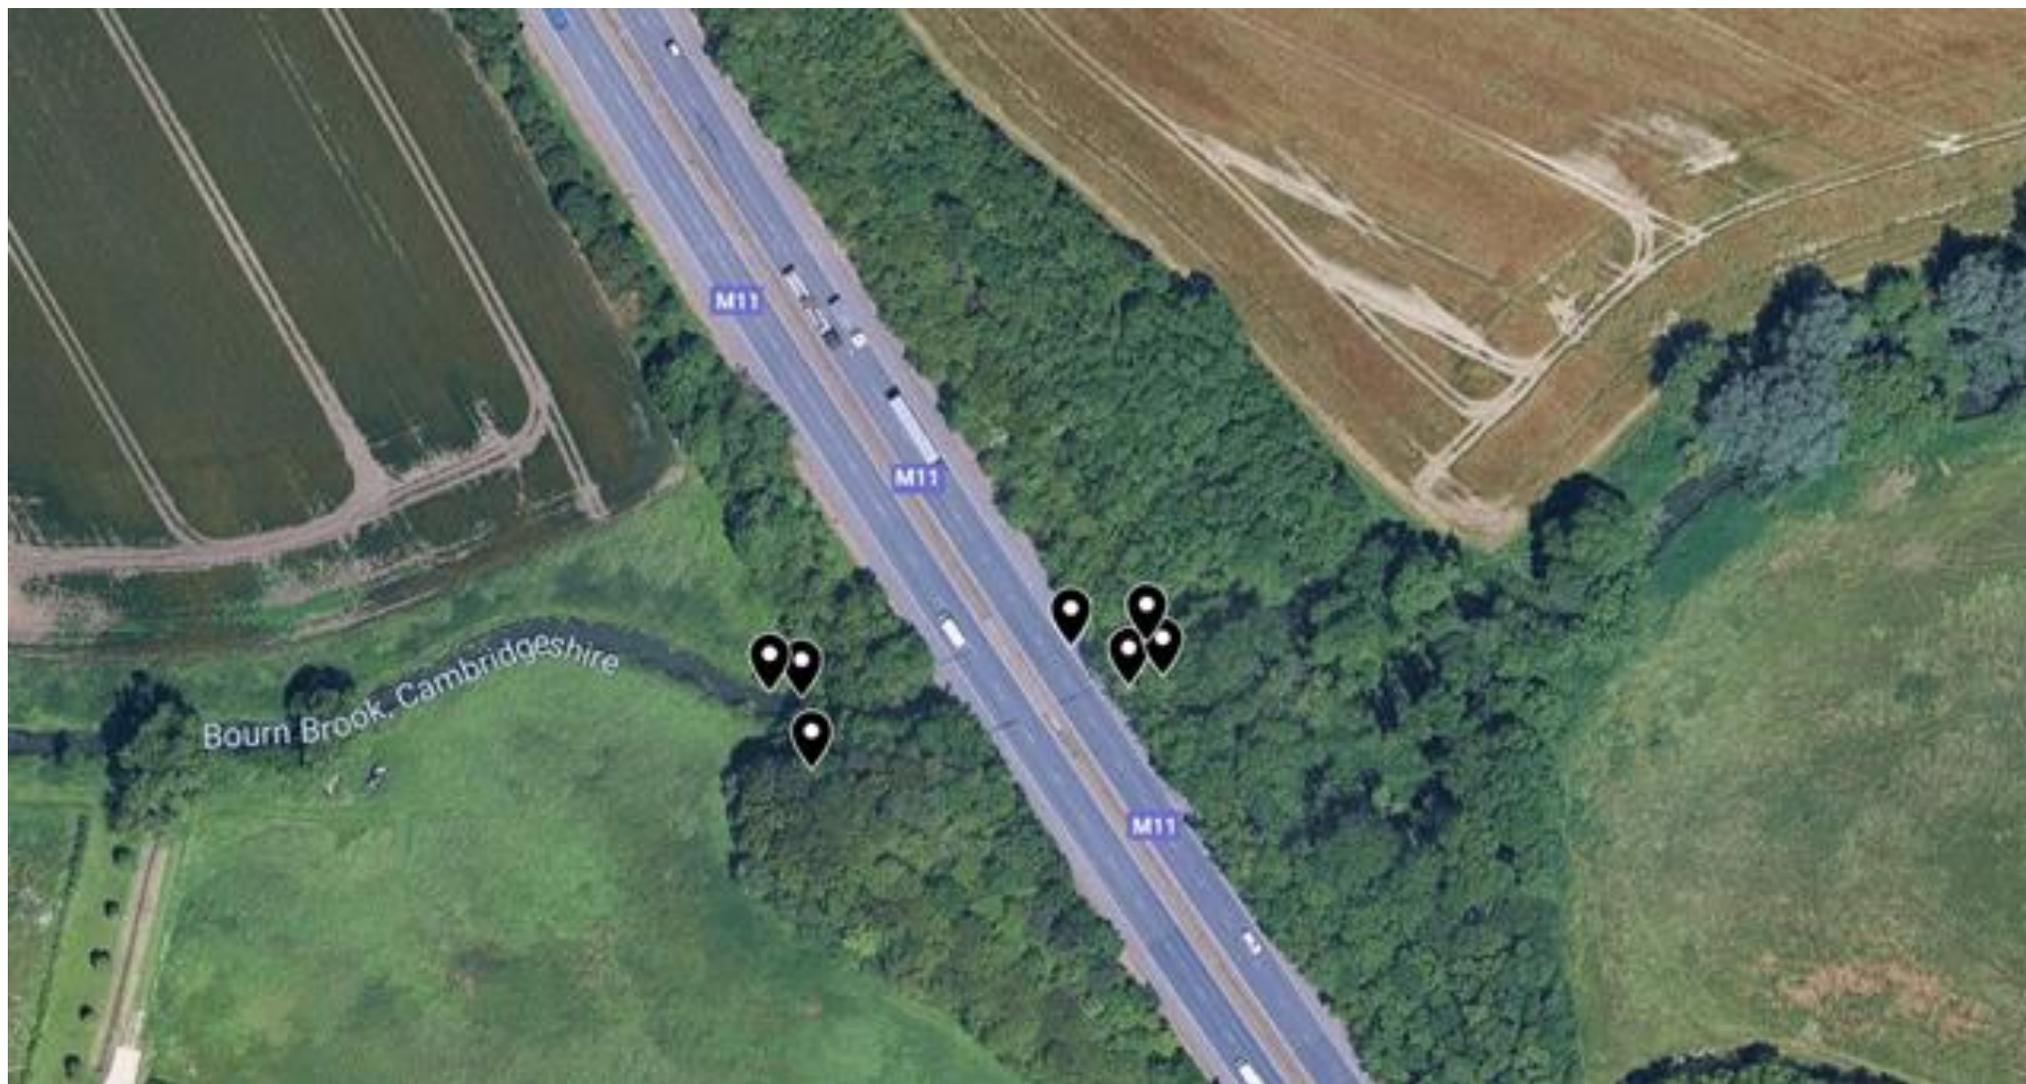
M11 outfall points discharging road runoff into the Bourn Brook, mapped by National Highways

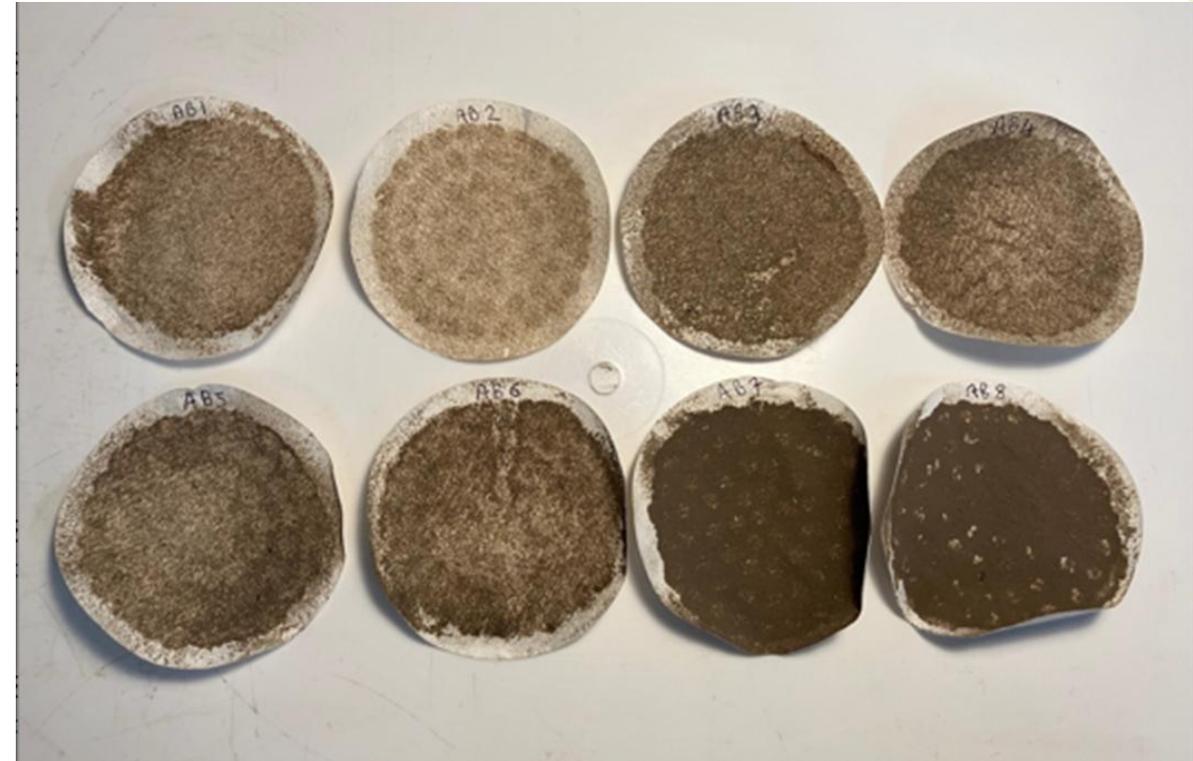
- Sampled 27/09/2024, spate conditions, Granta
- Suspended Solids collected onto weighed filter paper using vacuum pump. Dried at 105 deg C
- Organic matter determined by "loss on ignition, i.e. 950 deg C furnace
- Weighed to one milligram

Sites	% organic	% CaCO ₃	% silicate residue
7+8	21.7	22.7	55.6
