Why are the Rhee and Cam murky?

Can we clean them up?

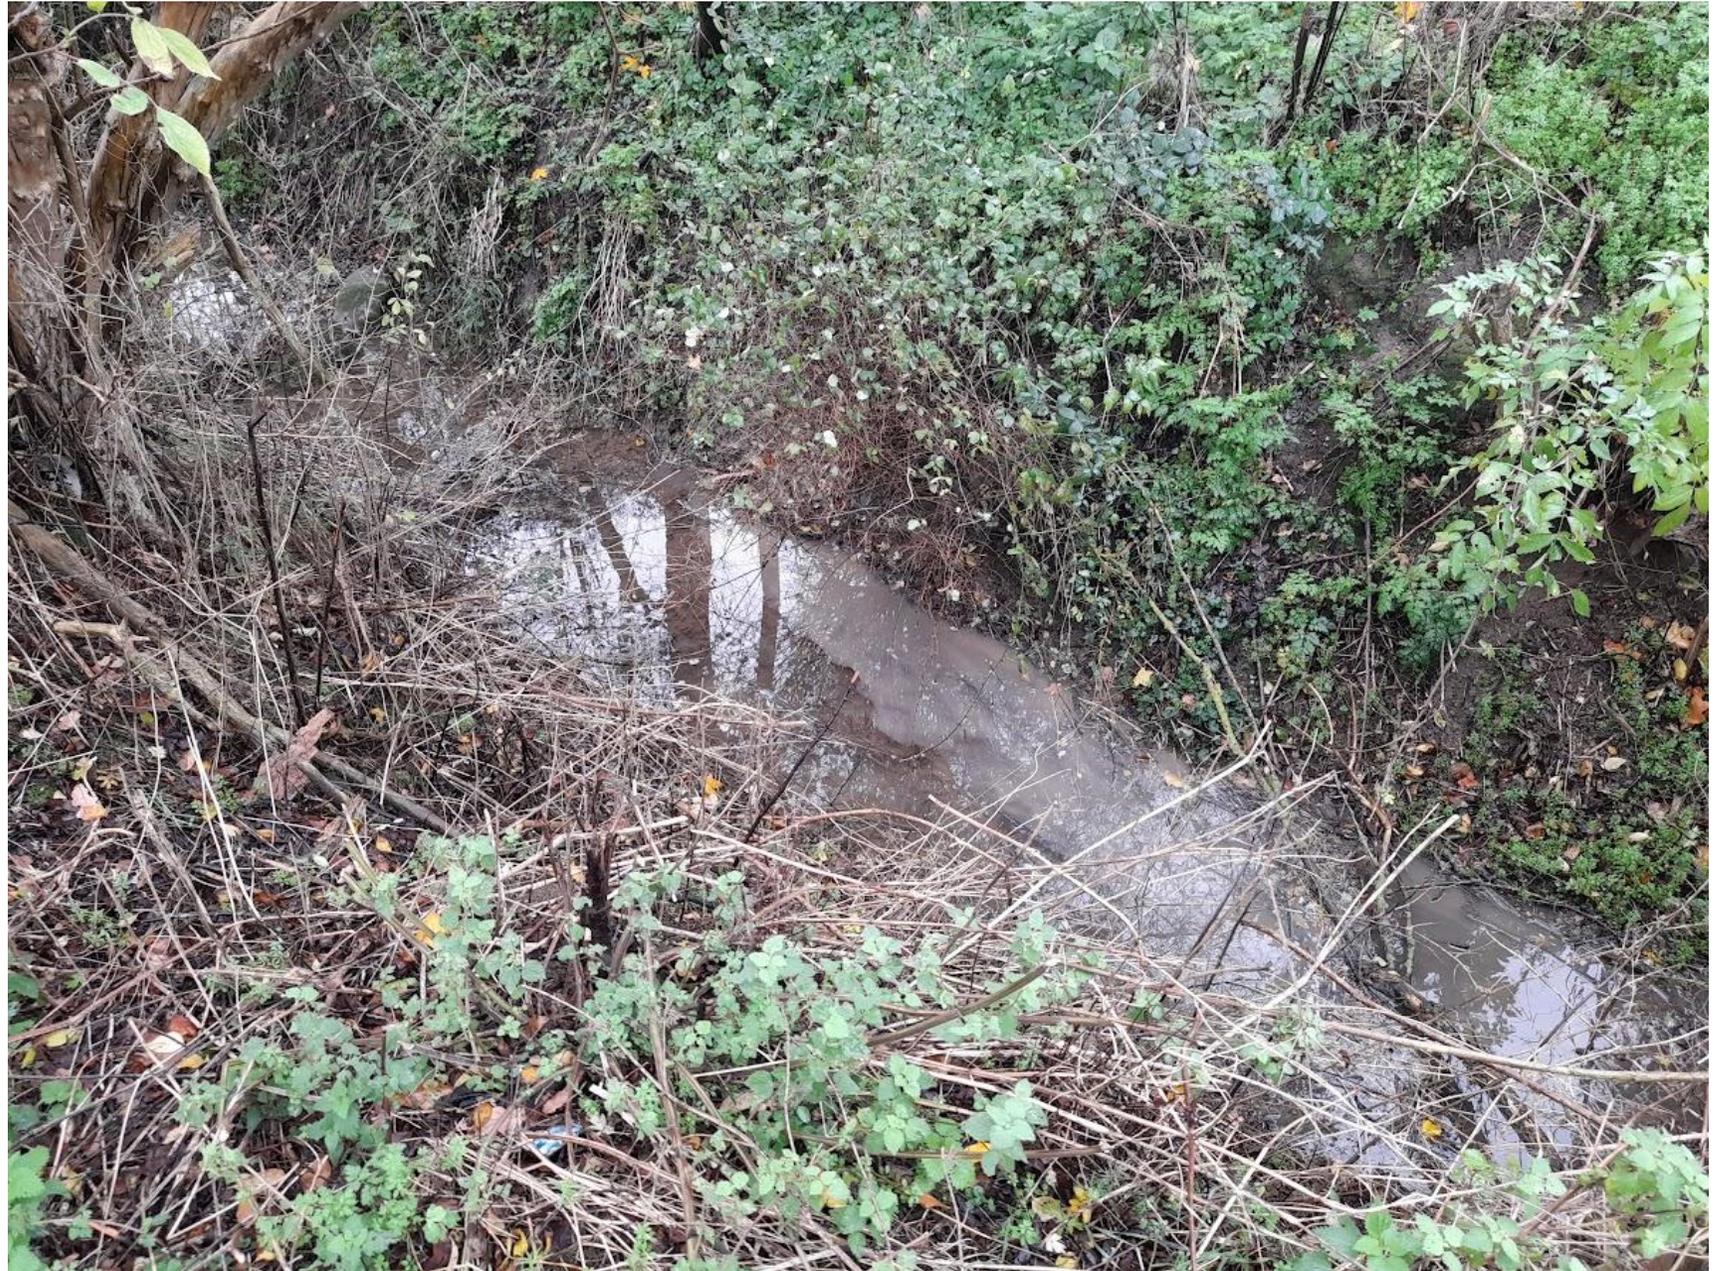
Small amounts of soil runoff from an arable field quickly makes a ditch turbid

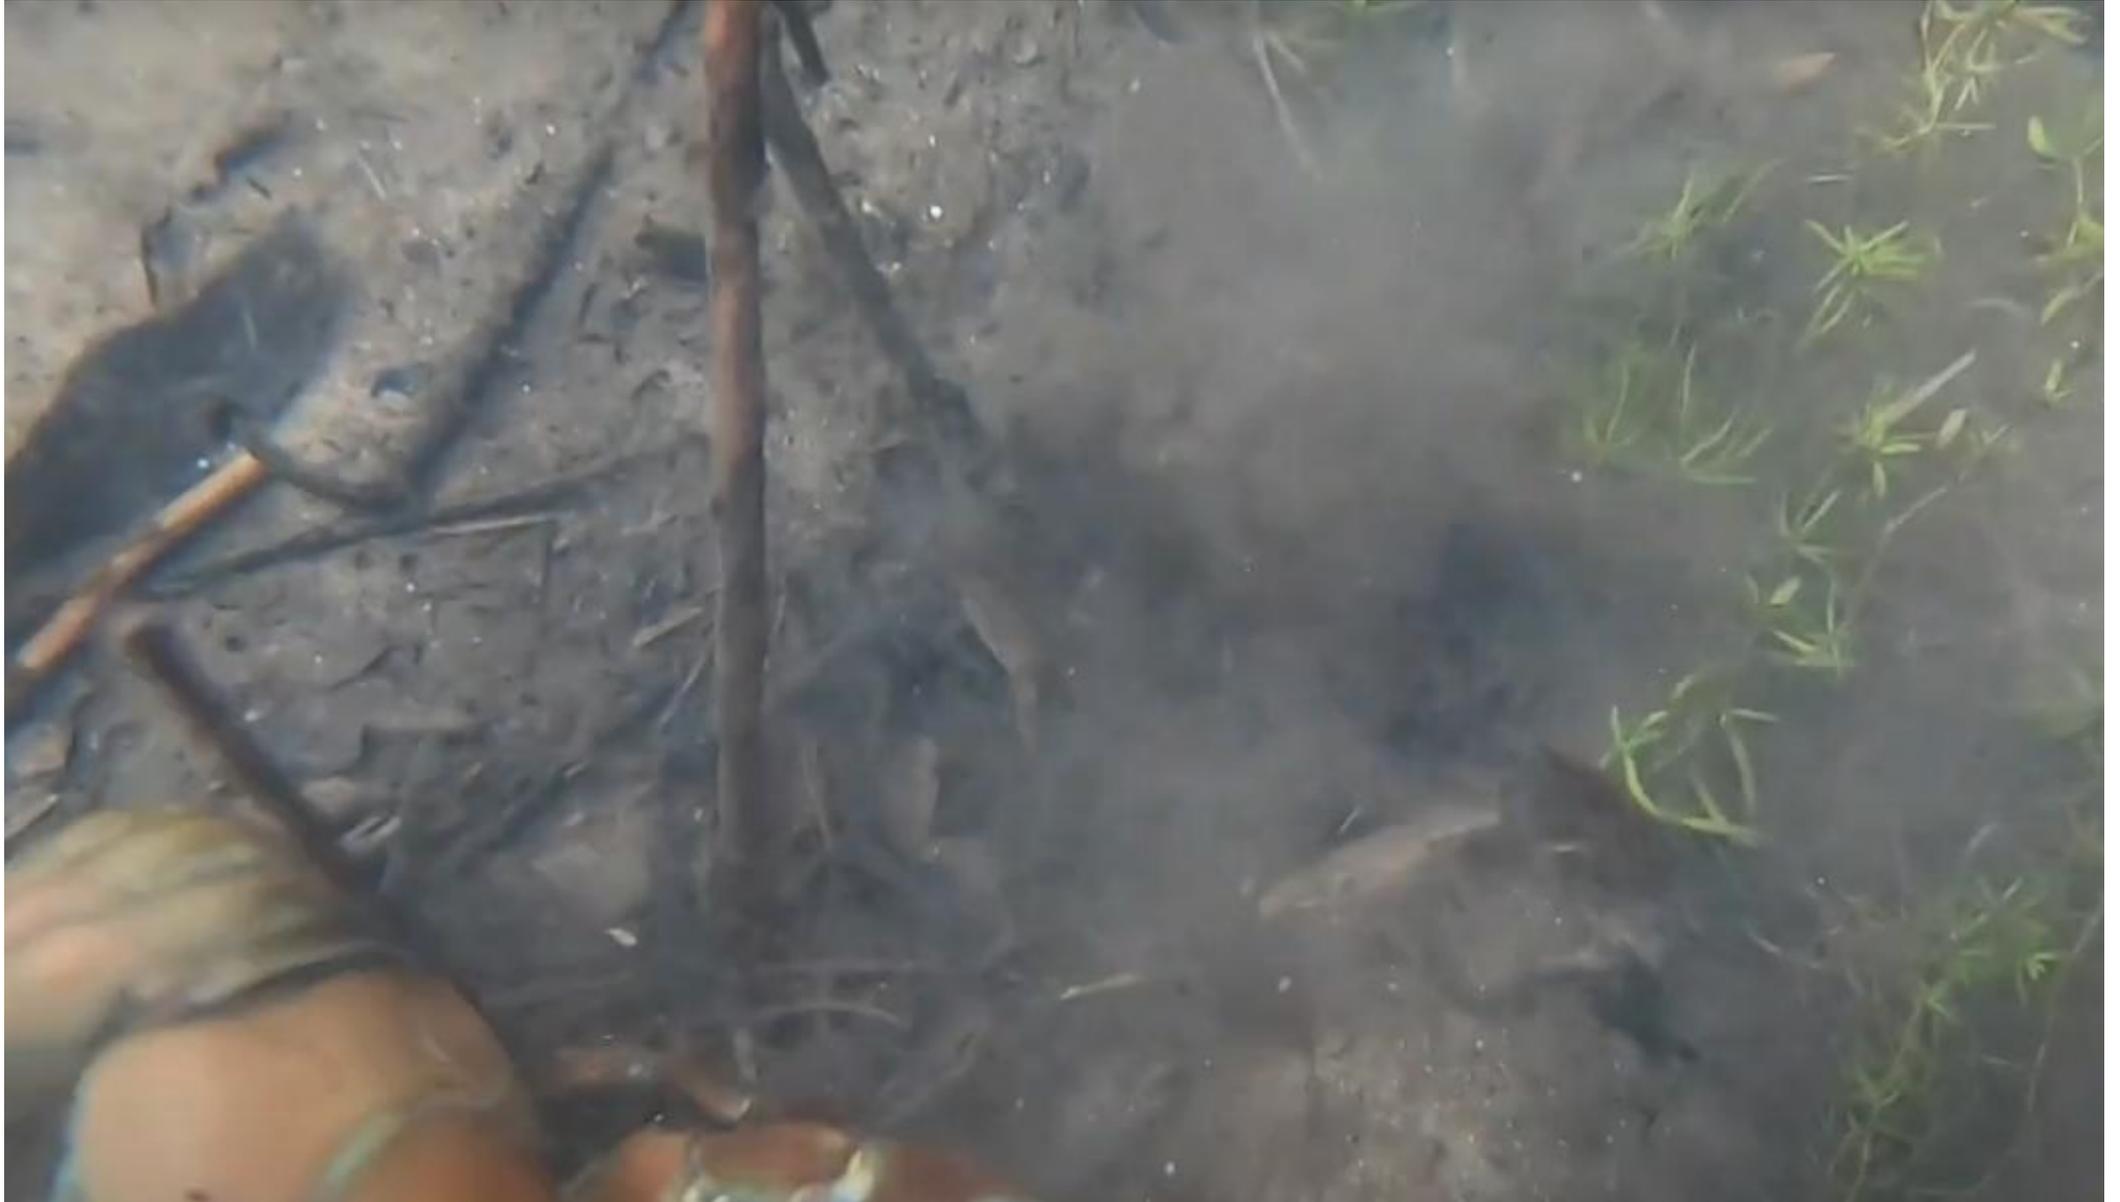
Fighting between adults creates significant uplift of sediment from the bed

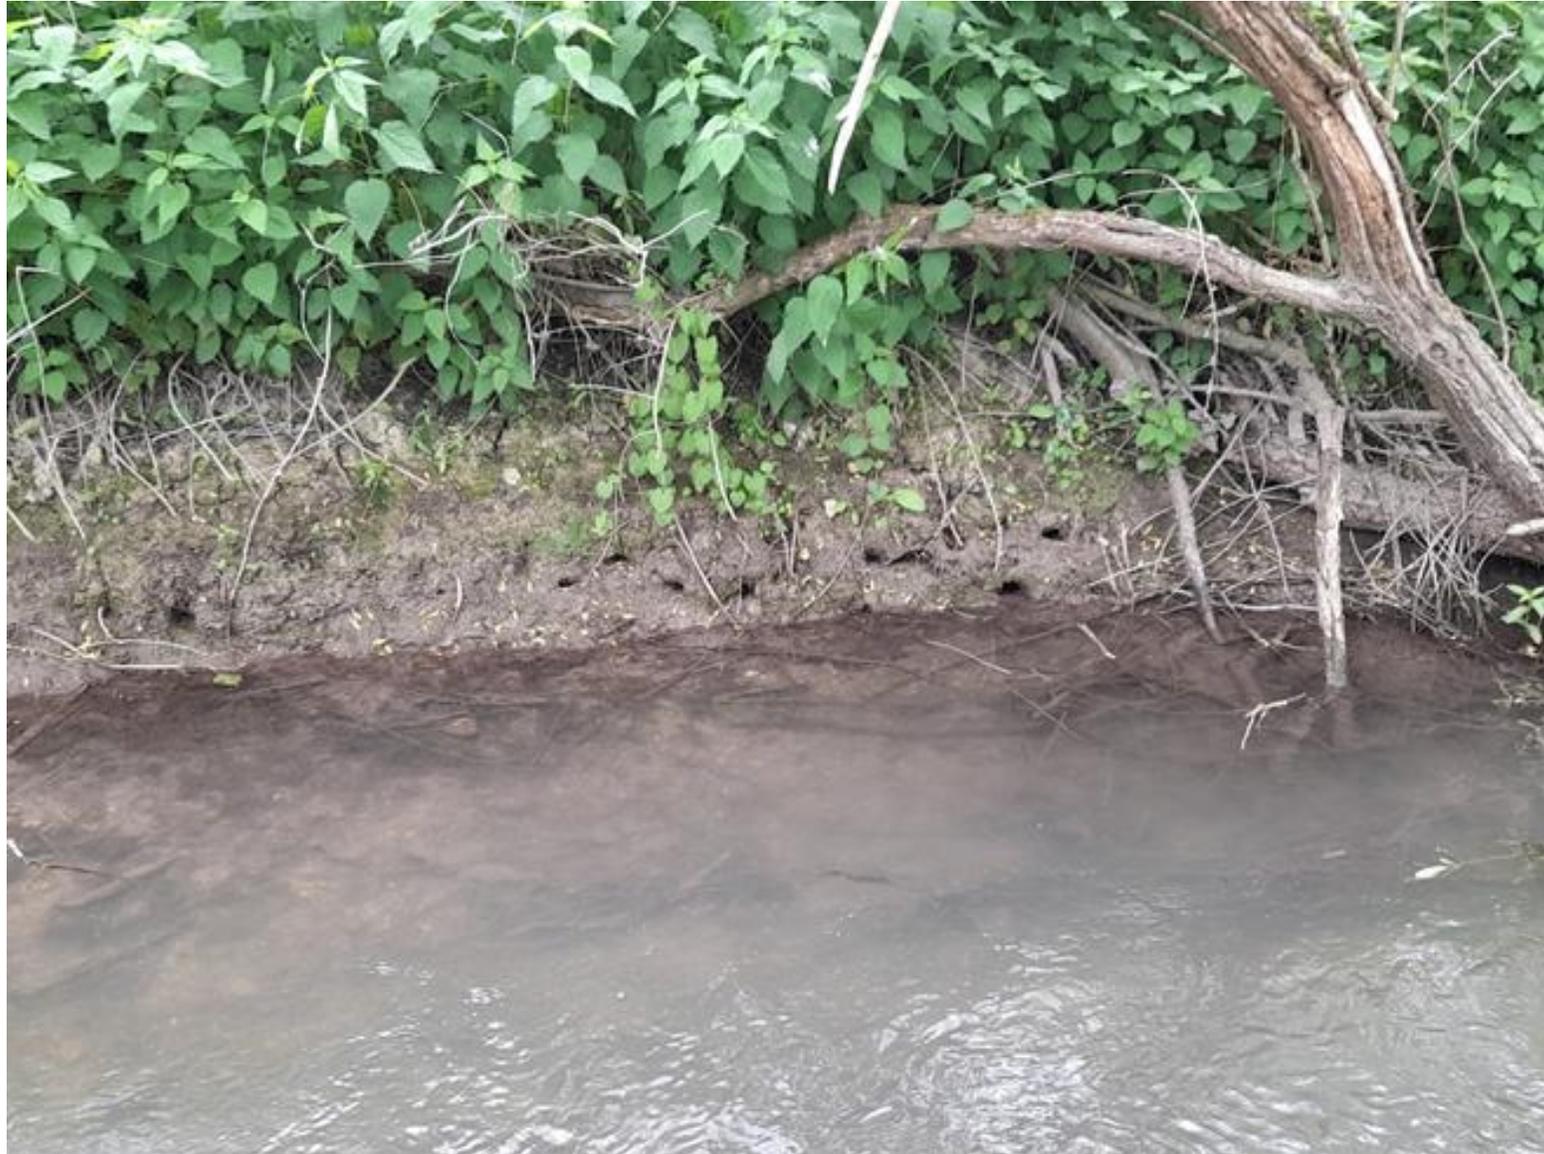
Crayfish burrows
cause Bank erosion
even collapse.

“Burrowing and the associated acceleration of retreat and collapse supplied an additional $25.4 \text{ t km}^{-1} \text{ a}^{-1}$ of floodplain sediments at one site”

= ONE TONNE of bank soil loss over 15 km PER DAY
