The Mystery of the Murky Rhee

Identifying the causes of the shocking increase in the turbidity of the River Rhee

Anne Miller, Mike Foley

17 May 2026

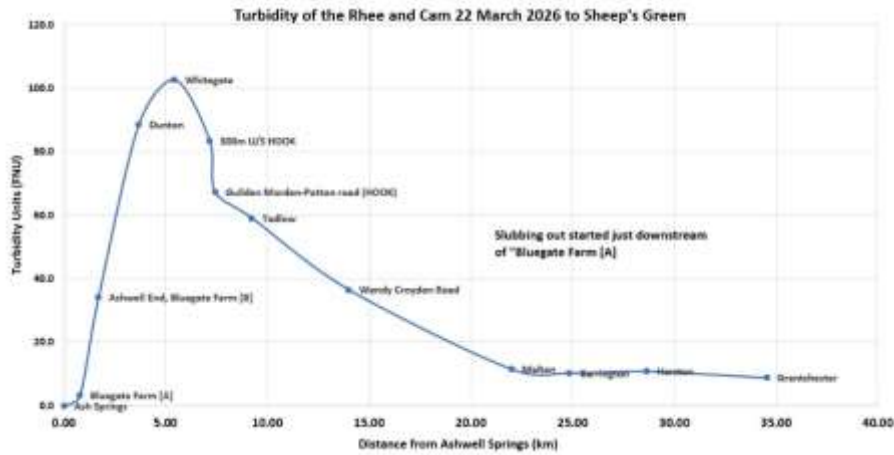
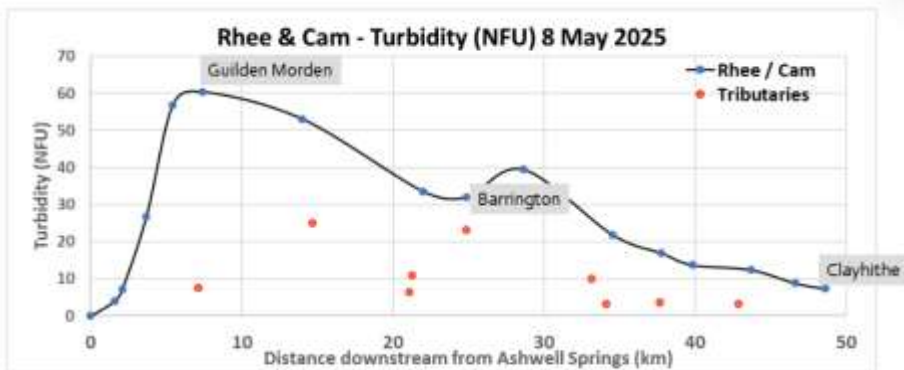
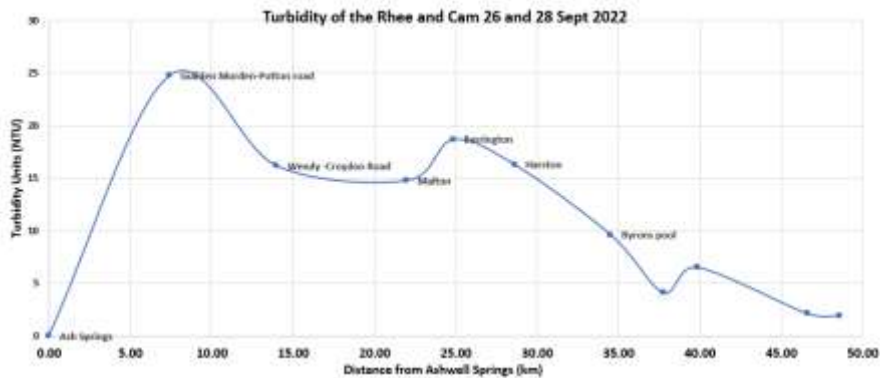
Although not specified in this chart some tributaries are Chalk streams and two have become turbid as they approach the junction with the Rhee

In March 2026, the big peak in turbidity (at Whitegate Bridge, just upstream of the Guilden Morden bridge – “Hook”) was nearly twice as bad as in May 2025, with turbidity reaching a shocking level of over 100 FTU. The turbidity peak here was less severe in September 2022. This is probably because 2022 had a prolonged period of summer drought with no rainfall for weeks, ditches were dry, and river flow rates were low. Yet, turbidity at Haslingfield remained high in 2022, presumably because of the presence of American Signal Crayfish.

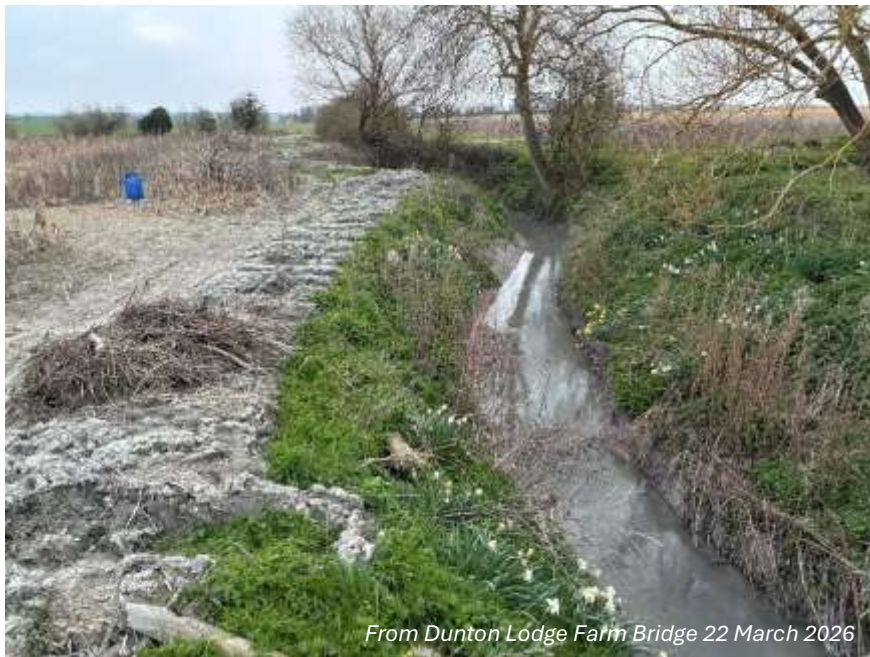
The damage to the bank is clearly visible at Ashwell End in early 2026, with extensive clay left in the bed, ready to be washed out in the next flood.

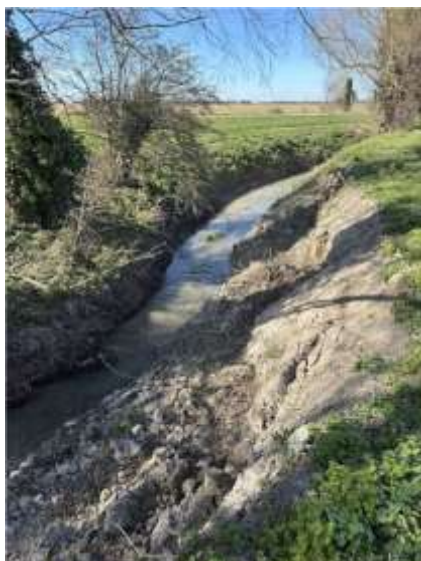
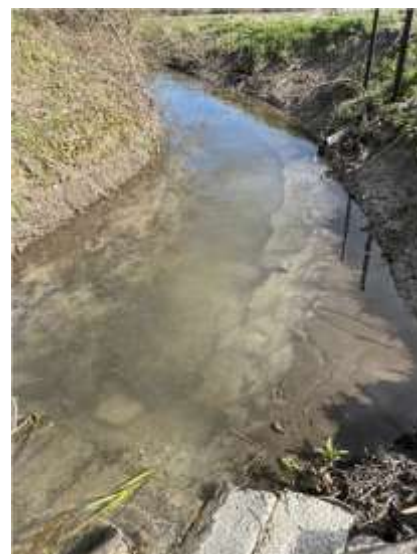
Even 4 months later, on 2 May 2026, the Rhee still appeared unpleasantly turbid at Wendy, about 8 km downstream of Ashwell End.

The primary cause of the turbidity in the upper Rhee appears to be dredging and slubbing-out. This was first done in 1816 and has been carried out frequently since 1972. Most recently, this was carried out by Bluegates Farm, who slubbed-out 3km of the Rhee and a tributary at Ashwell End from 28 January to about 7 February 2026. This caused very significant increases in turbidity (to over 100 FTU). Our monitoring suggested that, because of the fine clay soils, the turbidity extended over 20-25km downstream to Haslingfield, and it took weeks (or more) for the turbidity to settle out. However, the source material remains there to be continually put into suspension.

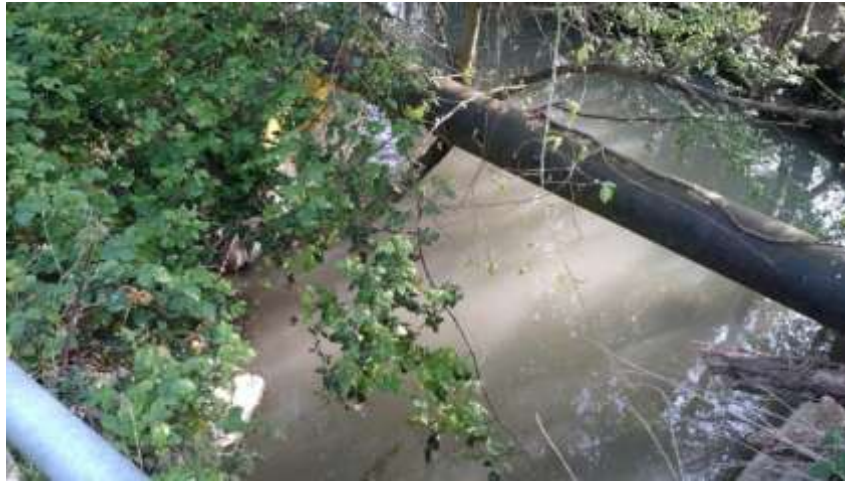
Photograph of Rhee at Wendy, taken from the bridge with the EA data sonde, 8am 2 May 2026, when the turbidity was around 23 FTU

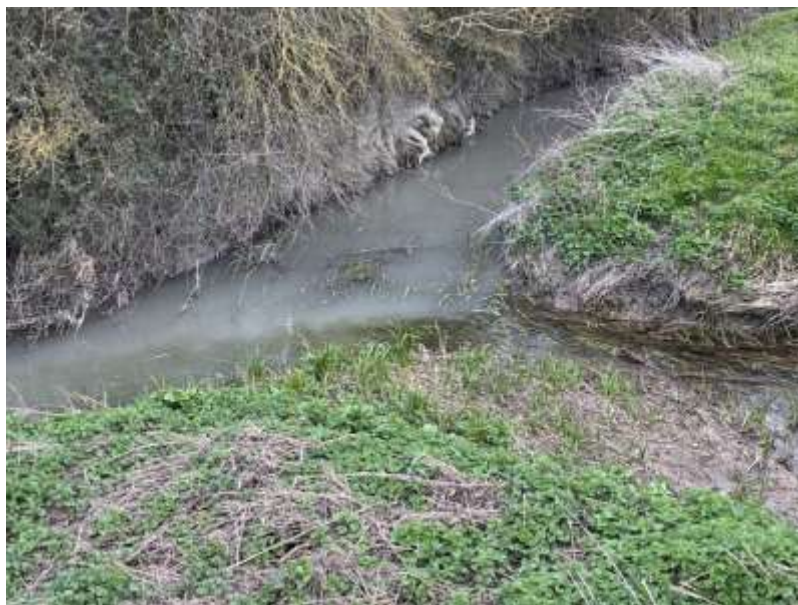
River Rhee, near Guilden Morden, high turbidity 22 March 2026, with much clearer water entering from right, exiting extensive field drainage systems from Edworth and Cockayne Hatley

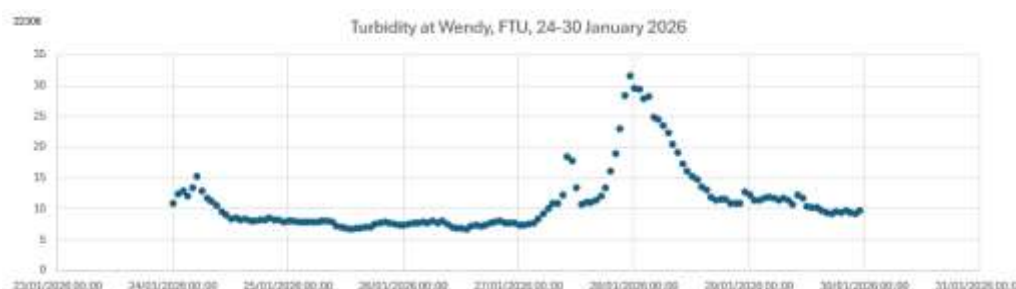
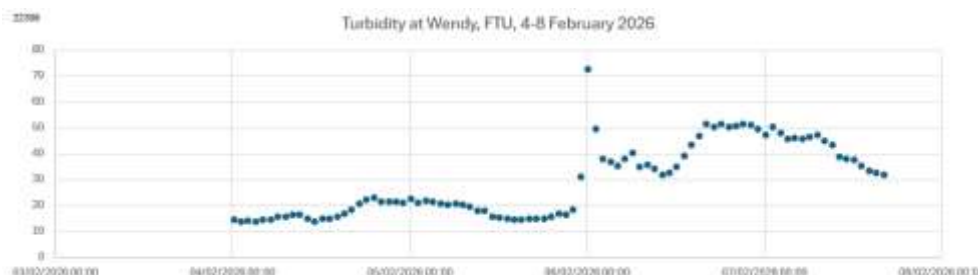
The Sonde data shows these events very clearly. For example at Wendy the data sonde stopped recording on 10 Jan when turbidity reached over 65 FTU, we suspect due to fouling of the sensor.

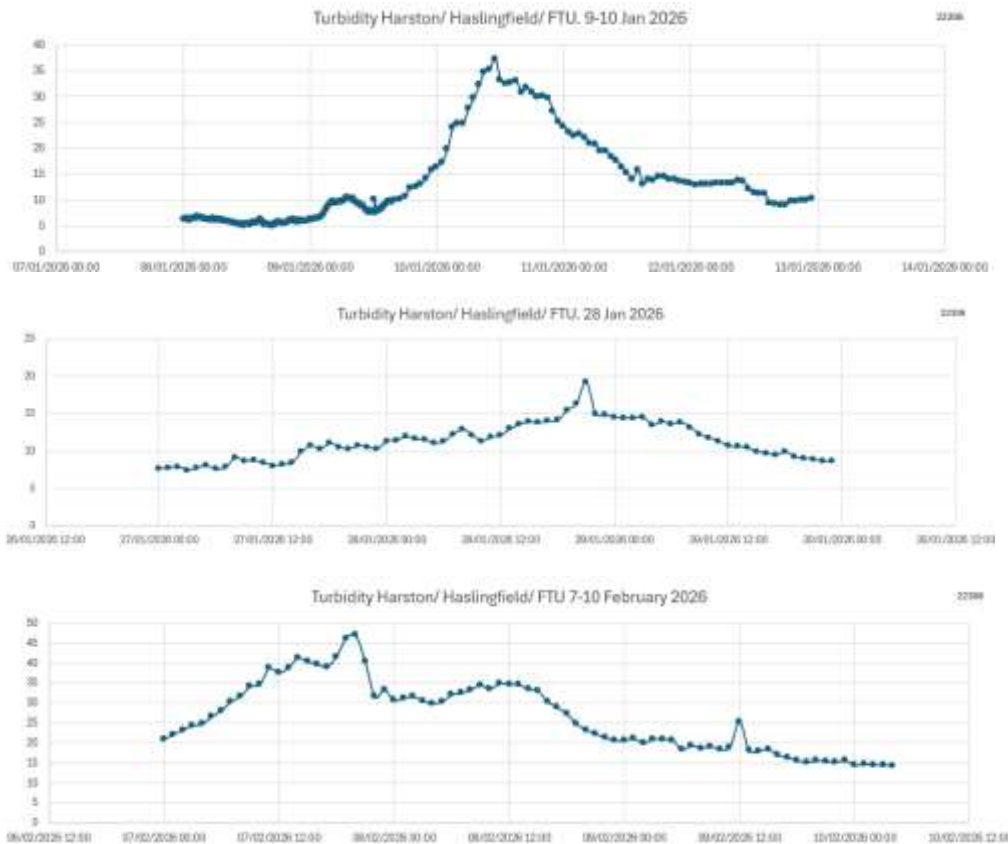
Downstream in Haslingfield the effects were more minor but the impact was still clearly evident, with the turbidity peaking at 47 FTU on 7 February 2026.

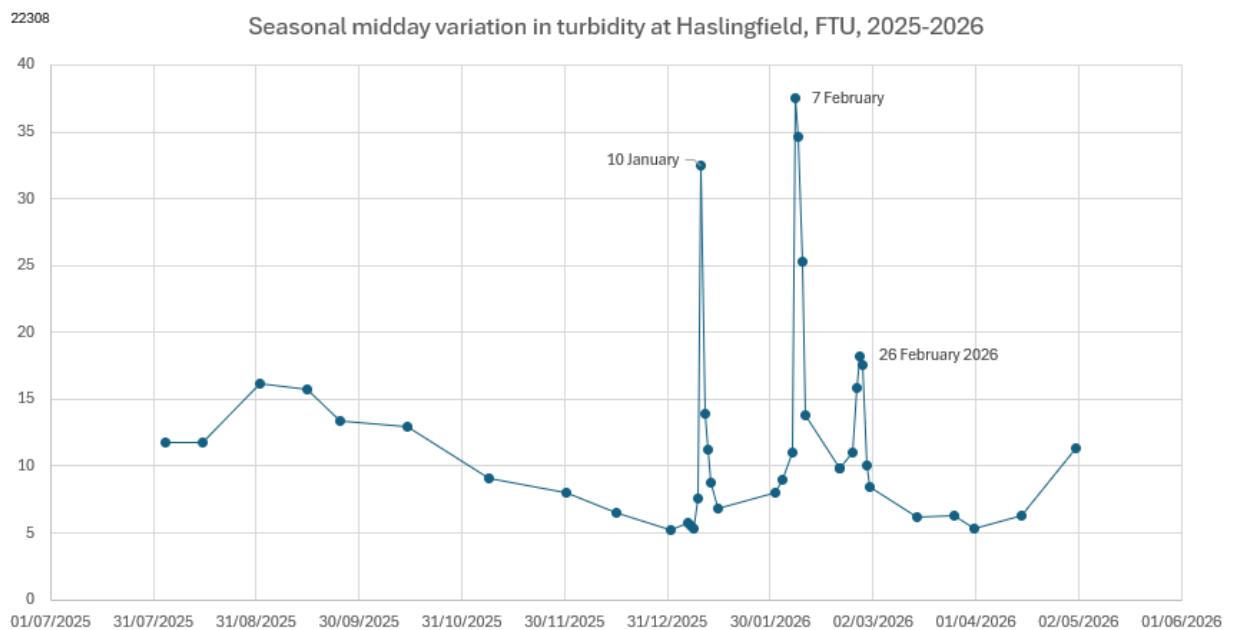
Discounting the obvious winter turbidity events discussed in the section above, the data confirmed that there IS a clear seasonal trend at Haslingfield. Turbidity is worse in summer, typically reaching around 15 FTU. The turbidity (excluding contamination events) then reduced and reached 5 FTU in winter. This seasonal pattern would be consistent with the activities of a high population of American Signal Crayfish.

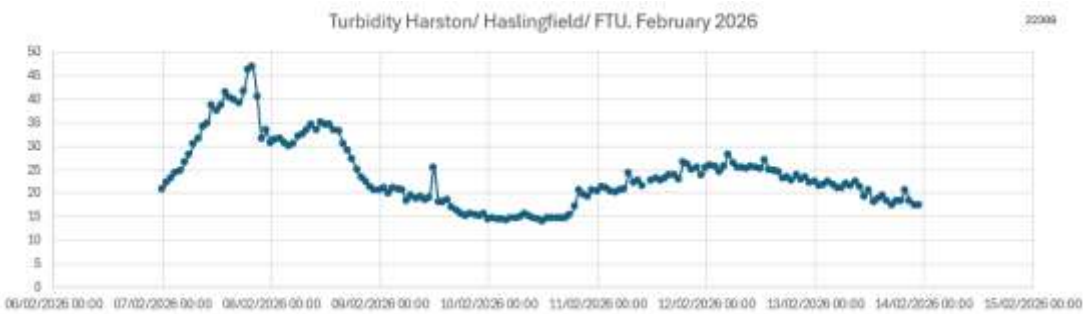
In contrast, in February 2026, there was no diurnal variation, although the turbidity peaked at around 47 FTU on 7 February 2026, probably due to slubbing out upstream.

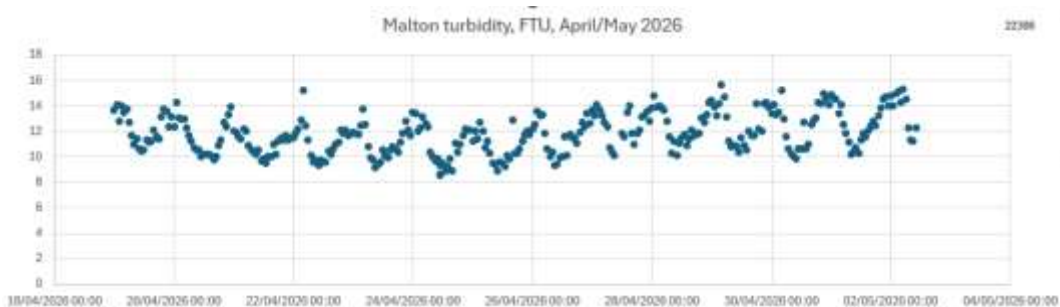
We can see from the Environment Agency sonde data that American Signal Crayfish are also present and active upstream of Haslingfield at Malton and we think this is contributing to the turbidity there. There was clear evidence of diurnal variation in April/May 2026, with the turbidity increasing from around 9 during the day, to a peak of around 14 at night.

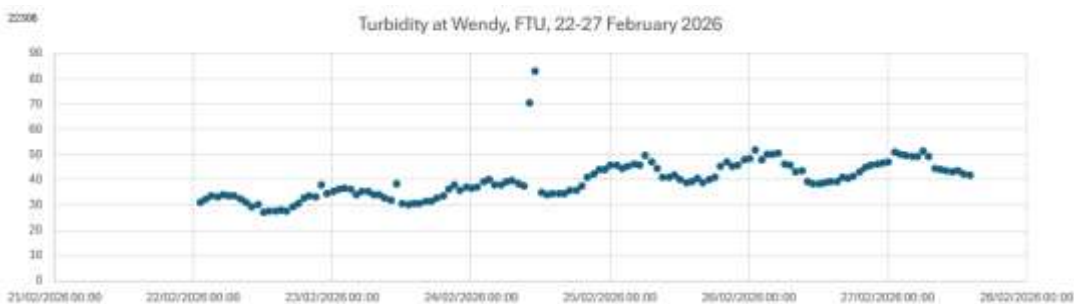
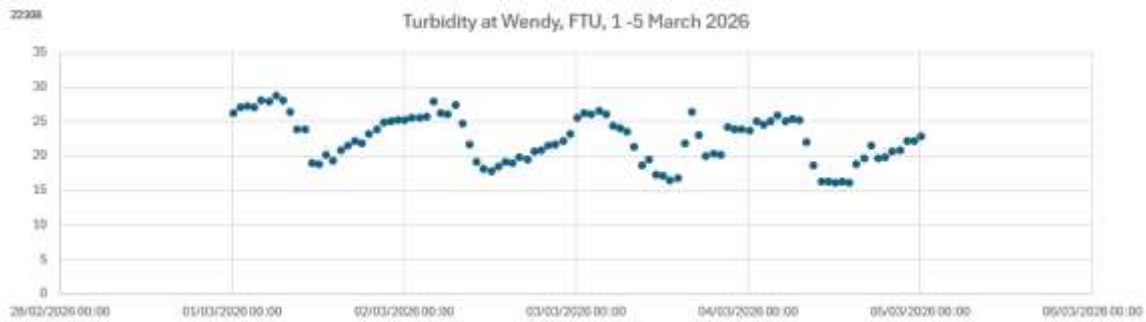
Further upstream still, at Wendy, there was again clear diurnal variation, noticeable in late February and March, but absent in January and early February 2026. Unexpectedly, the diurnal variation was also hard to discern in early May 2026.

Traditionally, the active period of American Signal Crayfish extends from early May to November, so evidence of activity in late February may be a sign that activity is starting earlier than we'd expected.

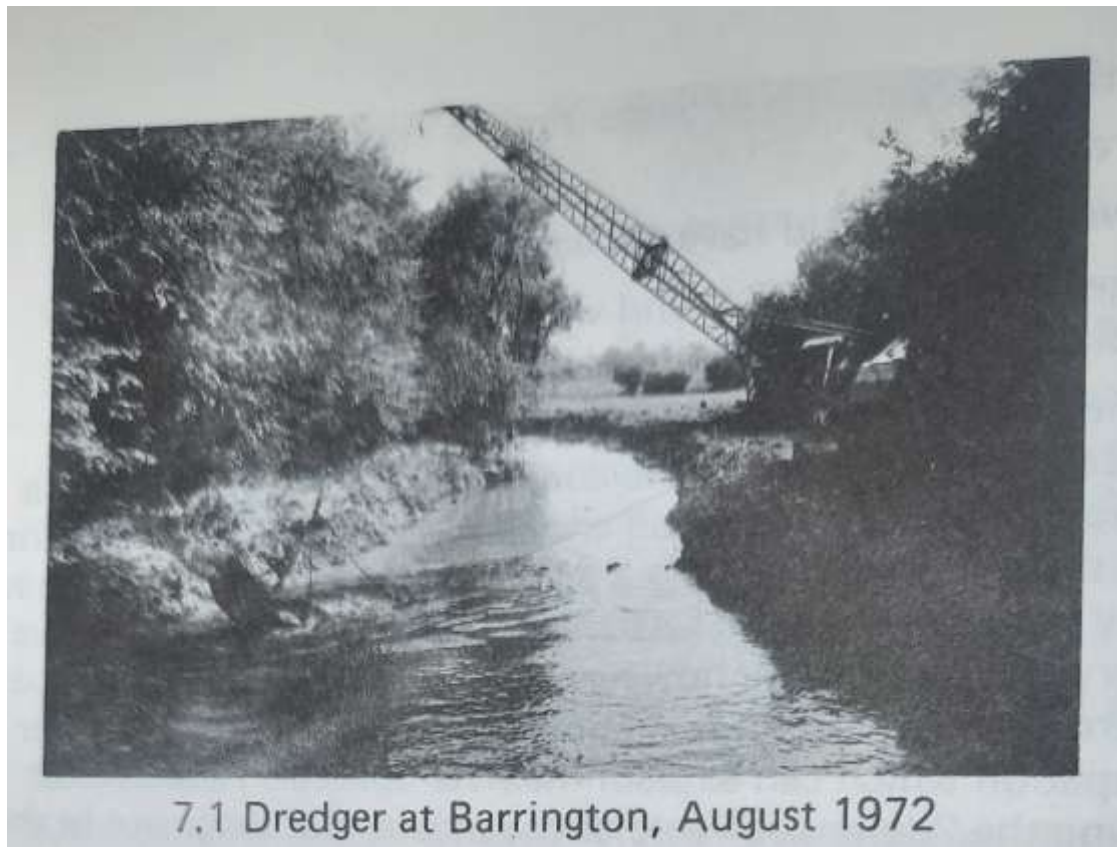
Photo by Roland Parker, from *Barrington/Foxton bridge*, published in *Barrington Local History and Conservation Soc's book "Cam or Rhee" 1973*

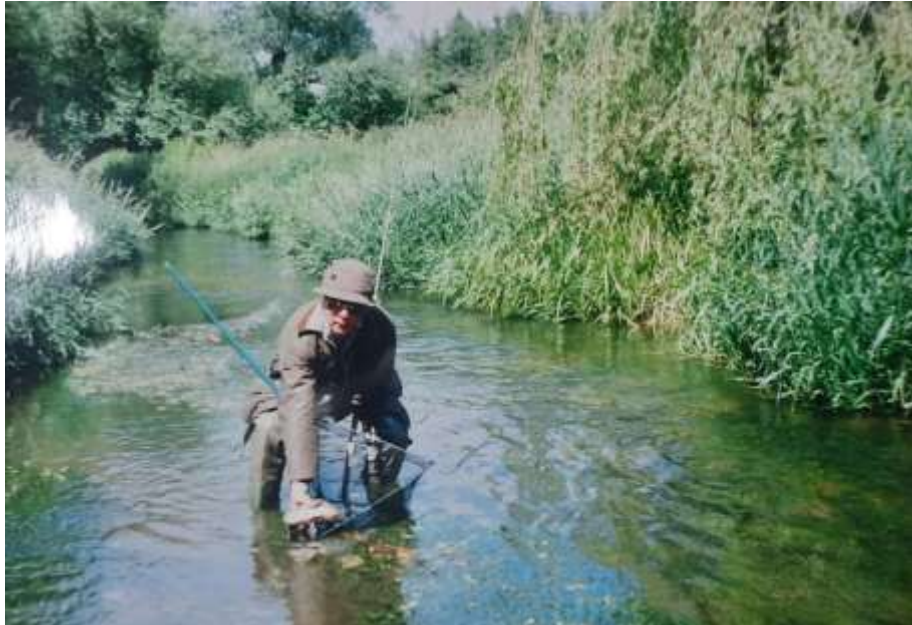
The Rhee between Barrington and Haslingfield was still crystal clear in 1996 and 2001

Rob Mungovan says “Note how clear the water is with water crowfoot and extensive margins of reedsweet grass. By late summer there was always dense stands of arrowhead and unbranched bur reed”

Chris Mungovan fishing near Harston/ Haslingfield bridge in the shallow clear water of Rhee with water crowfoot around him ~1996. Photo © Rob Mungovan

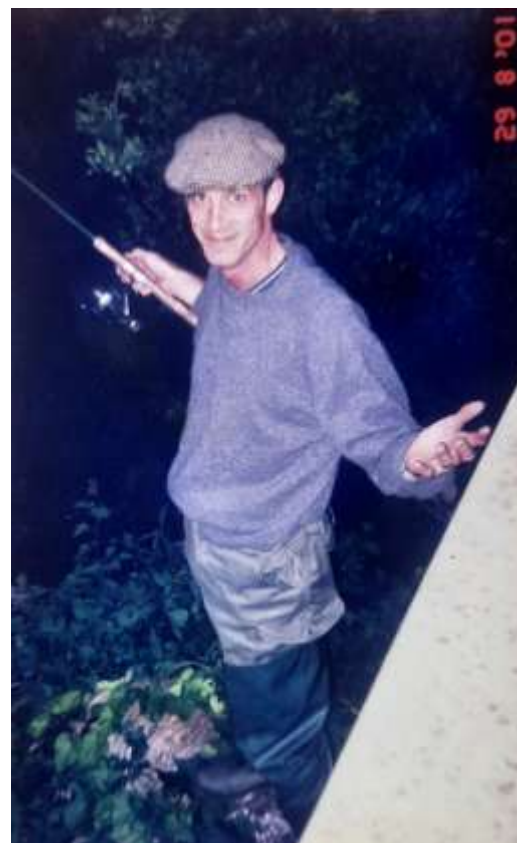
Rob Mungovan “This shows me at the bridge at Barrington having just lost a trout which I had sight-fished for in the clear water, that pic is dated Aug 2001.

In the early 2000's the river started to become turbid, I remember raising it as an issue at the Cambs Biodiversity Partnership meeting probably a few years later”

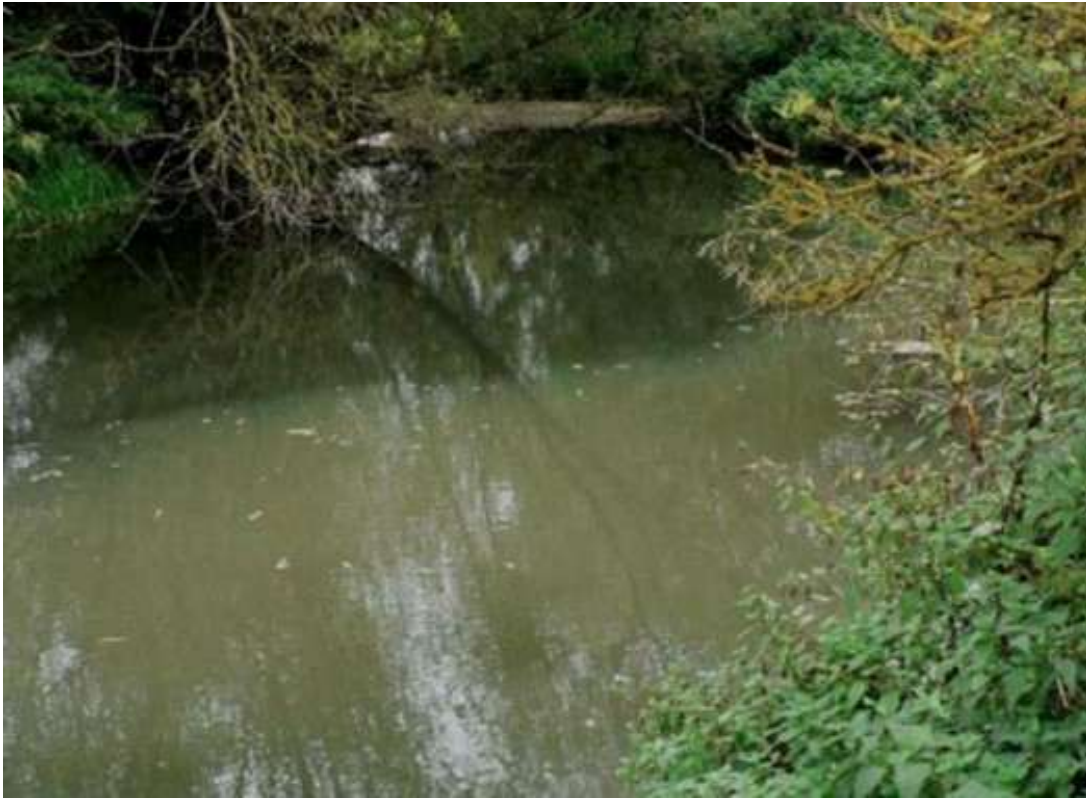
Confluence of Granta and Rhee, 2015, showing the murky flow from the Rhee in the foreground and the flow from the Granta Essex/Cam in the rear.

However, although American Signal Crayfish are present in both these rivers, the Granta is much less turbid than the Rhee, as can be seen at the confluence downstream of Haslingfield in a photo taken in 2015.

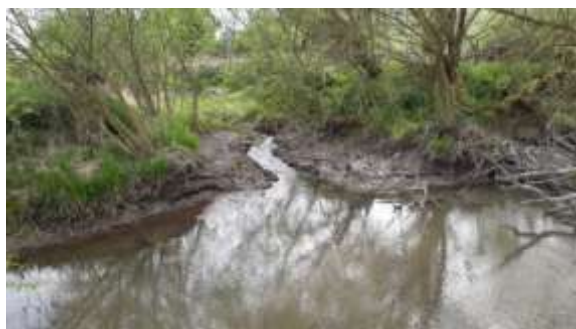
Reduced river levels on the Rhee in April 2019, showing Hoffers Brook entering the Rhee after completion of the removal of the weir at Harston Mill in March 2019 © Rob Mungovan.

The removal of the weir at Harston was a good idea but should have been part of a wider restoration project for that entire reach of river. By removing the weir, the river has spent this spring and summer flushing out tonnes of silt from the Barrington reach to Harston. That material can only move downstream and that is why the Rhee has been even more turbid this year. The Rhee valley contains no significant deposits of coarse material, hence I very much doubt if the river will achieve any meaningful restoration without physical intervention to re-create the former gravel beds and high bed level. With the bed having been lower by dredging, and with the weir removed which previously held back water levels, the river can only down cut as it tries to achieve a balance between gradient, sediment transport and flow. I predict that the Rhee will continue to transport high volumes of fine sediment downstream, and that once it becomes shallow it will become infested by branched burr reed which will dominate it until a shallow bed profile is restored”

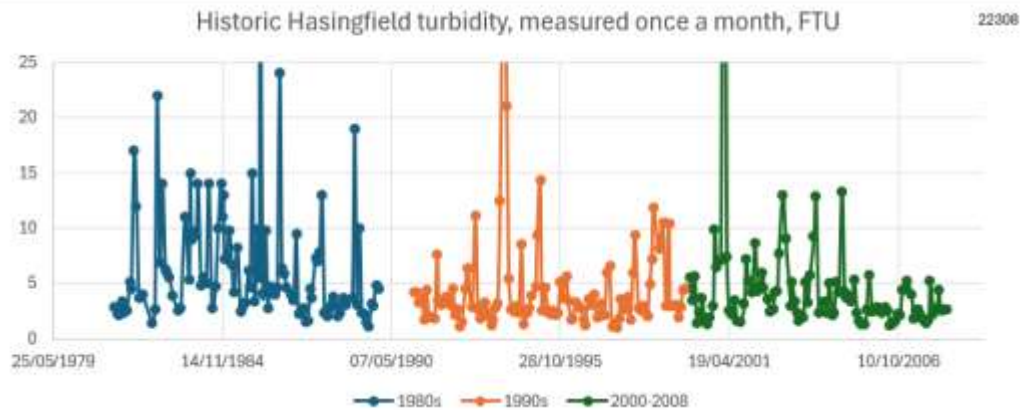
This shows that, although in some months, turbidity was higher than in other months (which will sometimes be because of higher rainfall washing soil and silt into the rivers) there was little difference in the pattern of turbidity between the 1980s, 1990s and 2000's.

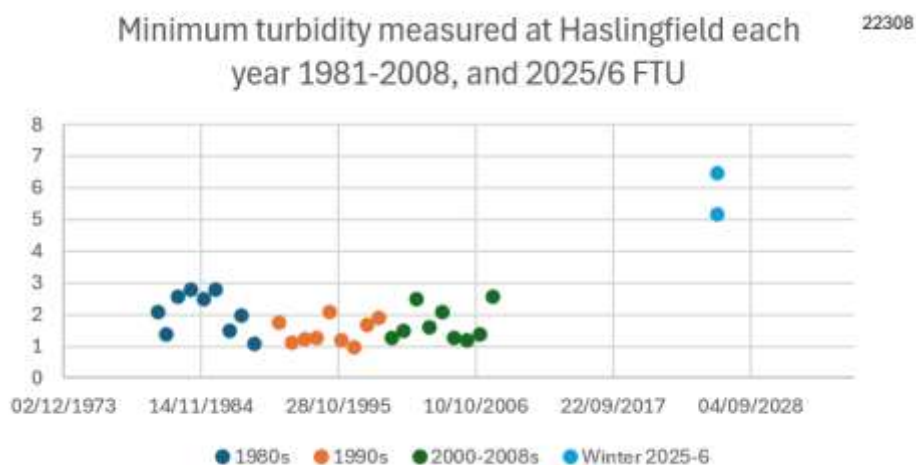
This shows clearly that the turbidity has indeed deteriorated at Haslingfield in the last 20 years. In the 1980s 90s and early 2000s it would frequently reach a minimum of 2 FTU which would have appeared crystal clear, in contrast to a minimum of 5 FTU in early 2026.
