Interim Report on phosphate monitoring in the upper Bourn Brook and its tributaries

Dr Mike Foley, Cam Valley Forum 8th April 2022

Interim Report on Phosphate Monitoring in the upper Bourn Brook and its Tributaries

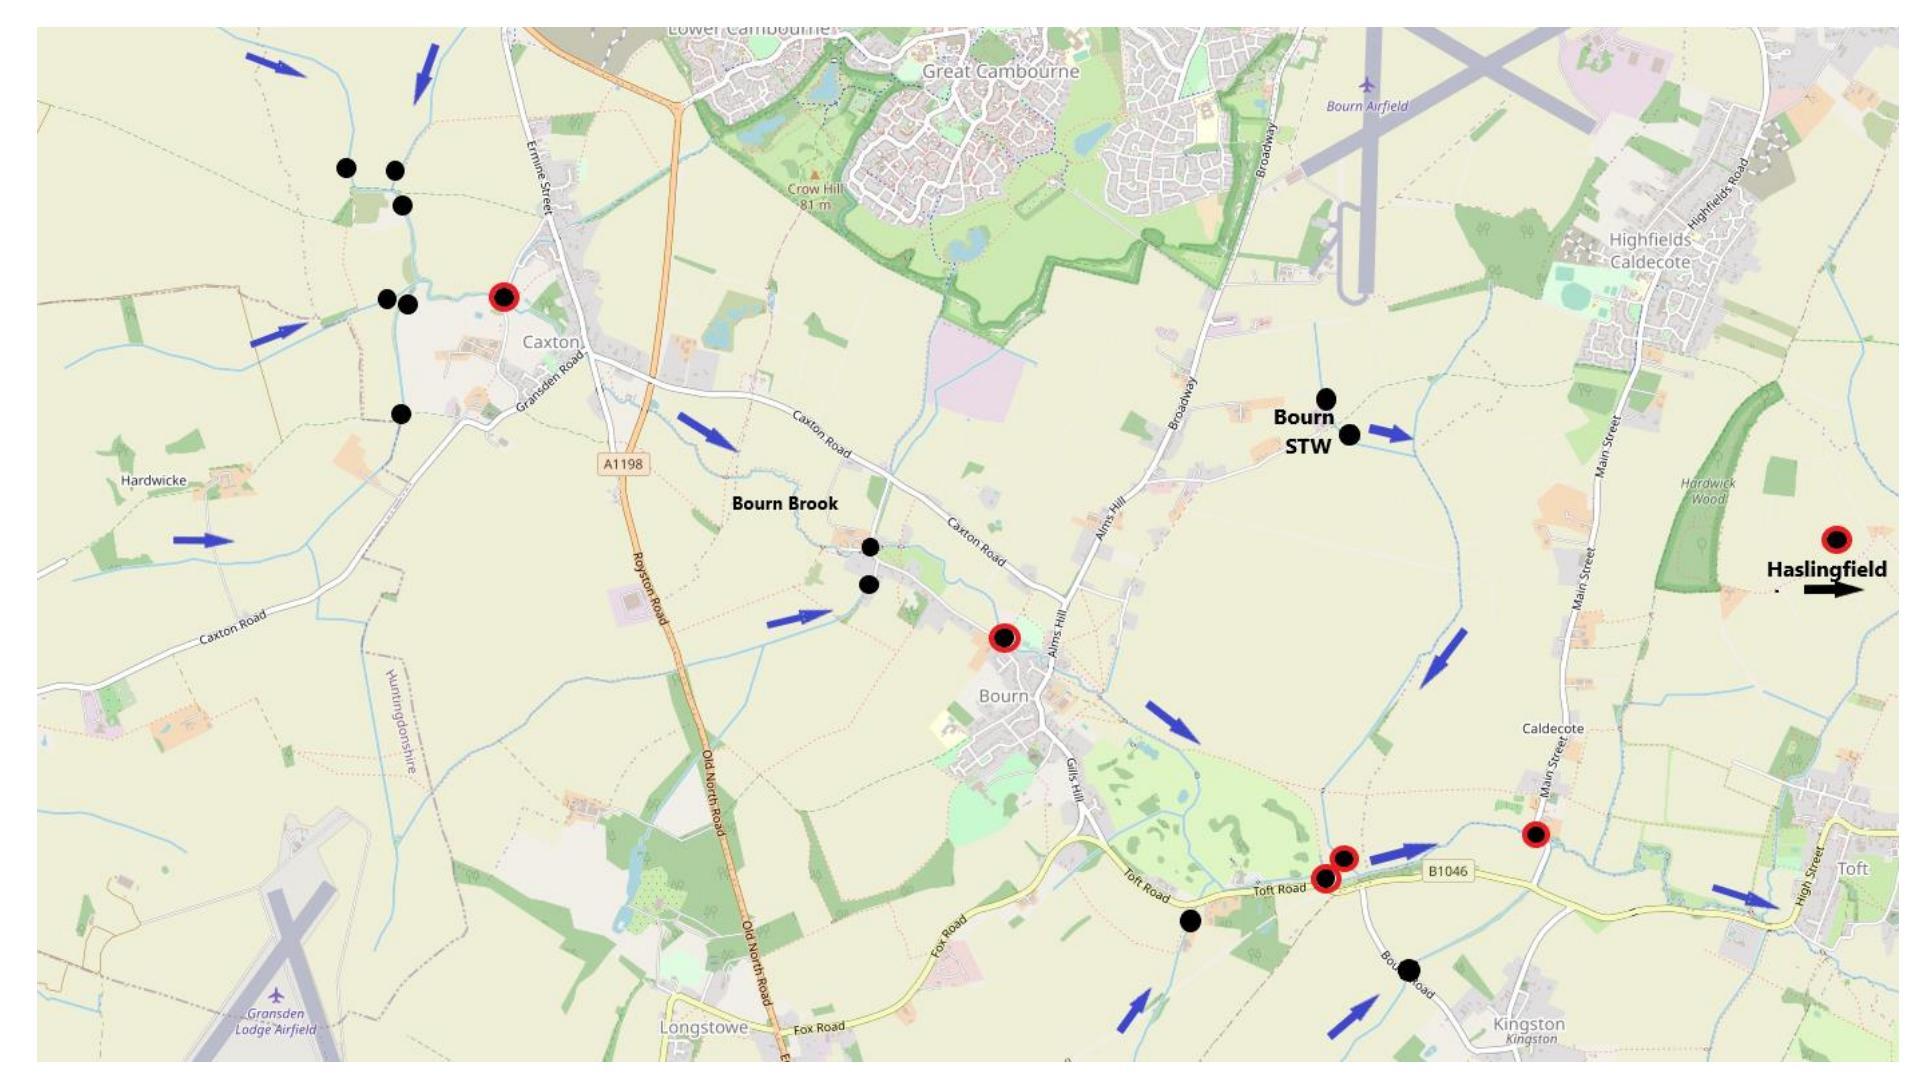
Figure 1: Locations of all sampling sites, key locations (red-ringed), and direction of flow of watercourses

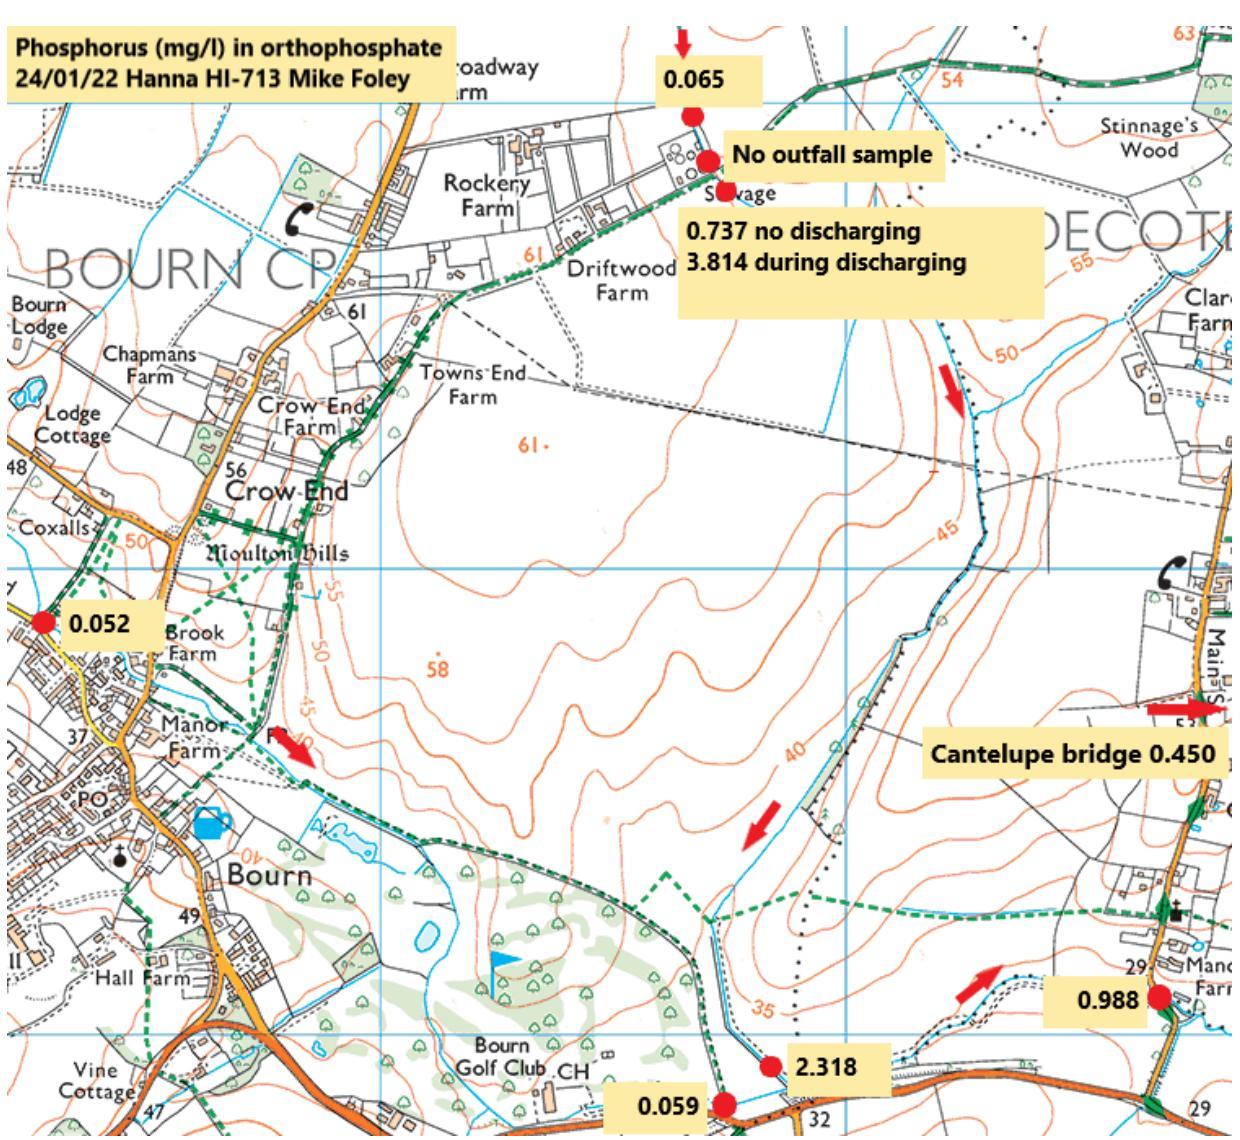
Figure 3: Sampling sites and P values 24th Jan

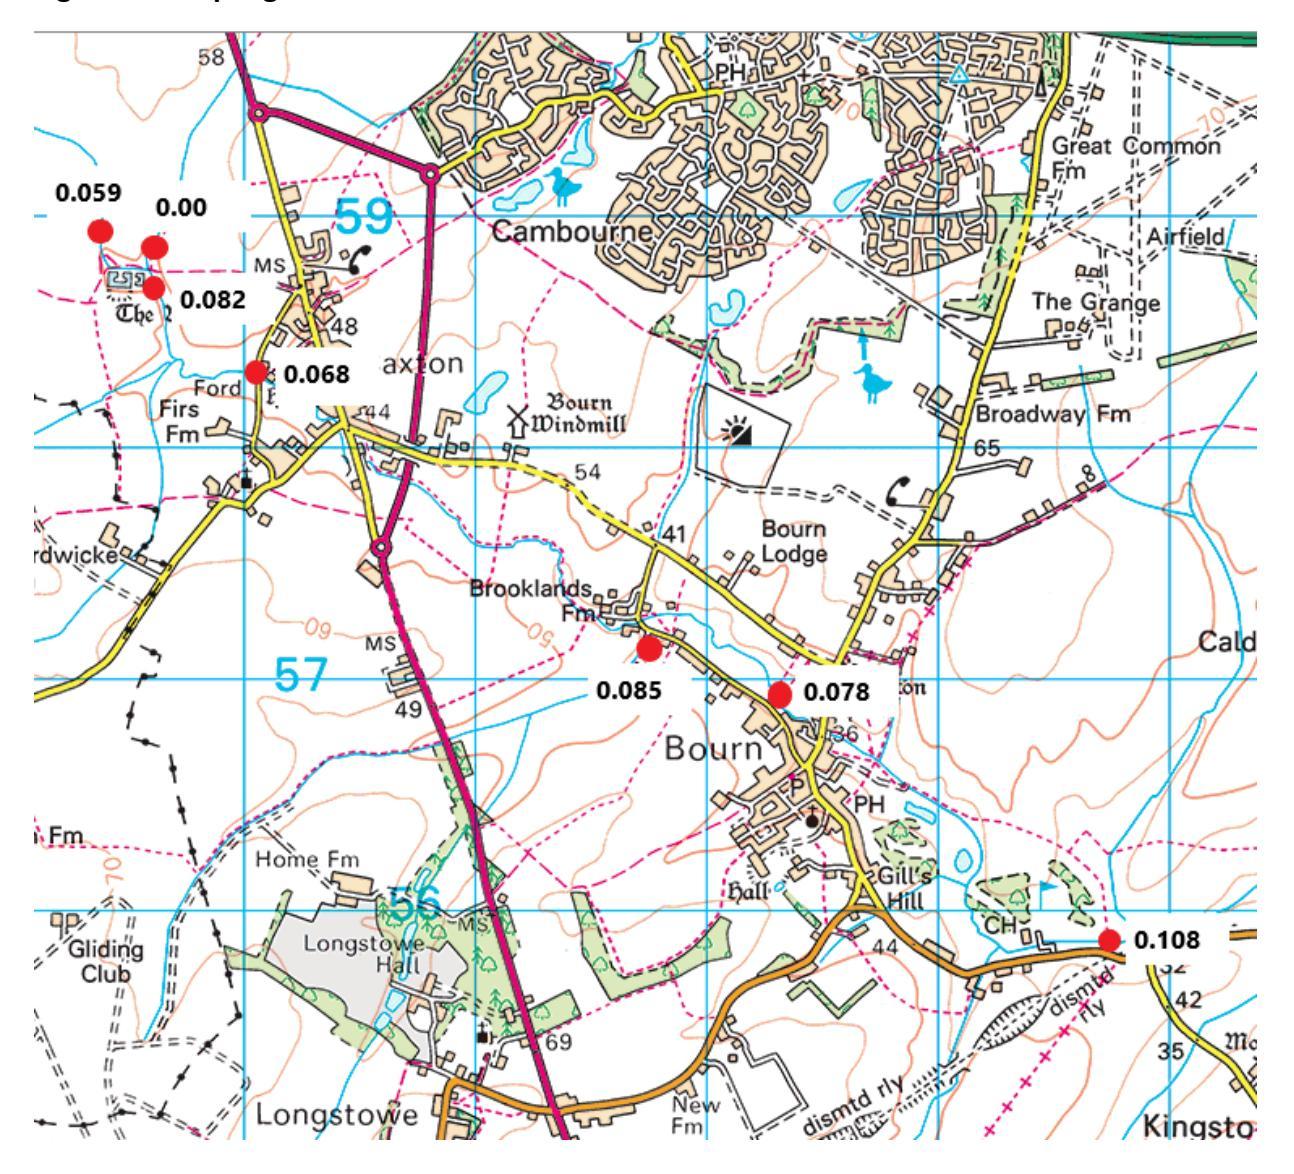
Figure 4: Sampling sites and results 6th Feb

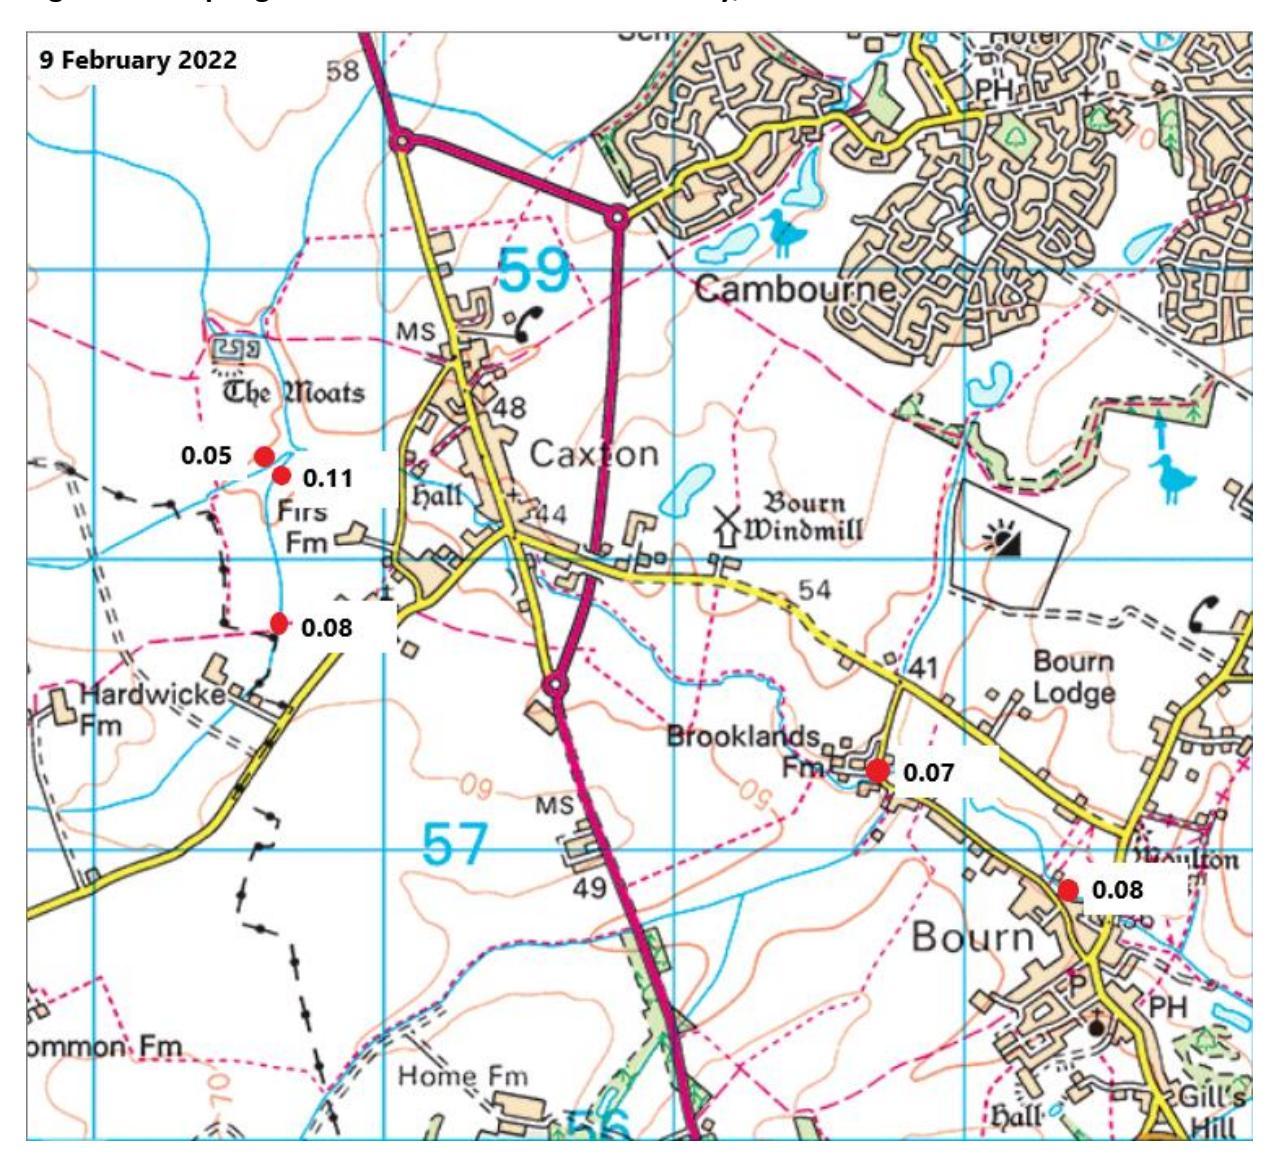
Figure 5: Sampling sites and results above Bourn only, 9th Feb

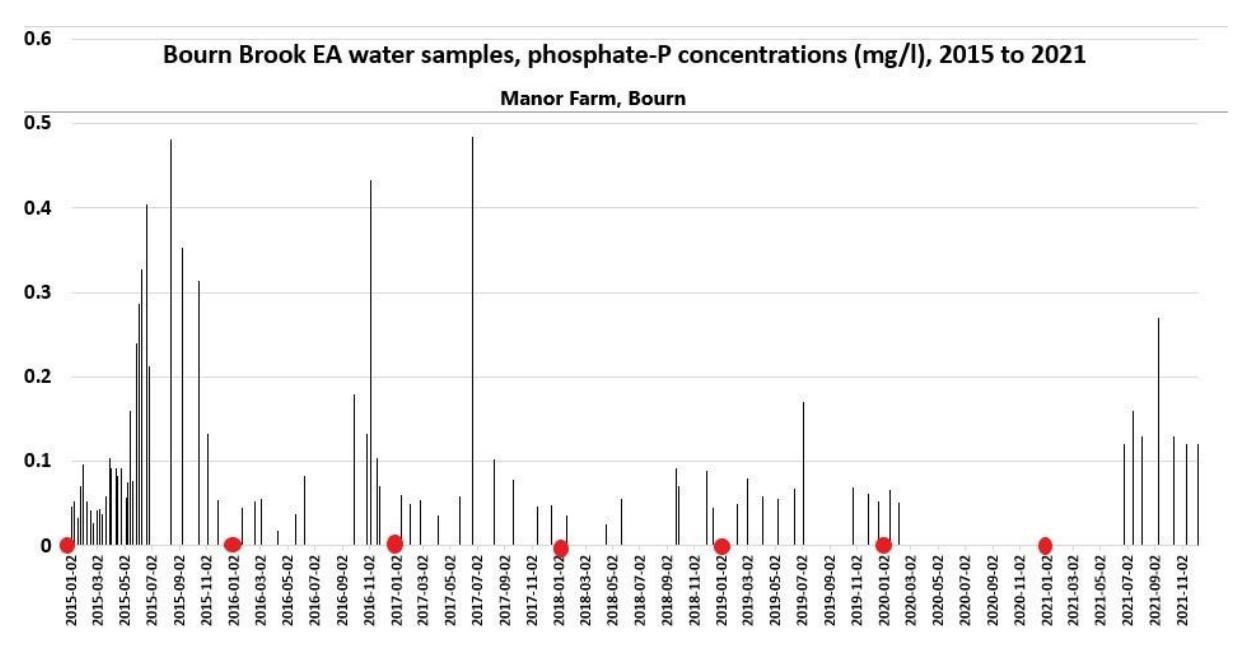
Figure 6: EA historic data on phosphate-P concentrations, extracted data from 2015 to date, for samples taken at Manor Farm footbridge, Bourn. Red markers show 1 January for each year.

Although phosphate levels were mostly very low in the upper catchment between 24 January and 3 March, historic EA data for summer or early autumn in the Bourn Brook at Bourn (Figure. 6) shows that higher levels could occur. EA data for their Haslingfield sampling site (Figure 7) showed much higher levels overall – however Haslingfield is downstream of the Bourn STW. Furthermore, higher concentrations of P from any source will inevitably occur in summer when there is <u>less flow</u> to dilute the pollution.

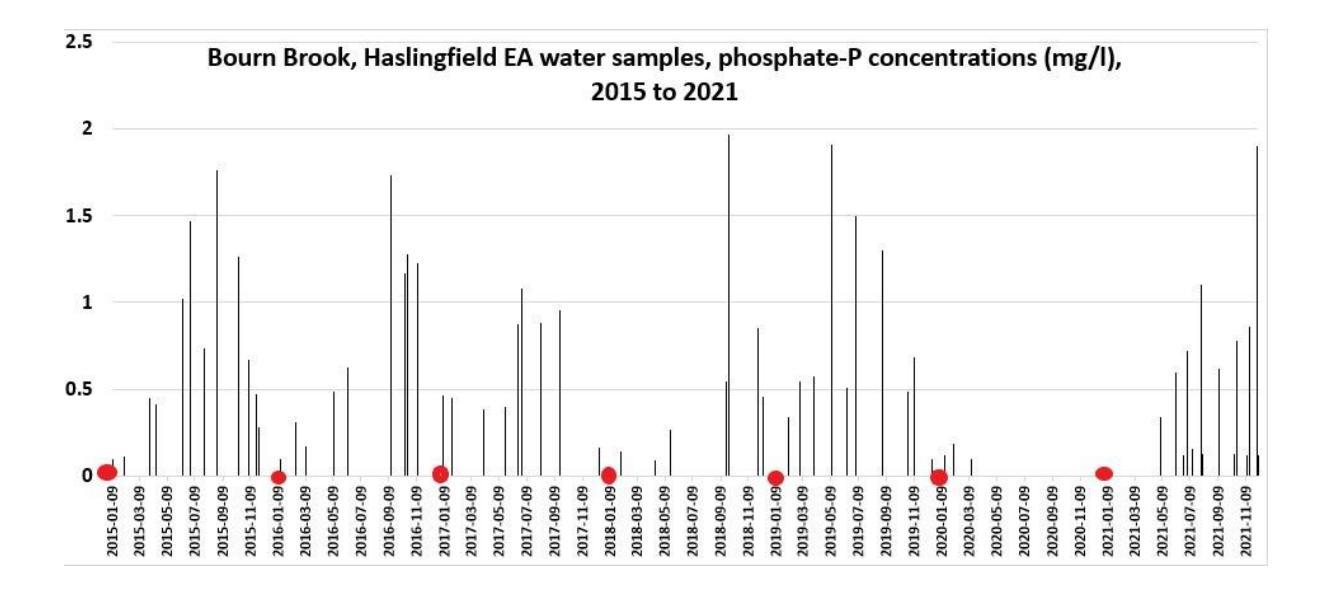
Figure 7: EA historic data on phosphate-P concentrations, extracted data from 2015 to date, for samples taken at Cantelupe Farm road bridge, Haslingfield. Red markers show 1 January for each year.

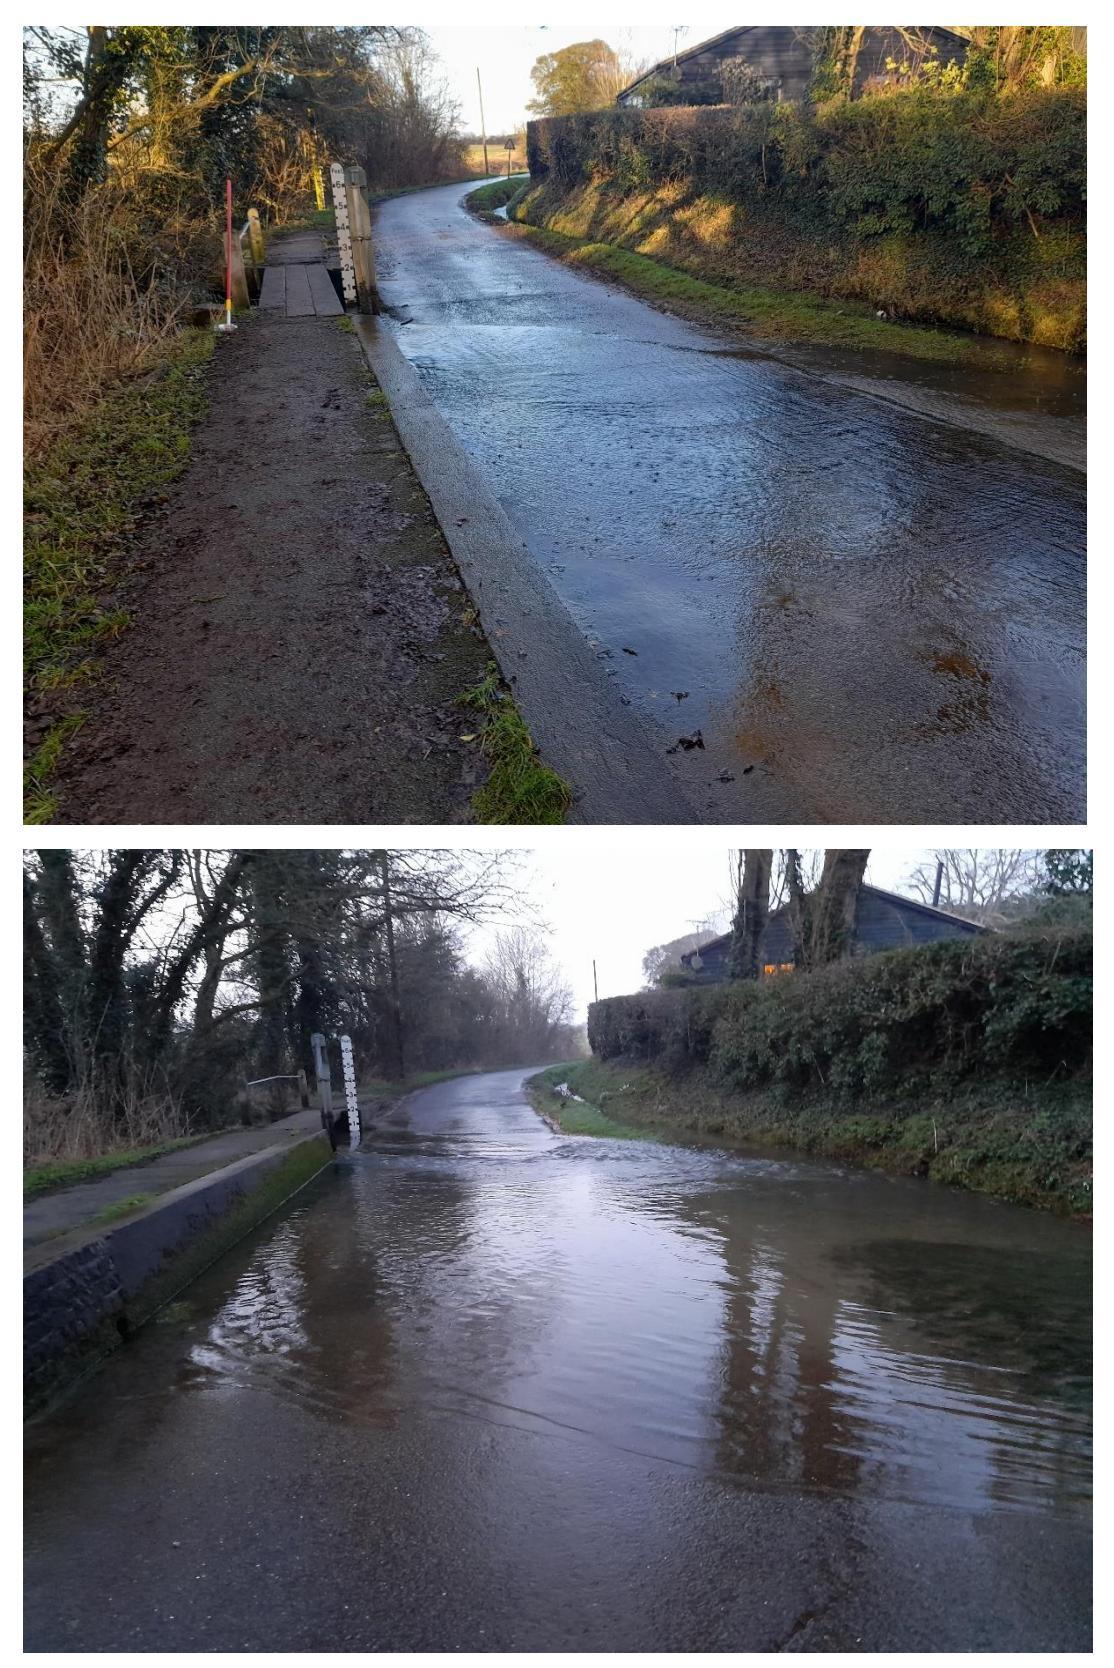
Bourn Brook, St Peters Street, Caxton, ford - 6 February (upper) and 3 March (lower)

On 3 March, the water level was nearly double the levels at the previous samplings. This was evident in all watercourses (see photos), and would have been linked to rainfall amounts of ~15mm over the previous 3 days.

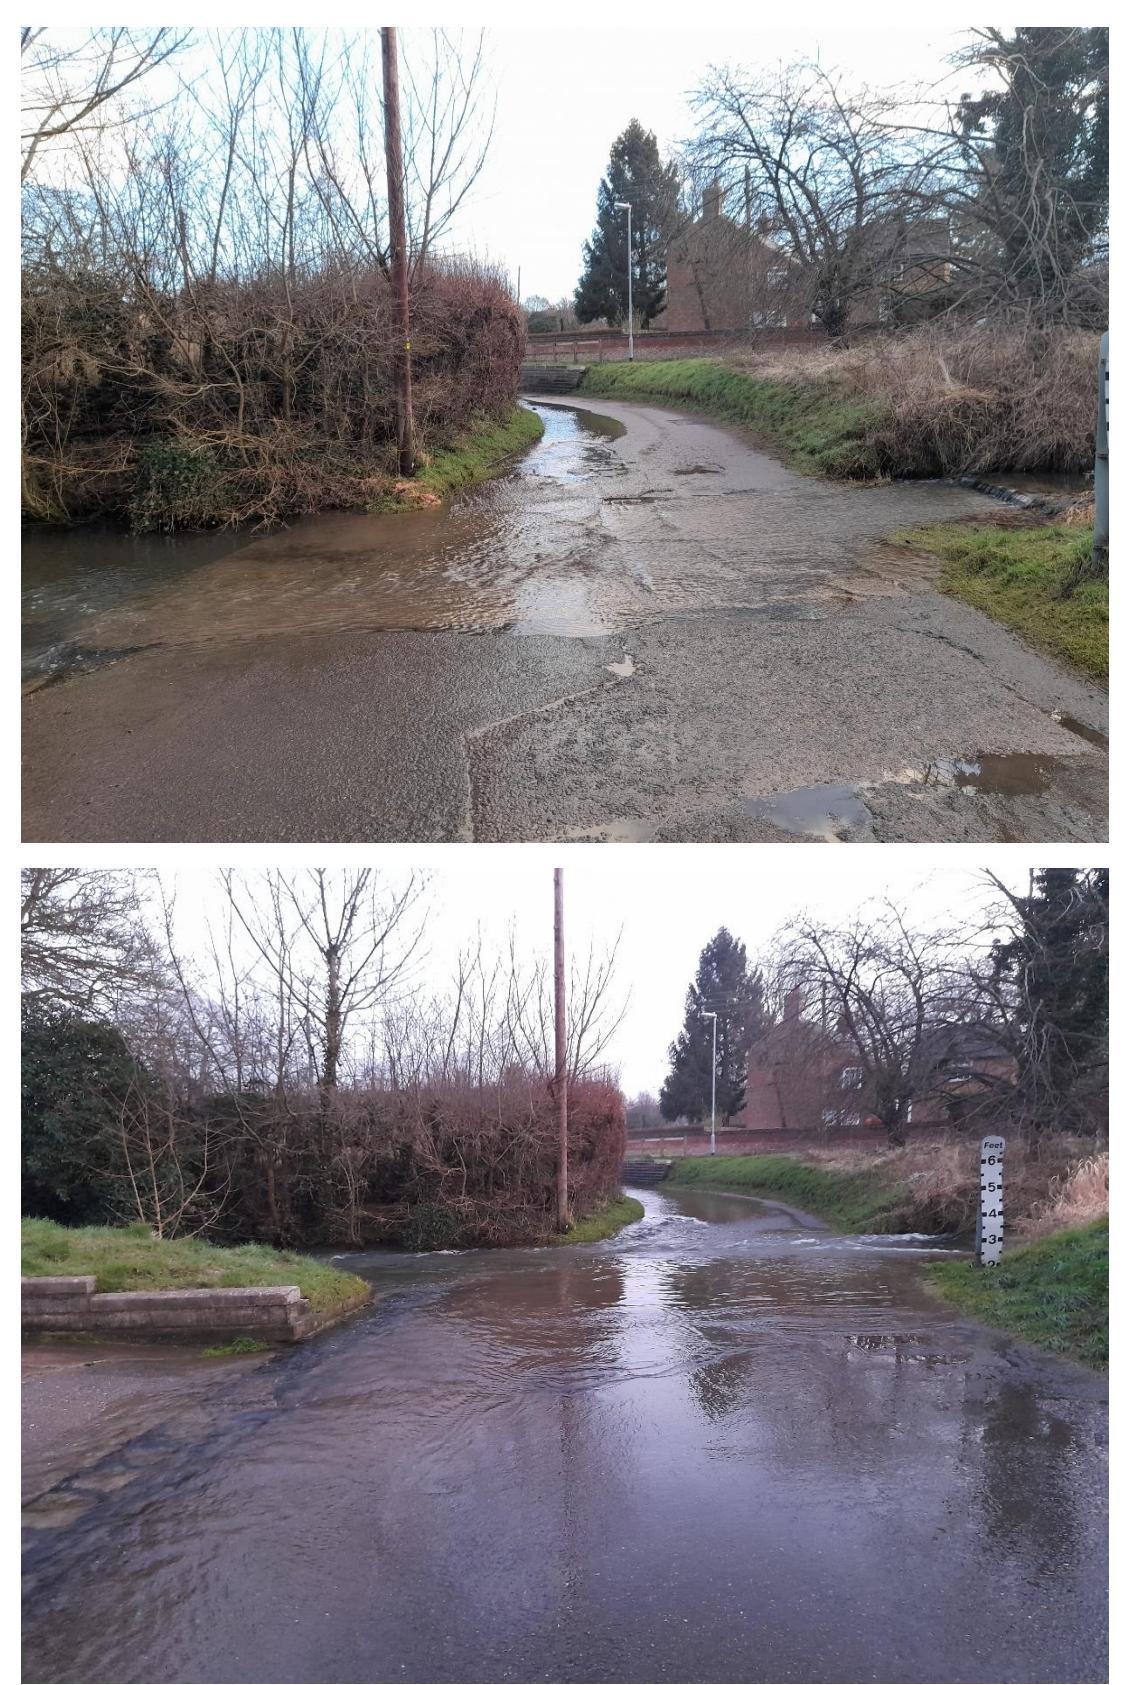
Bourn Brook, Caxton End ford, field stream using road to enter it (LHS) - 6 February (upper) and 3 March (lower)

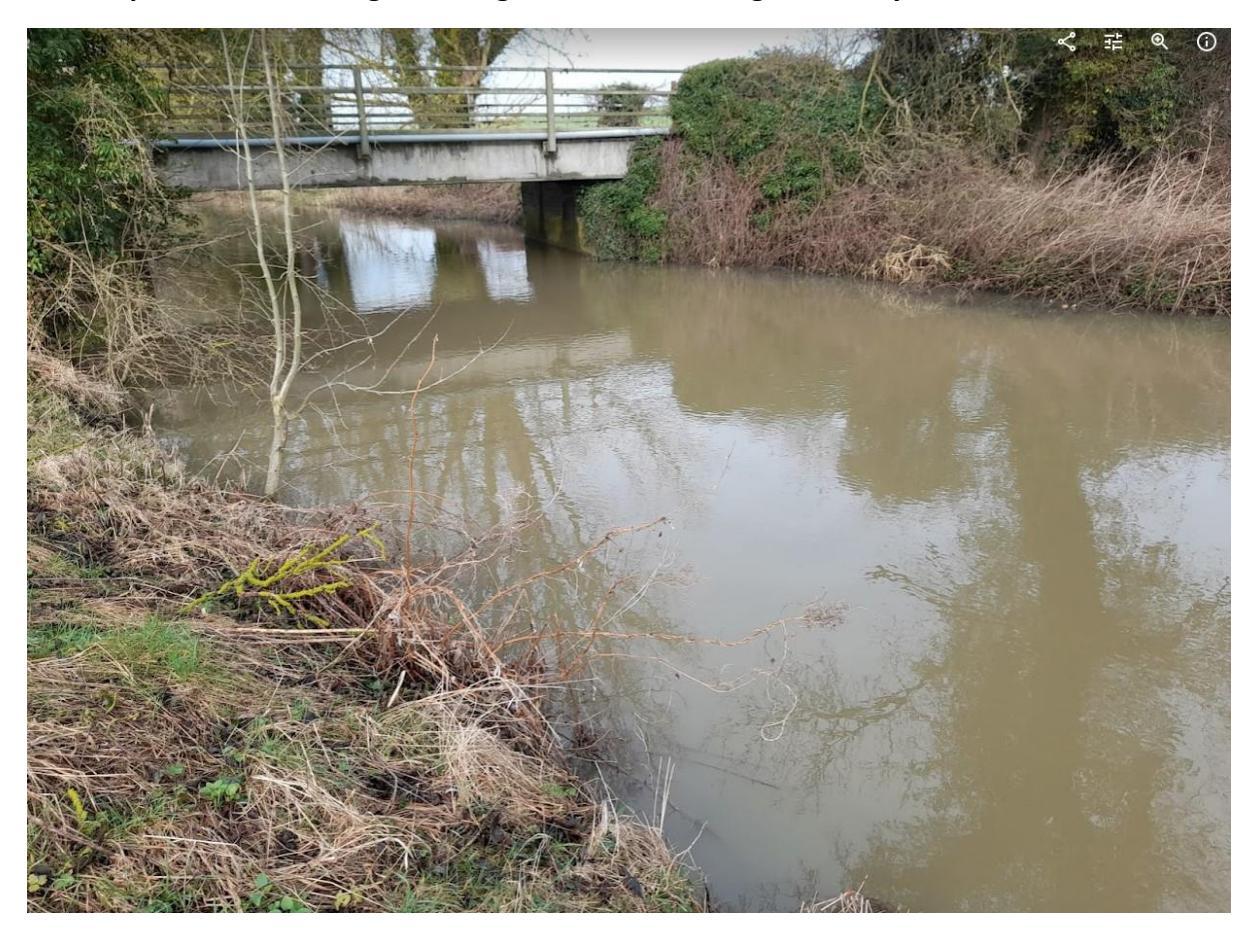
The tributaries had low turbidity, but Bourn Brook itself did appear murkier than before, viewed at the sampling site east of the Bourn golf course. At Haslingfield the Brook was highly turbid and brown, the metal rake head invisible at 30cm depth.

Cantelupe Farm road bridge, Haslingfield, 3 March – high turbidity

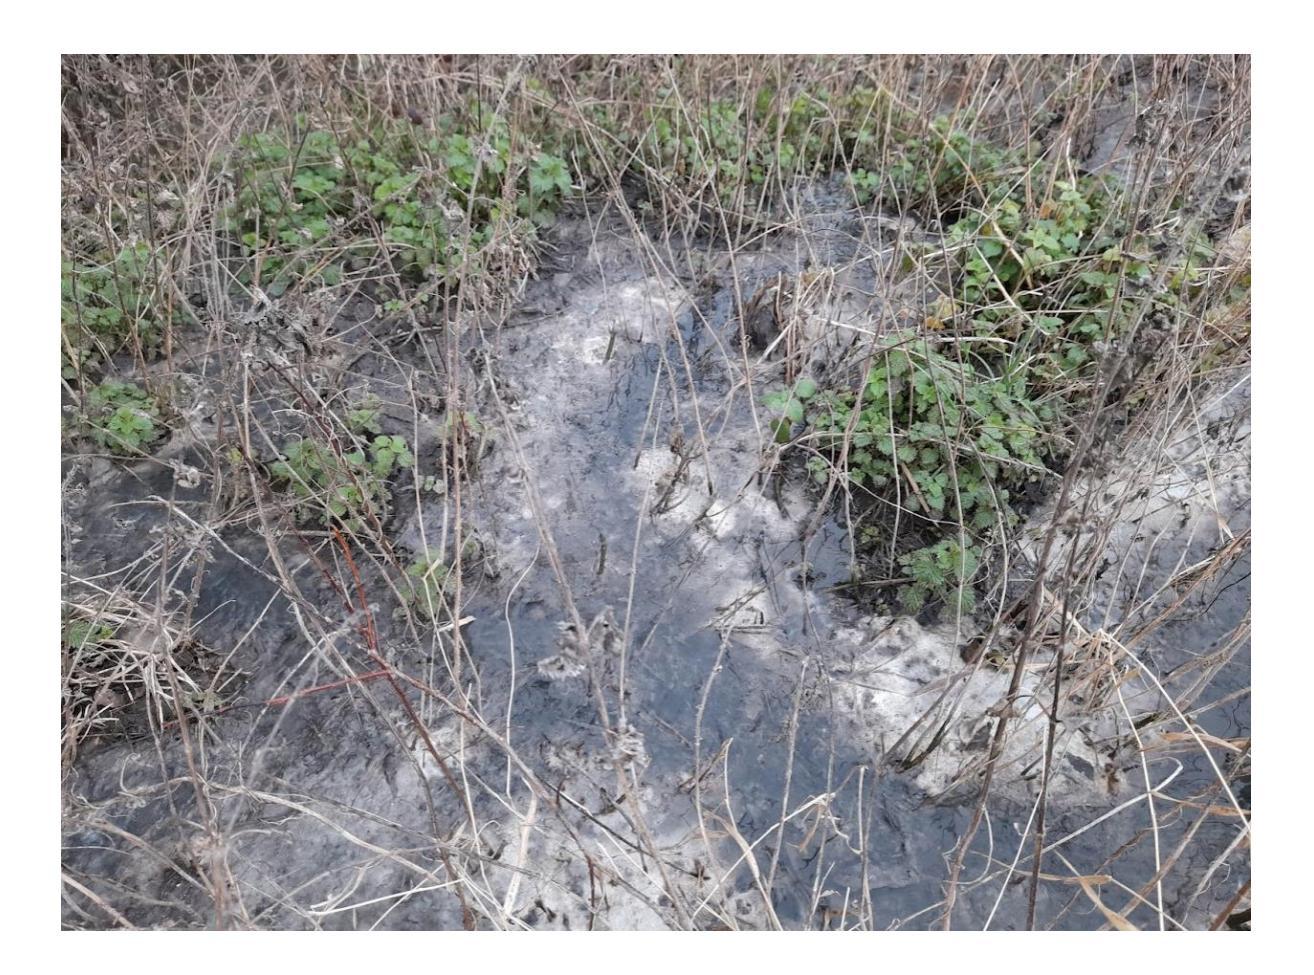
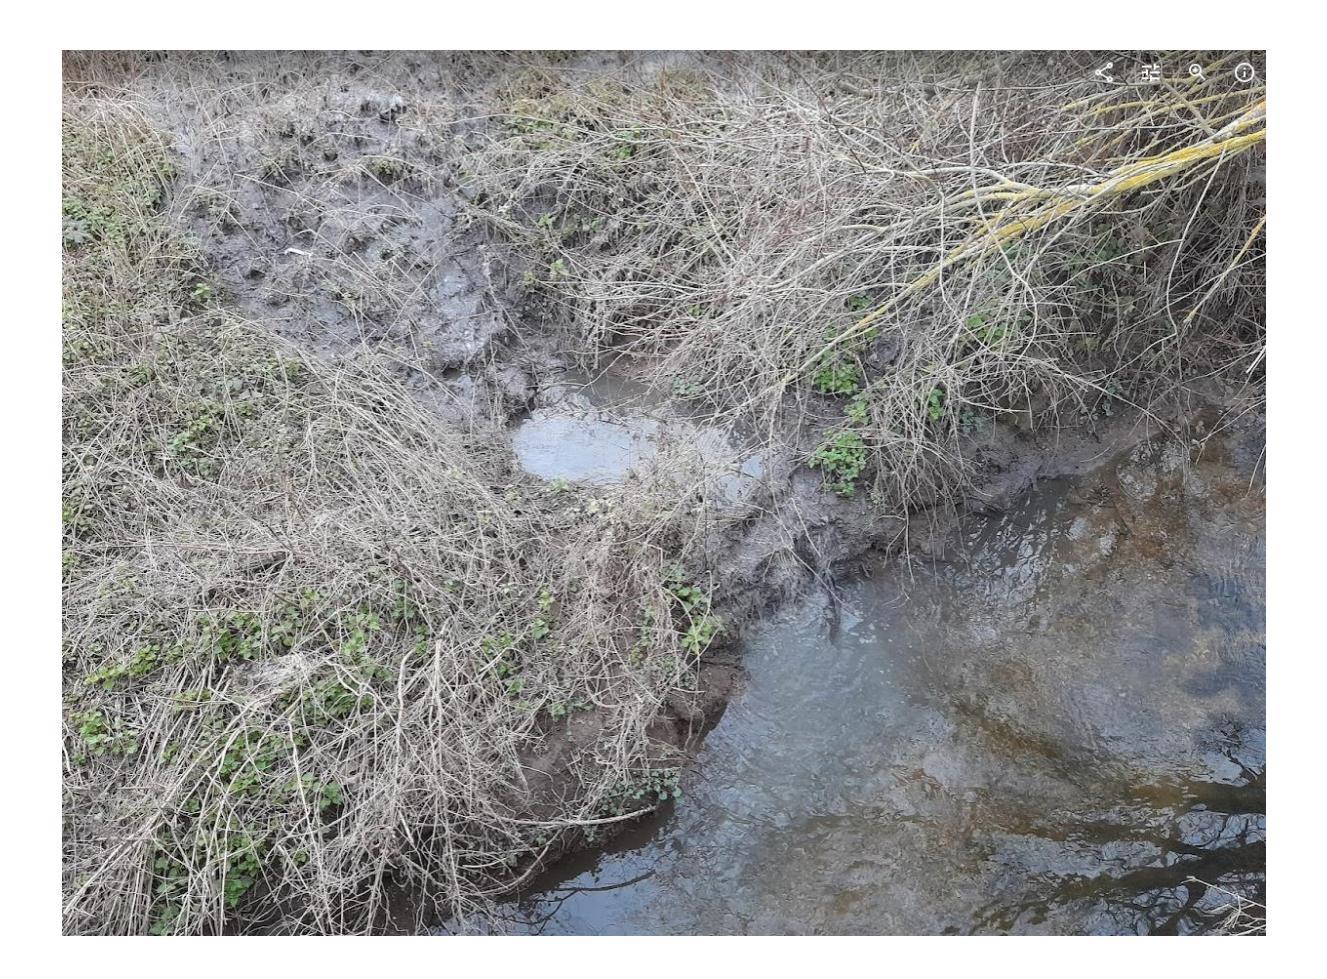
On 11 Feb a leaking sewer pipe was seen to be gushing sewage into the Bourn Brook at Main Street, Caldecote. Its position would not have affected the samples taken for phosphate, except at Haslingfield.

PX Farms field, Caldecote sewage pipe leakage adjacent to Bourn Brook - 11 February

Passage of sewage into Bourn Brook from a broken sewer pipe between the pumping station nearby and Bourn STW, just upstream from Main Street road bridge. The flow was considerably less at the time when this photo was taken. Liquid was pouring into the brook, with a rapid slowing down before the photo could be taken as the pump shot down. Prompt action was taken by Anglian Water.
